# Effect of Coal-Contaminated Aggregate on Asphaltic Concrete Pavement Performance

VISHNU A. DIYALJEE

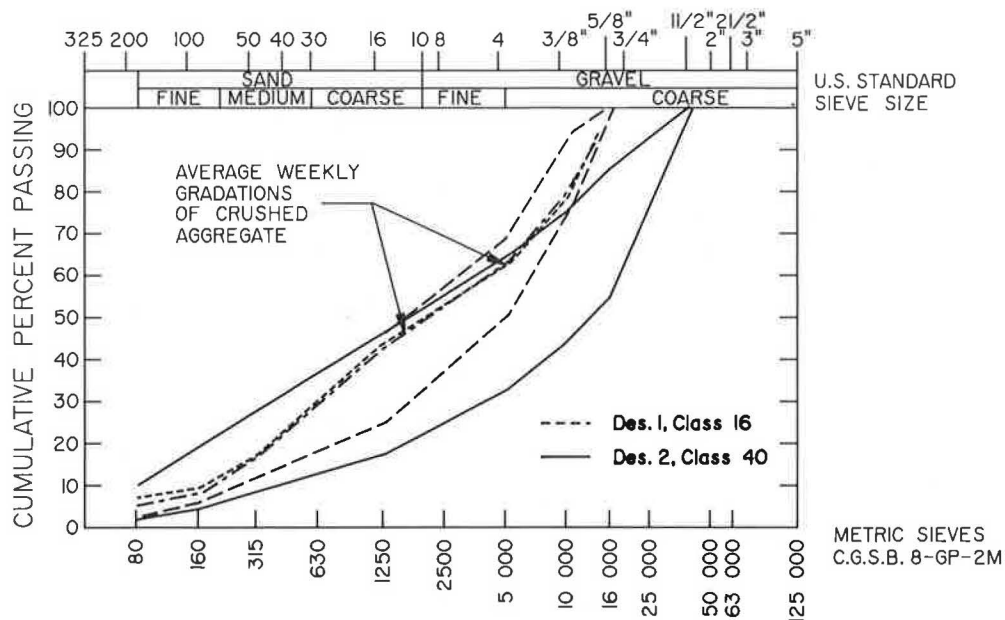
**FIGURE 3** Aggregate gradation specifications.

Production of Designation 1 Class 16 material from the contaminated source was resumed on October 7, 1983. The supplier continued to produce an "all-in" aggregate satisfying the gradation and fracture specifications. The weekly average gradation up to the completion of crushing is shown in Figure 3.

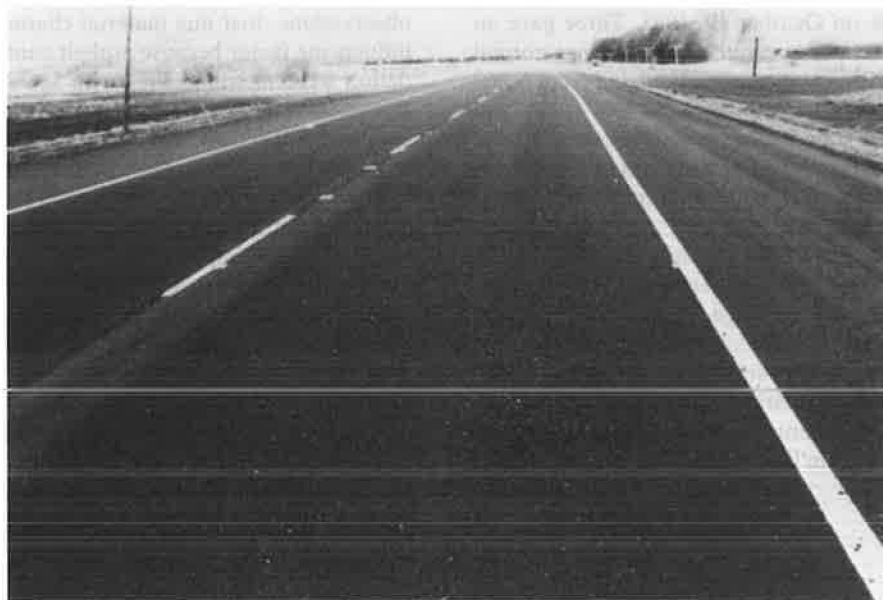
FIGURE 5 Pavement surface texture due to loss of fine aggregate.

The loss of fine aggregate was evident throughout the entire roadway length. This loss gave the pavement a very coarsely textured appearance, which was very pronounced along wheelpaths and at the intersection of Hwy. 28:04 and SR 827:02. The appearance of the pavement resulting from this loss of fine aggregate is illustrated by Figure 5.

On May 7, 1984, a further inspection of the roadway was undertaken by the department's surfacing consultant. On the basis of his observations, it was recommended that SR 827:02 and SR 644:02 be fog-sealed immediately with an SS-1 emulsion at an effluent rate of 0.5 kg/sq m. Further, it was recommended that all roadways be scheduled for seal coating in the 1985 construction program.

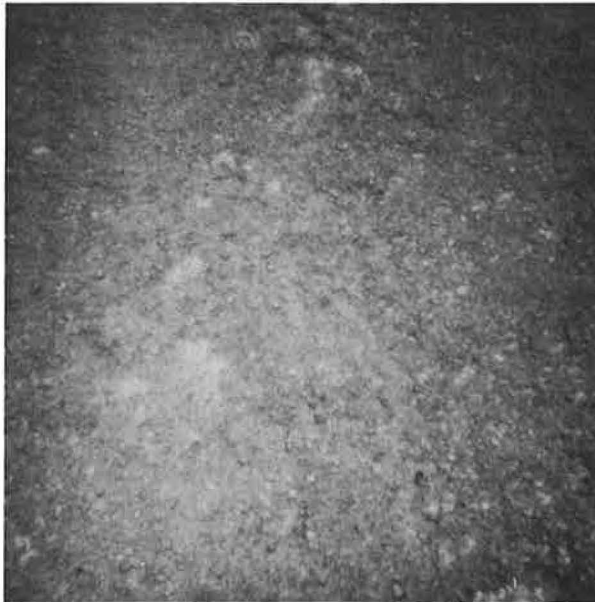
**FIGURE 6** Pitted or pock-marked appearance due to coarse aggregate loss.

The loss of coarse aggregate particles from the pavement surface, giving the mat a pitted or pock-marked appearance, was also quite evident. This distress manifestation was distinct from the loss of fine aggregate and from the raveling that occurred at the tapers. On close visual and surface examination of the pavement, it was found that some of the coarse aggregate particles could readily be removed with a penknife using moderate pressure. Some of these particles were associated with poor aggregates, such as chert and clay ironstone, typically found within the Saskatchewan gravels. Figure 6 depicts the pitted or pock-marked appearance of the pavement surface.

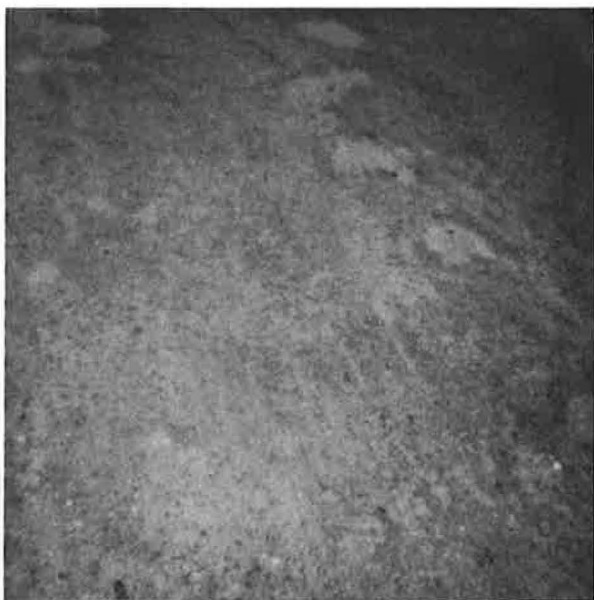
**FIGURE 7** Severe raveling.

In the Town of Thorhild the loss of fine aggregate was extremely severe, resulting in a very rough textured pavement surface as shown by Figure 7. Random pavement cracks, similar to those observed on Hwy. 28:04, were also observed at isolated sections.

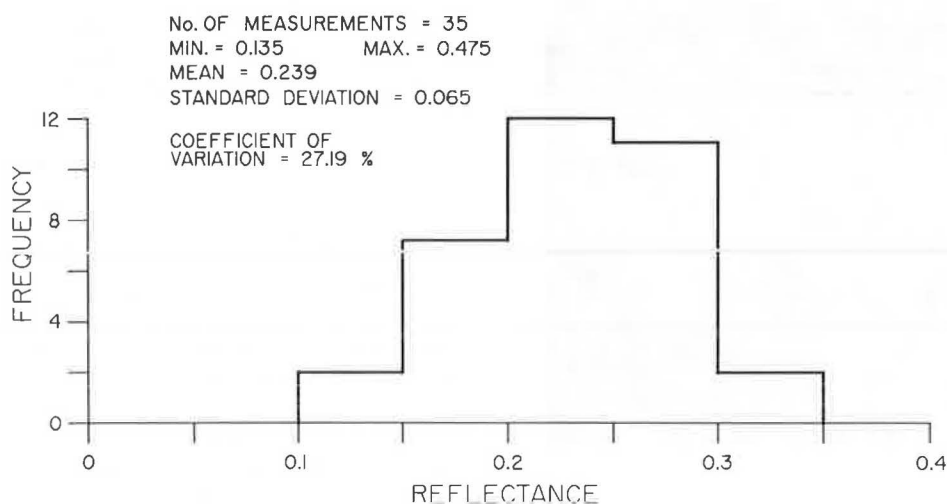
FIGURE 8 Reflectance diagram, coal petrography.

The results of the petrographic analysis are summarized in Figure 8 as a plot of frequency versus reflectance. These data were obtained from a 35-point vitrinite analysis. As shown, the reflectance ranges from a minimum of 0.135 to a maximum of 0.475, with a mean of 0.239. On the basis of these results the coal can be ranked as "peat," according to the German and North American (ASTM) classifications. A characteristic feature of the rank of this coal is its bed moisture, which is about 75 percent.
