TRANSPORTATION RESEARCH RECORD

*Work-Zone Traffic
Control and Tests of
Delineation Material*

TRANSPORTATION RESEARCH BOARD
NATIONAL RESEARCH COUNCIL
WASHINGTON, D.C. 1989

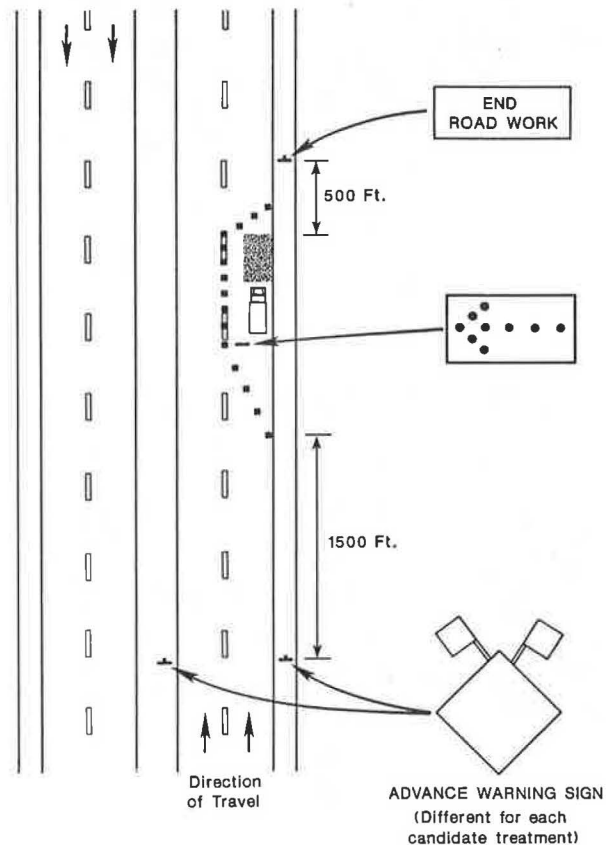
FIGURE 2 Candidate traffic control configuration for short-duration maintenance operations.

plement the arrow panel. The upstream sign would inform drivers that they are approaching a work zone hazard and possibly reinforce the lane change information provided by the arrow panel. Figure 2 shows a schematic layout of the candidate traffic control configuration for short-duration maintenance operations.

For this configuration, dual ROAD WORK AHEAD signs (identical to the first sign encountered in the standard TMUTCD traffic control configuration) were placed 1,500 ft upstream from the beginning of the cone taper. This sign does not provide information about the closure, but indicates that some type of road work exists ahead. This candidate configuration relies on the flashing arrow panel in the cone taper to inform drivers that the lane is closed and that they must be in the open lane when they reach the work zone.

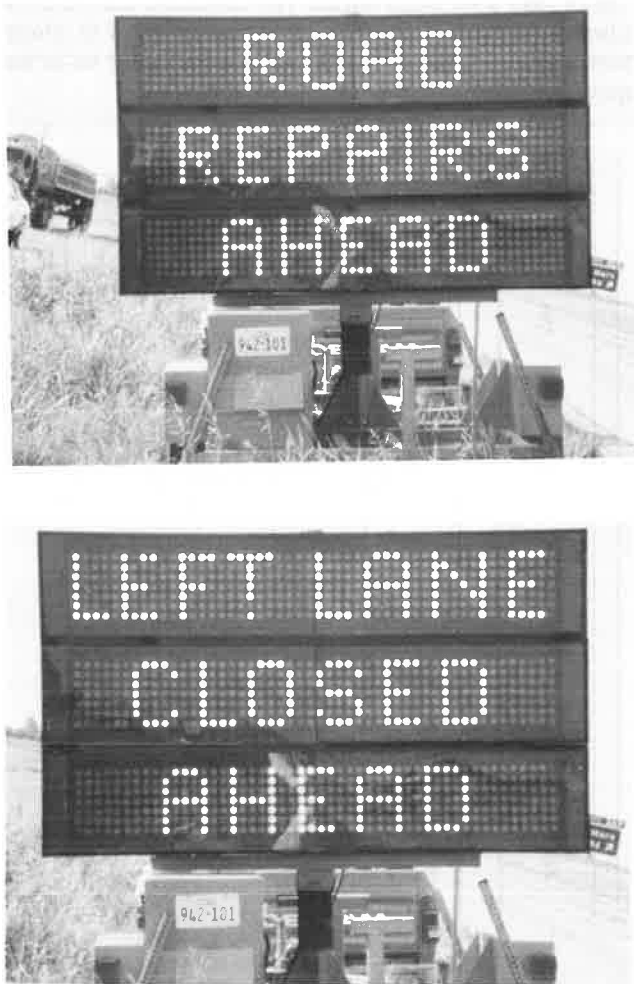
FIGURE 3 Changeable-message signs used in study.

In effect, the information provided by the first two advance warning signs in the standard traffic control configuration is consolidated into this one sign. Figure 3 shows the CMS used in this study.

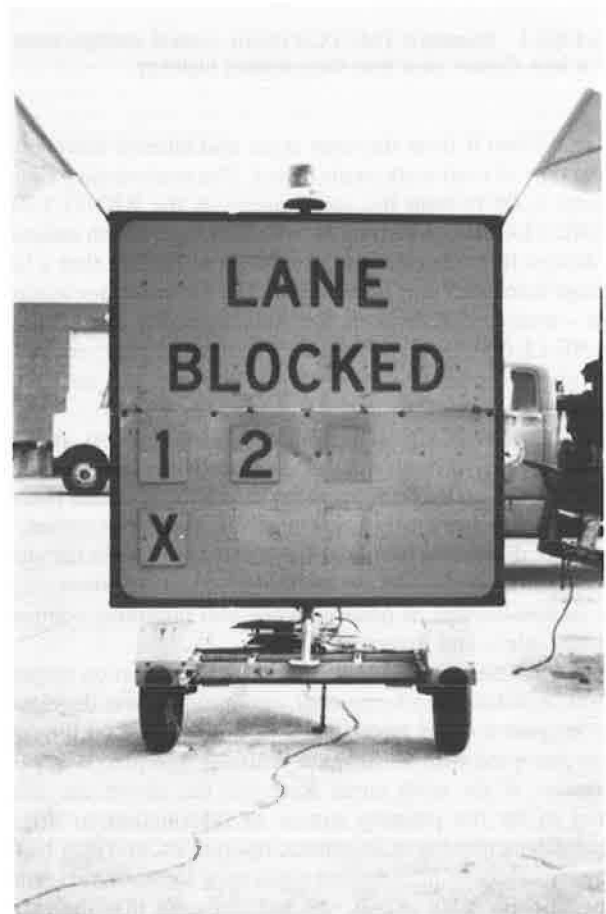
FIGURE 4 The Texas LANE BLOCKED sign.

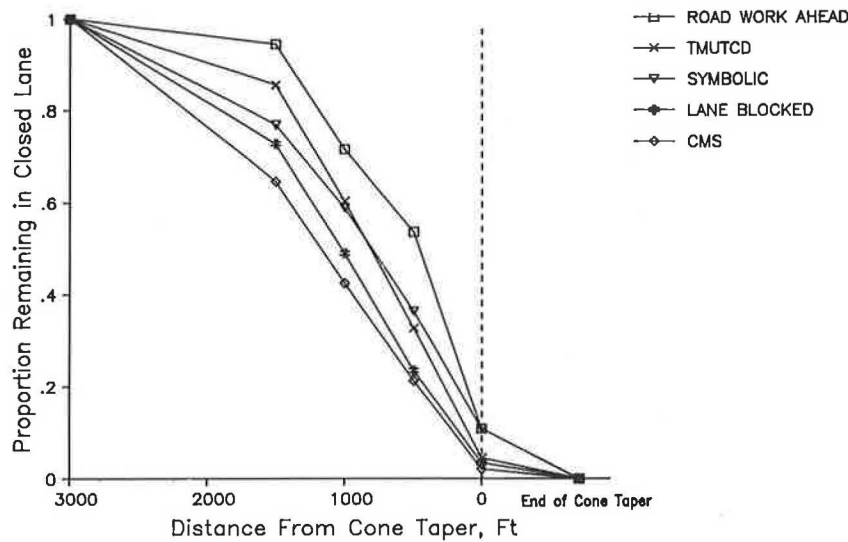
FIGURE 6 Average effect of TMUTCD and candidate signing treatments (left-lane closures; all sites combined).

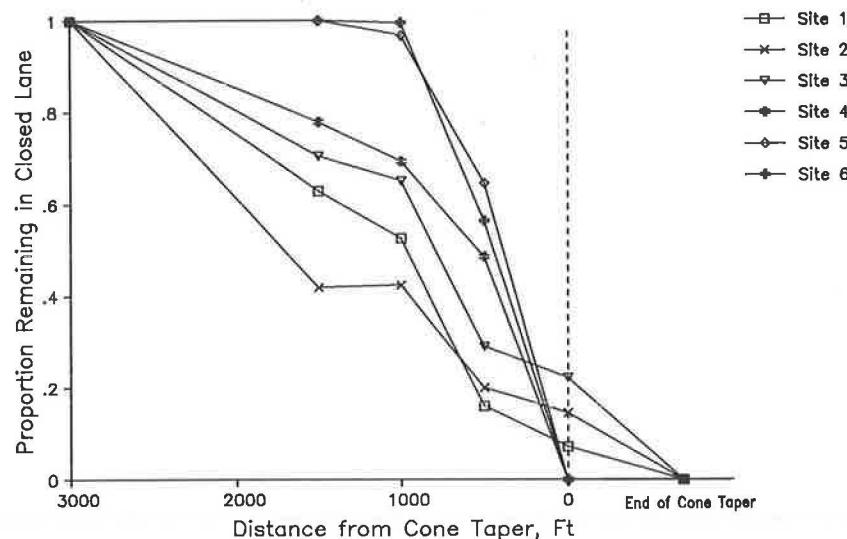
FIGURE 8 Variation in effect of TMUTCD sign treatment (right-lane closure sites).

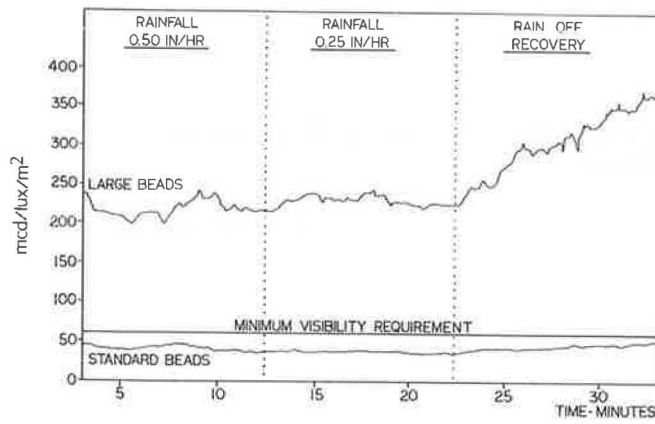
FIGURE 2 Large beads versus standard beads in thermoplastic.

As these graphs indicate, the large-bead pavement marking system provides retroreflectivity levels 3 to 4 times higher

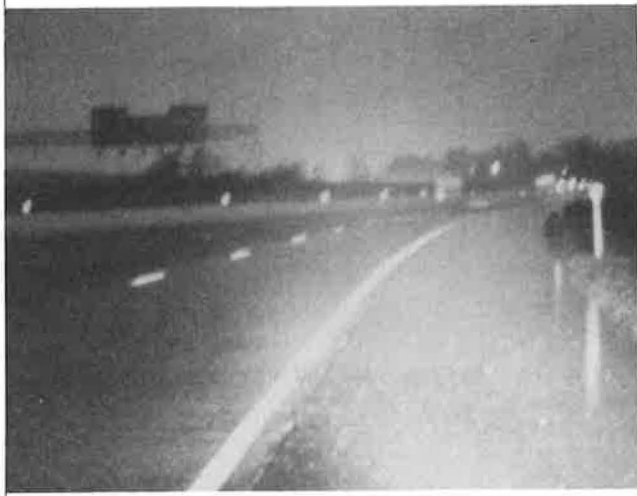
FIGURE 6 Interstate 795, Baltimore, Maryland: large beads in epoxy installed May 1986 on edge and skip; rain of 0.20-in./hr, Nov. 1987.

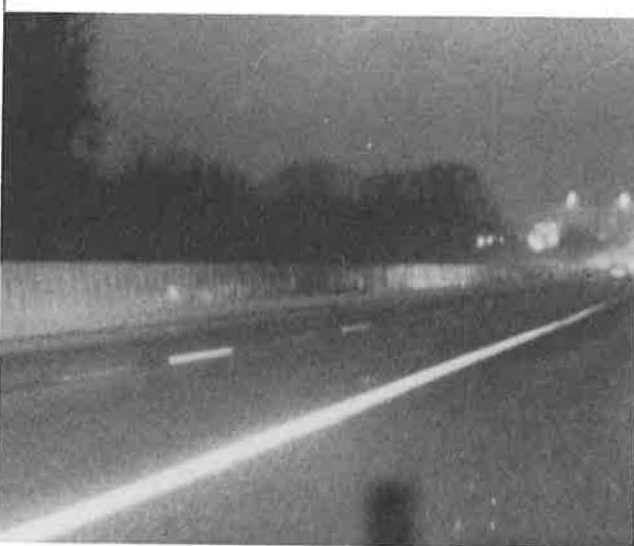
FIGURE 8 Schuylkill Expressway (I-76), Philadelphia, Pennsylvania: large beads in epoxy installed Dec. 1986; standard beads used for skipline between large-bead skips; Dec. 1986 during recovery after rain.

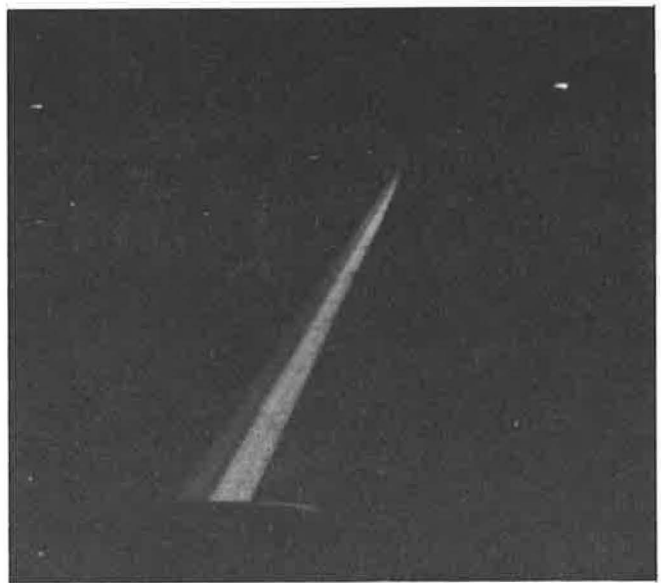
FIGURE 10 Salem, Oregon: large beads in epoxy installed June 1987; large bead edgeline adjacent to standard bead line; Dec. 1987, wet pavement/nighttime.

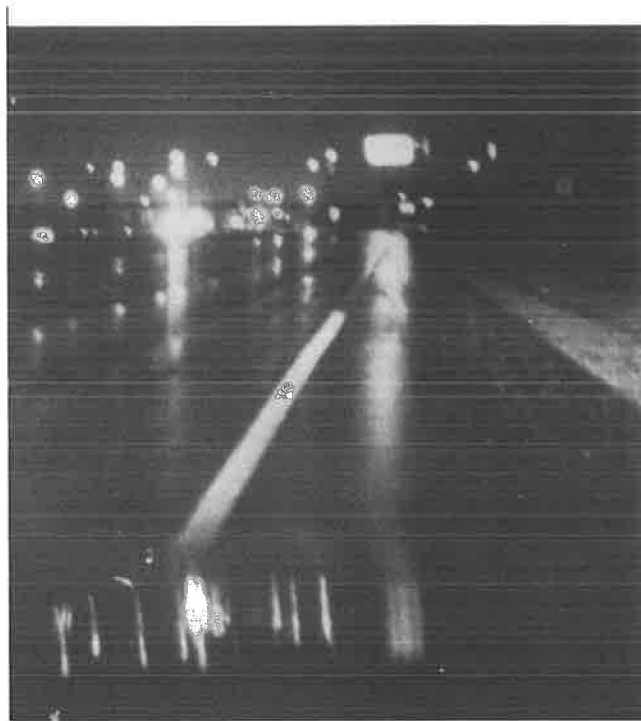
FIGURE 11 Cleveland, Ohio: large beads in polyester installed Aug. 1987; edgeline with standard beads in background; Dec. 1987, wet pavement/nighttime.

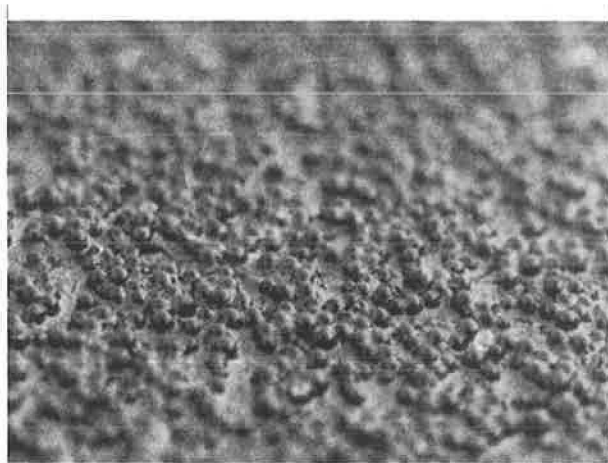
FIGURE 13 Ohio Turnpike: large beads in polyester (profile view).

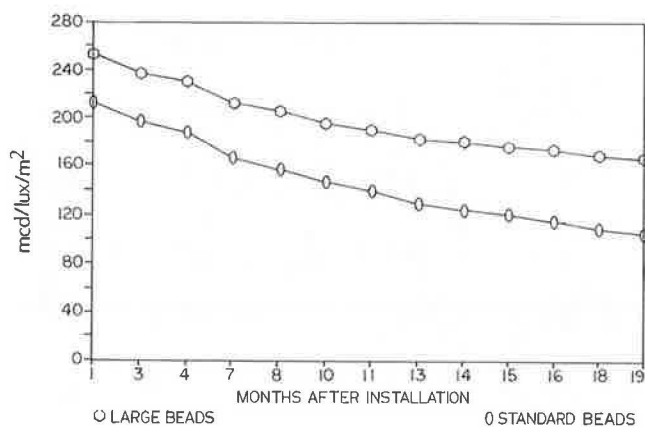
FIGURE 15 Retroreflectivity: large beads versus standard beads in epoxy.

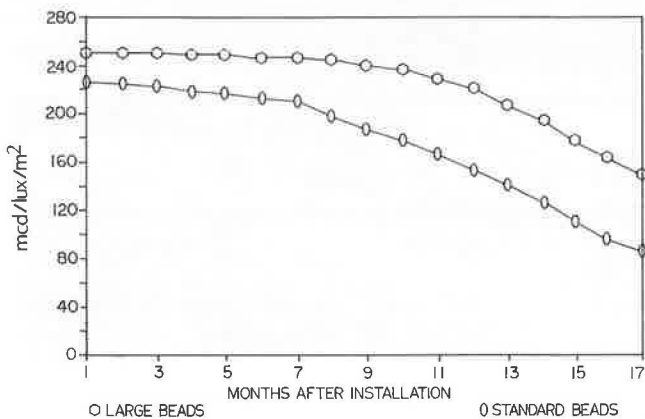
FIGURE 16 Retroreflectivity: large beads versus standard beads in thermoplastic.

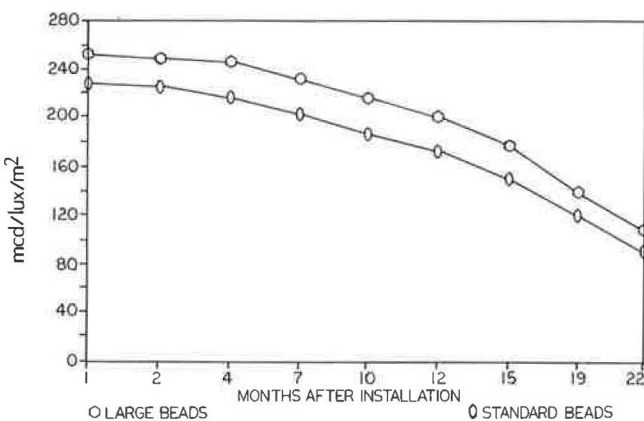
FIGURE 17 Retroreflectivity: large beads versus standard beads in polyester.

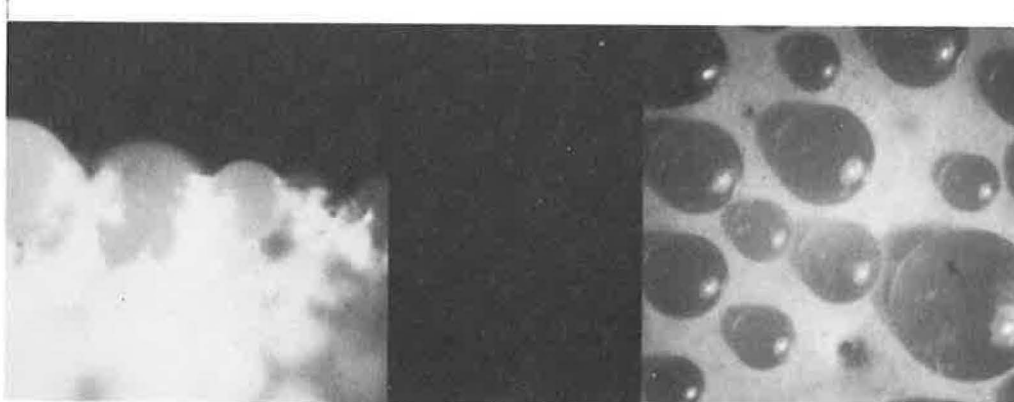
FIGURE 7 Drawdowns and cross section of Systems A, B, C, and D, Sphere 2C (bead rate: 6 lb/100 ft², white). *Left*, cross section (magnified 100×). *Right*, top view (magnified 100×).

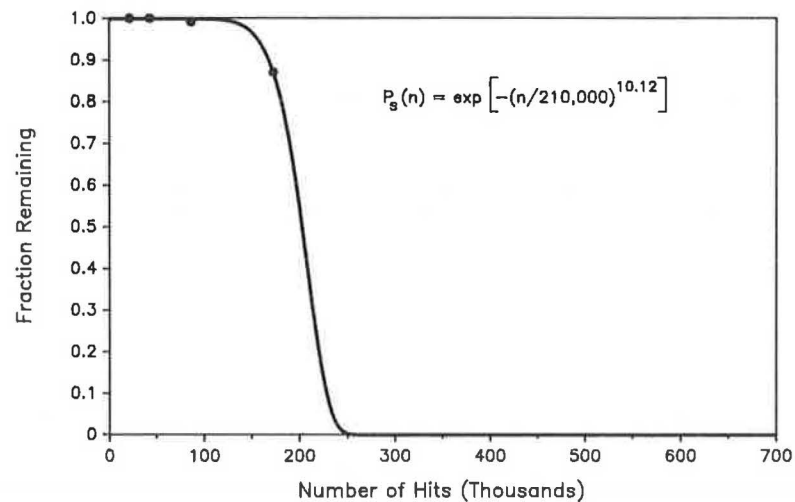
FIGURE 13 Loss rate curves for 4- by 4-in. markers using epoxy adhesive: IH 35 in San Antonio (asphalt concrete).

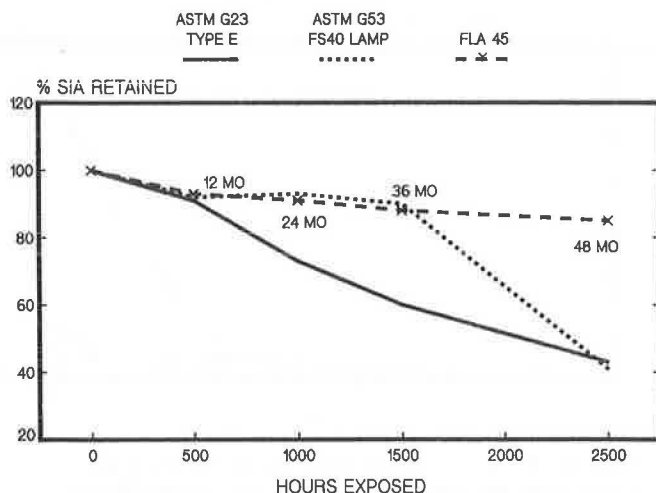
FIGURE 3 Comparison of results for artificial accelerated and Florida 45-degree exposures of retroreflective sheeting lot A.
