# Development of Guardrail Extruder Terminal

DEAN L. SICKING, ASIF B. QURESHY, AND HAYES E. ROSS, JR.

**Development of the Guardrail Extruder Terminal (GET), a low-cost end treatment for W-beam guardrails, is presented in this paper. When impacted, this end treatment causes the W-beam to be flattened and deformed in a controlled manner ahead of the impacting vehicle. The flattening process dissipates energy, and impacting vehicles are decelerated to a controlled stop. The paper discusses static and dynamic laboratory testing of extruder components as well as full-scale crash tests of the GET. The GET is shown to be in compliance with nationally recognized impact performance standards.**

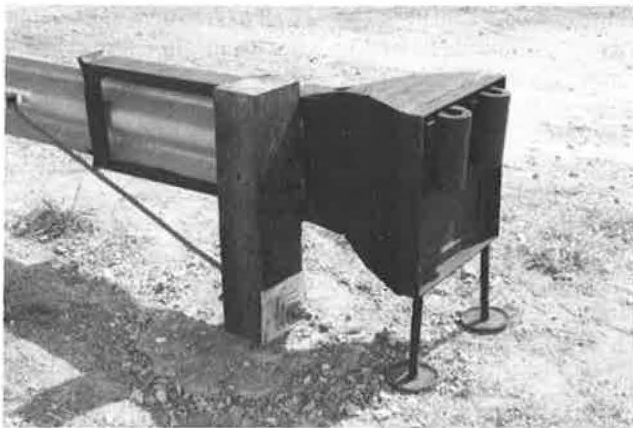
FIGURE 9 Guardrail extruder terminal.

Surprisingly, changing the direction of W-beam bending significantly increased extrusion forces. Static test results indicated that bending the W-beam toward the roadway increased average extrusion forces from 11 kips to 15 kips. As a result of the large increase in extrusion forces and the problems associated with projecting extruded guardrail across the roadway, this solution to the extruder rotation problem was abandoned. Another important finding from these development tests was that extruder performance was not sensitive to the guardrail post attachment. Therefore, standard button head guardrail post bolts were used in the final GET design. Figure 9 shows a typical GET installation incorporating the final extruder design.

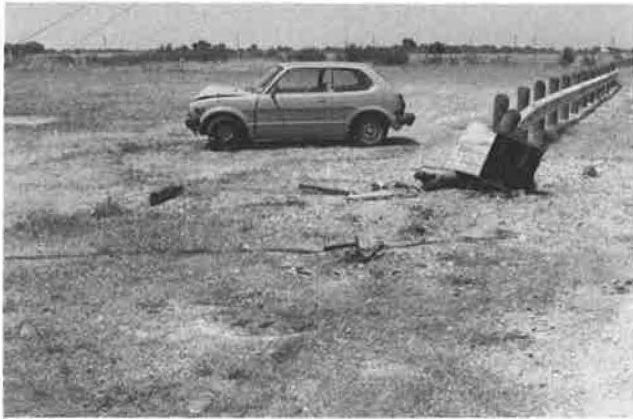
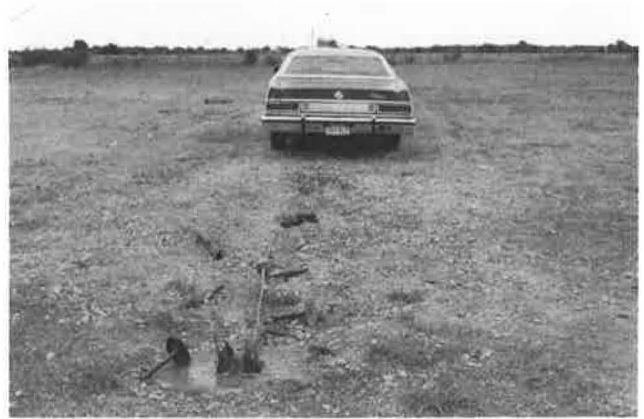
**FIGURE 12** Vehicle and treatment after test MB-6.

The first compliance test involved a 1979 Honda Civic impacting the GET head on at 60 mph with the GET offset 15 in away from the roadway. It was believed that offsetting the vehicle in this manner would increase the probability of the test vehicle yawing away from the guardrail end at a high rate of speed. The test vehicle was smoothly decelerated as 13.2 ft of guardrail was forced through the extruder. After the forward motion of the vehicle was virtually stopped, the vehicle began to yaw slowly away from the roadway. The test

vehicle exhibited no tendency to roll over and came to rest within 30 ft of the original guardrail end. The maximum roll angle during this test was less than 5°, and all occupant severity measures were within recommended limits (13). Figure 12 shows the test vehicle and end treatment after test MB-6.

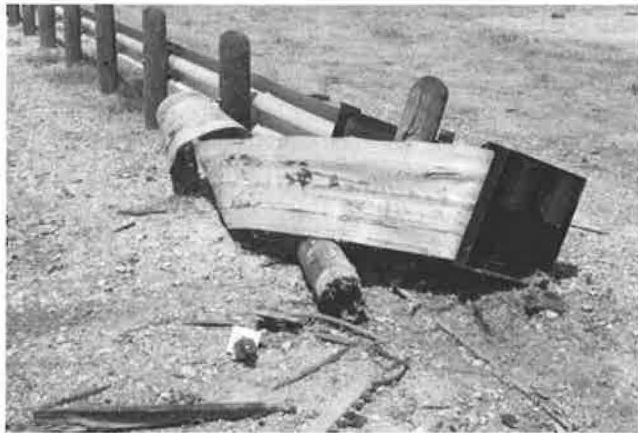
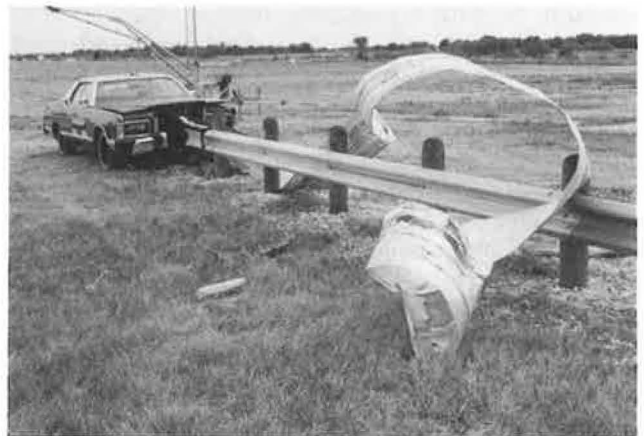
**FIGURE 13** Vehicle and treatment after test MB-7.

Test MB-7 evaluated the performance of the GET for head-on impacts with full-size automobiles. This test involved a 4,500-lb vehicle impacting the extruder head on at 61.6 mph. The terminal performed well and decelerated the test vehicle to a smooth stop over 45 ft. The test vehicle exhibited no tendency to ride over the end treatment, and all occupant-

impact severity measures were well below recommended limits. The test vehicle and end treatment after test MB-7 are shown in Figure 13.

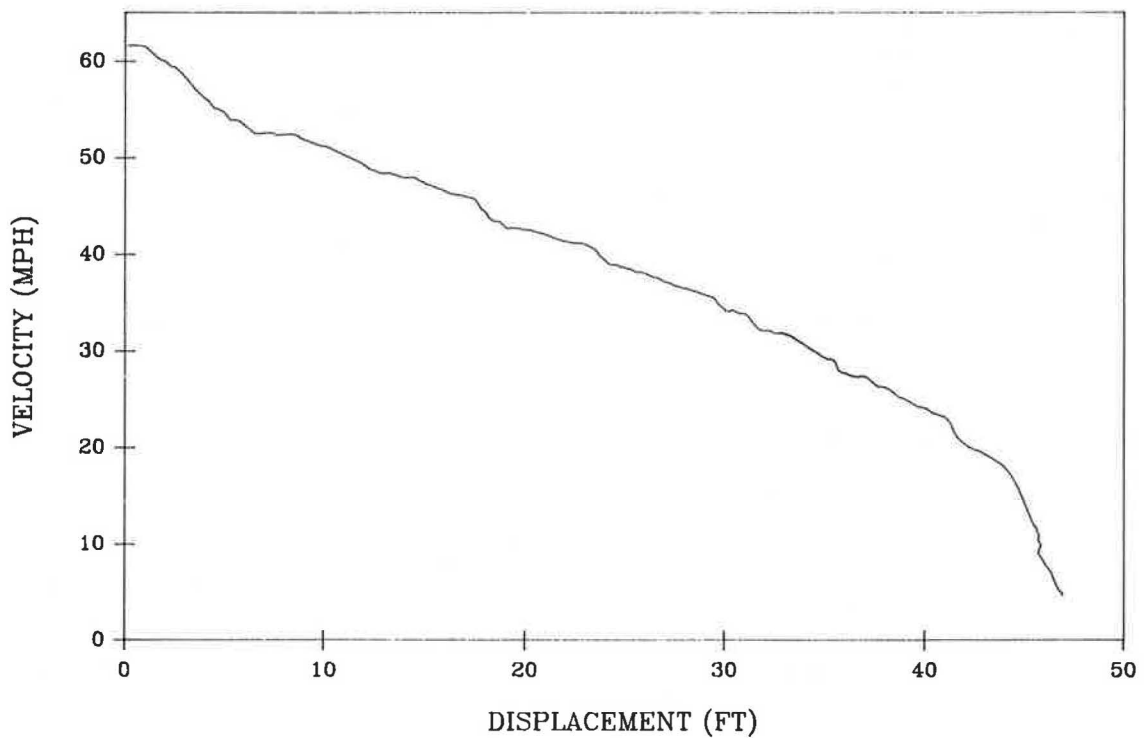
**FIGURE 14** Velocity-displacement relationship for test MB-7.

Note that, as discussed previously, the splice between the first and second 25-ft segments of guardrail was welded to eliminate bolts that may inhibit extruder performance. As shown in Figure 14, the test vehicle was traveling at approximately 38 mph when the extruder encountered the welded splice. At this point, high deceleration forces would likely have developed if a bolted splice had been incorporated. Thus, the GET system cannot be expected to perform acceptably with a bolted splice at this point in the guardrail system. However, the test vehicle was decelerated to 25 mph after extruding 37.5 ft of guardrail. Further, if the test vehicle had weighed 4,500 lb and impacted at 60 mph, as required by *NCHRP Report 230* (13), it would have decelerated to less than 20 mph after extruding 37.5 ft of guardrail. Although the extrusion process would be restricted by a bolted splice connection, severe deceleration forces would not likely develop when the impacting vehicle is traveling at speeds less than 20 mph. A full-scale crash test should be conducted to verify the safety performance of a GET with a bolted splice 37.5 ft from the end. Syro Steel Company, a leading guardrail manufacturer in Ohio, has indicated that a 37.5-ft length of guardrail could be purchased at a cost only modestly more than that of 37.5 ft of guardrail cut in shorter lengths. Such a design modification would allow the terminal to be constructed without field welding a guardrail splice.
