Salt Weathering of Limestone Aggregate and Concrete Without Freeze-Thaw

CARL F. CRUMPTON, BARBARA J. SMITH, AND G. P. JAYAPRAKASH

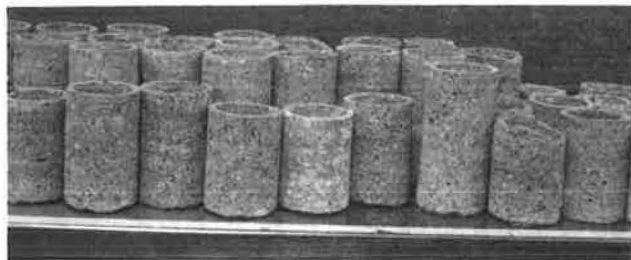
FIGURE 1 A group of concrete cups made by taking two concentric cores such that the cup walls are about ¾ in. thick and the bottom is at least ½ in. thick.

For making concrete cups (Figure 1), two concentric cores are taken in the concrete. The smaller, shallower inner core is drilled first and broken out before the larger outer core is drilled to a greater depth—often through the full thickness of concrete (17). The cored cups are rinsed and allowed to air dry before being used for salt movement studies. In order to obtain cups with walls ¾ in. thick, the authors used a core bit with a 2¼ in. outside diameter for the inner core or "well" of the cup. The larger core bit is 3 in. in inside diameter. Other sizes and combinations may be used. For variable thickness walls the authors used a bit of 4 in. inside diameter for the larger core. By offsetting the larger core to one side of the inner core, they obtained cup walls that range from ¾ in. to about 1½ in. thick in the same cup. All cups have a bottom from ½ in. to several inches thick.

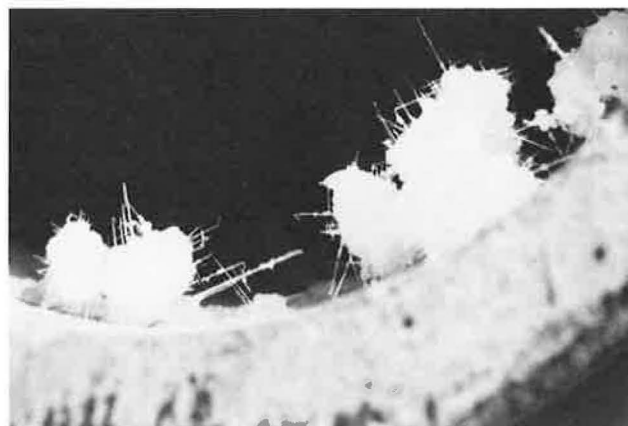
FIGURE 3 Salt crystal deposits and fibers on the inside top of a cup. These formed from salt water wicking up the inner walls and evaporating.

At the top of the cup in Figure 2 is a mass of salt around the inside perimeter. This is from salt water wicking up the inside walls, evaporating, and leaving the halite crystals behind. Figure 3 shows this buildup in an early stage. Rounded masses of halite crystals appear first. Needle crystals of salt then often grow from those masses. More massive crystals begin to grow on the needles. As evaporation continues, the entire inside perimeter at the top of the cup becomes coated with the salt deposit, as seen in Figure 2. The needles are eventually completely overgrown and no longer show as salt deposition continues.

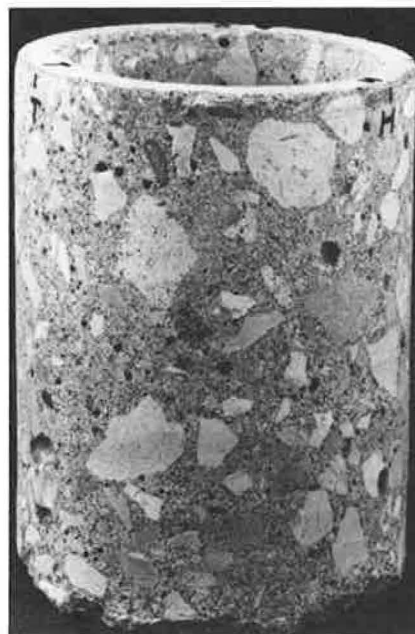
FIGURE 4 A concrete cup before any treatment with salt water. Note the two limestone aggregates at the top just to the left of the letter H.

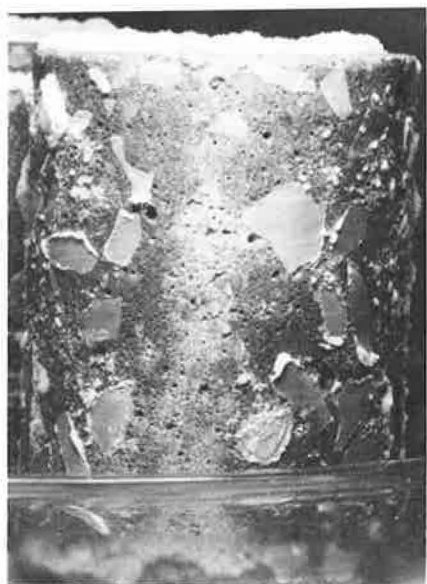
FIGURE 2 A concrete cup which has been filled with a 15-percent solution of deicing salt. The salty water has moved through the cup walls primarily at the border of limestone aggregates and has left salt deposits there as the water evaporated. The salt often draws moisture from air and leaves the surface damp on humid days.

The photograph in Figure 2 also shows general surface dampness on the outside of the cup. This is moisture adsorbed from the air. On humid days the salt drew the moisture from the air and the cup surface remained damp as long as the humidity was high. This did not occur on untreated cups. On days when it was raining outdoors, the moisture buildup on the outside of the cups was often great enough to dissolve some of the salt deposits. The water ran down the outside of the cups and collected in the glass plates containing the cups. Thus, periods of very high humidity sometimes obliterated the original depositional pattern of the salt on the outside of the cups.

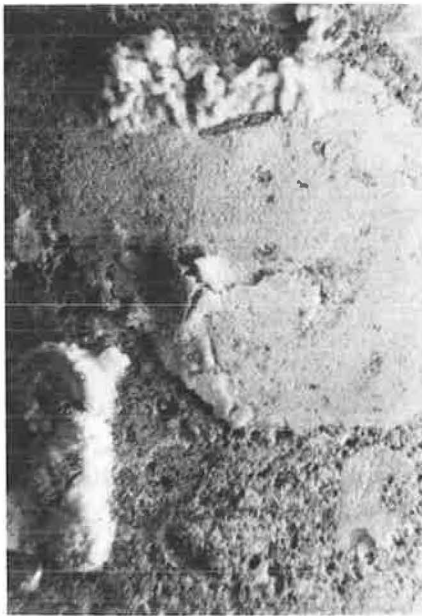
FIGURE 5 The larger of the two aggregates noted in Figure 4. Salt has moved through the aggregate, depositing near its top surface. The salt is also pushing thin flakes from the surface of the aggregate.

When salt water came through the walls of the cup, halite crystals also grew on the outside of the cup. Small oatmeal-sized flakes of paste and aggregates scaled from the cup's outside surface. Figure 4 shows a cup before salt treatment. Note especially the two limestone aggregates near the top of the cup to the left of the letter H. Figure 5 is a close-up of the larger of those two aggregates after salt treatment. Notice the surface cracking and thin flakes pushing out of that aggregate. Salt crystals are growing below the surface and causing

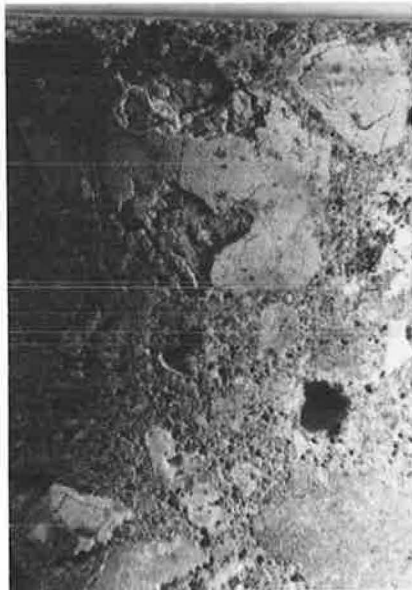
FIGURE 6 The aggregate particle in Figure 5 after the salt has scaled away part of the surface. A distinct rim shows in the second aggregate slightly above and to the right. The limestone in the rim has been separated from the aggregate particle by salt weathering.

surface flaking or scaling. Figure 6 shows the same aggregate after the surface had flaked off and the salt deposits were dissolved by gentle immersion of the emptied cup in plain water.

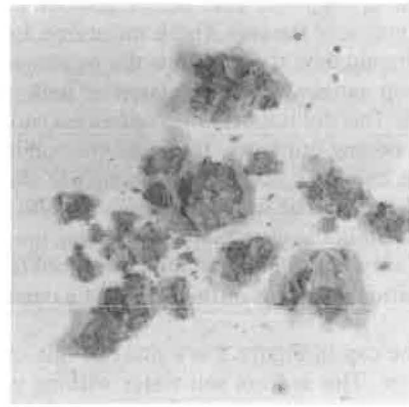
FIGURE 7 Typical scaled particles of paste and limestone aggregates. These range up to 0.2 in. in longest dimension.

The authors cycled the first two cups through a dozen salt water treatments. Each cycle consisted of five days with 15 percent salt water in the cups, followed by emptying, gentle soaking in plain water to remove the salt deposits, and air drying for nine days. More oatmeal-sized flakes were dislodged by the salt crystal growths during each cycle. Figure 7 is a close-up of some clumps of those flakes, the largest of which is 0.2 in. long. Figure 8 shows the largest individual scaled flake collected, which is 0.6 in. in length. The flake is

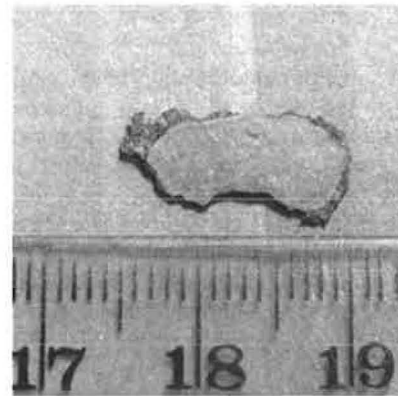
FIGURE 8 A bean-shaped flake of aggregate 0.6 in. long. This is the largest flake that remained in one piece after being scaled off by the salt. The aggregate this came from may also be seen in Figures 2, 10, 11, and 12.

about $\frac{1}{16}$ -in. thick and includes the surface of a limestone aggregate particle.

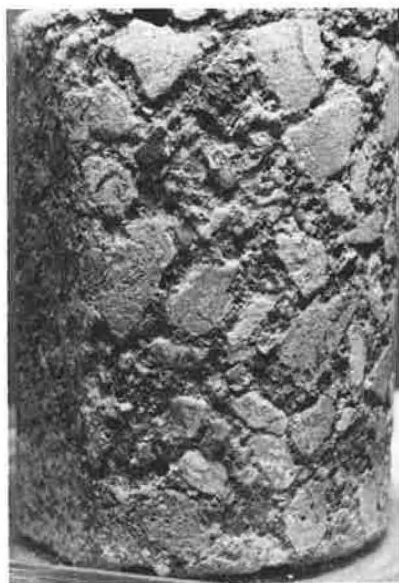
FIGURE 9 A concrete cup that has gone through 12 cycles. Here the aggregates were more durable; the cement paste has weathered away and the limestone aggregates stand out in relief.

Figure 9 shows the surface of a cup after 12 salt cycles. The paste phase has scaled or flaked away and the coarse aggregate stands out in relief. The coarse aggregates shown in this photograph did not scale as much as the paste, but other aggregates do scale as seen in Figures 5, 6, and 8. All this was from salt scaling without any freeze-thaw. The cups and salt water were kept at ambient laboratory temperature of 68 to 74°F.

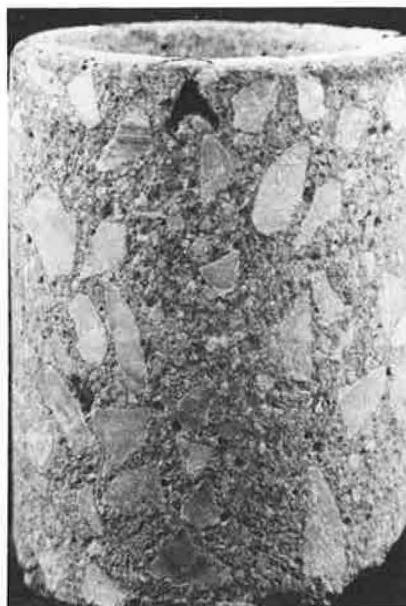
FIGURE 10 The same cup as shown in Figure 2 but rotated clockwise slightly to show another area. Note the two limestone aggregates at the top and to the left of the letter A. This cup is air drying between salt water treatments.

Many of the aggregates that scaled did so at their perimeter, adjacent to the zone of salt water movement at the aggregate borders. Figure 10 is the same cup as in Figure 2, but the cup has been slightly rotated in a clockwise direction for the photograph of Figure 10. This picture was taken after the salt water was emptied from the cup, the salt deposits dissolved by immersion in fresh water, and the cup allowed to air dry. Note the two aggregates near the top of the cup, just to the left of the letter A. (Three letters were placed about 120

degrees apart around the top of the cups for aid in cup identification and to help in orientation of pictures; this particular cup was labeled ABC.)

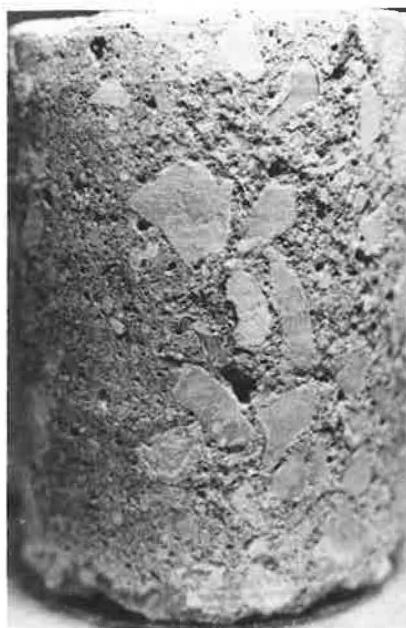
FIGURE 11 The same cup as in Figure 10 after more salt treatments. The two aggregates noted in Figure 10 show distinct rims that have separated from the rest of the aggregate due to salt weathering. Note the bean-shaped aggregate near the middle of the photograph.

Figure 11 shows the same area of the cup in Figure 10 after several more cycles of salt water treatment, immersion wash, and air drying. Note the perimeter of the two aggregates at the top of the cup to the left of the A. Both aggregates have a rim that has separated from the aggregate. This type of rim eventually flakes away, leaving a depressed border zone in the aggregate. At the center of Figure 11 are two elongated limestone aggregate particles with their long axis nearly vertical in the cup wall. The smaller of the two, a bean-shaped aggregate, is the flake shown in Figure 8. Figure 12 is the same general shot as Figure 11 after the flake in Figure 8 had scaled off; the pencil points to the spot where the flake came from. Other aggregates in both Figures 11 and 12 also have rims separating from the aggregate proper. A similarly scaled rim can be seen in the top right corner of Figures 5 and 6. Many of the same aggregates shown in Figures 10, 11, and 12 may also be seen in the right half of Figure 2. The location of the salt deposits are visible in Figure 2. After 12 cycles, about 95 percent of the limestone aggregates in this cup had been scaled to some extent.

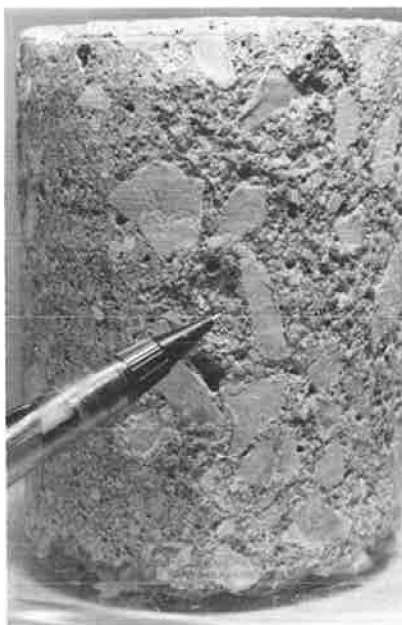
FIGURE 12 The same cup as in Figure 11 after more salt weathering cycles. The bean-shaped aggregate surface has scaled away. The pencil points to where it was. The fragment shown in Figure 8 came from this location.

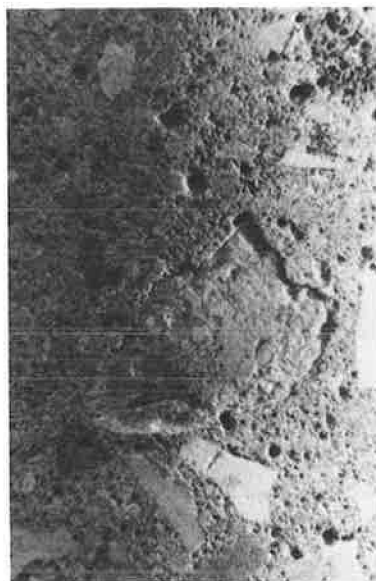
FIGURE 13 A limestone coarse aggregate particle with the entire rim flaked away by salt weathering. This left the aggregate surface depressed relative to the surrounding cement paste. No freeze-thaw was involved. Contrast the aggregate pictured here with those in Figure 9, where the paste was “eaten away” by salt.

Figure 13 shows a limestone coarse aggregate where the entire rim has flaked away, leaving the aggregate depressed compared to the cement paste. This is the opposite of the condition shown in Figure 9, where the paste has flaked away and the aggregates stand out in relief. The salt attacks the most susceptible component of the concrete—sometimes the paste, sometimes the aggregates, sometimes both. No two concretes are alike, but salt is persistent in finding a weakness to attack.

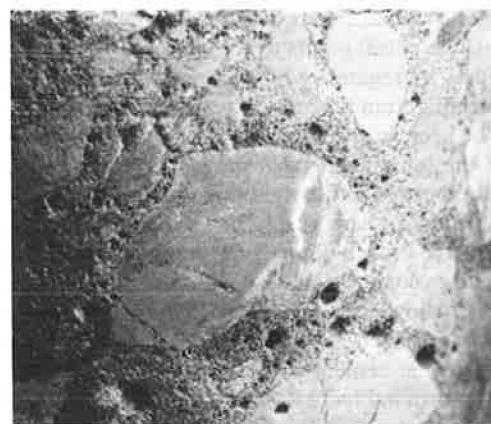
FIGURE 14 A limestone aggregate with preexisting cracks that salt water has moved through. This aggregate would probably deteriorate under freeze-thaw conditions.

Sometimes the salt water found preexisting cracks in the limestone aggregate particles. Figure 14 shows such a particle with salt deposits along cracks in the aggregate. Under freeze-thaw conditions this aggregate would probably have deteriorated from water freezing in the cracks.

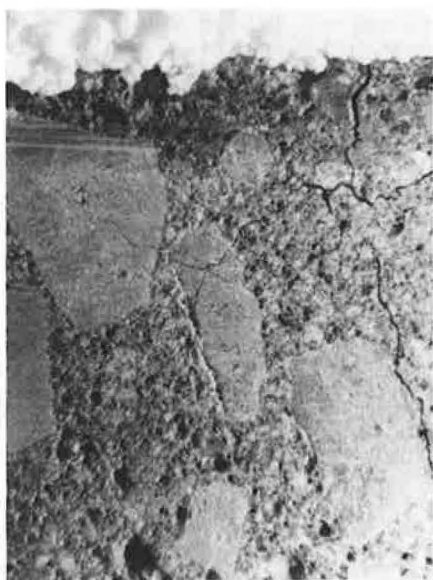
FIGURE 15 Cracks in a silane “sealed” concrete cup that occurred during the first cycle of salt water treatment. The silane did not keep salt water from moving through many limestone aggregates. The cracks go through some aggregates and alongside others.

Three cups were treated internally with an alkyl-alkoxy silane type “sealer” such as used in the NCHRP 244 studies (25). This sealer did not prevent salt water movement through the limestone aggregates (19). One surprising result, however, was the cracking of all three silane-treated cups during the first cycle of salt water treatment. None of the nonsealed cups cracked even after as many as 12 cycles. Figure 15 shows one of the silane-treated cups with a pattern of cracks that goes through some limestone aggregates but alongside others. These were not the aggregates that the salt water passed through. Halite crystals at the top of the cup were deposited from evaporating salt water that wicked up the inside walls of the cup.

A silane sealer did not prevent salt water from moving through the limestone aggregates. All three cups treated on the inside with silane cracked on the first salt treatment cycle.
