Crash Tests of Work Zone Traffic Control Devices

JAMES E. BRYDEN

Full-scale vehicle crash tests were used to evaluate performance of typical work zone traffic control devices. Modified test procedures and evaluation criteria from National Cooperative Highway Research Program Report 230 were used in 108 tests, providing significant insight into impact performance. Plastic drums used as channelizing devices, cones, tubes, and vertical panels performed well in most tests, presenting no hazards in terms of passenger compartment intrusion, interference with vehicle control, or threat to workers and other traffic from impact debris. Various nonstandard forms of ballast placed on top of or inside channelizing devices detracted from performance, and sometimes posed a severe threat to test vehicle occupants, workers, and other traffic. Similarly, impact debris formed in several tests on Type I and III barricades and portable signs and supports posed a threat, and was often thrown long distances through work zones. Warning lights attached to traffic control devices were also thrown free in a number of tests, and appeared to threaten workers and other traffic.

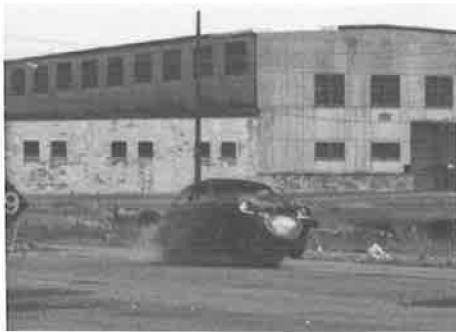
FIGURE 1 An 1,800-lb car impacting a 55-gal steel drum at 60 mph resulted in loss of vehicle control.

None of the five tests on steel drums provided satisfactory results in terms of all evaluation criteria. None resulted in passenger compartment intrusion, but all five interfered in some measure with vehicle control. Two 1,800-lb cars and one 4,500-lb car rode up onto the collapsed drum, with partial or full loss of steering control in 45- and 60-mph tests. In addition, the small car nearly rolled over in the 45-mph test before coming to rest partially on the drum. In the other two tests, at 30 and 45 mph with 1,800-lb cars, the drum bounded ahead of the car, threatening injury to workers as well as loss of control by other drivers resulting from severe evasive maneuvers. Figure 1 shows an 1,800-lb vehicle riding up on a 55-gal drum in a 60-mph impact.

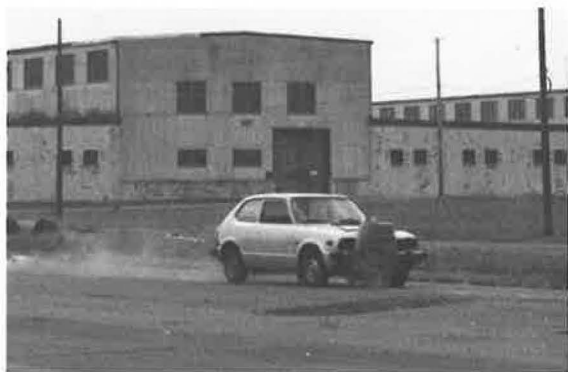
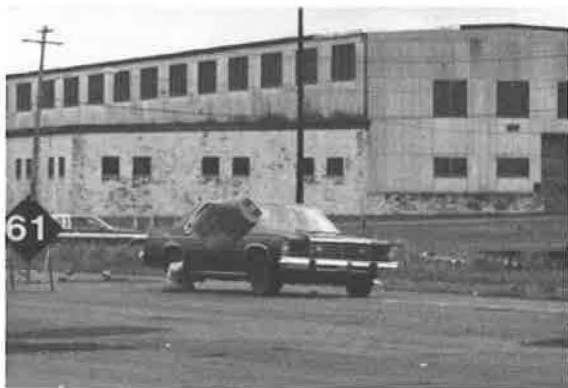
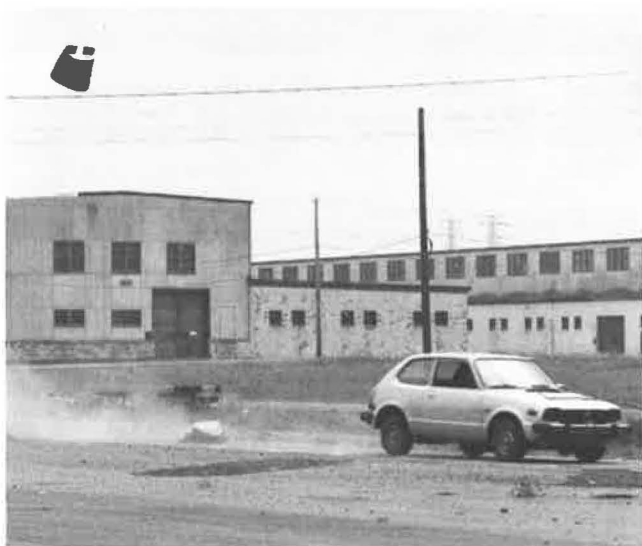
FIGURE 2 Typical impacts with plastic drums ballasted with 50-lb sandbags resulted in drums staying with the front of the car (top), being pushed aside in a brushing impact (center), and two-piece drum being thrown high into the air (bottom).

Drums ballasted with 50-lb sandbags at ground level (see Figure 2) underwent 24 tests, with satisfactory results in 18 tests. Five of the six unsatisfactory tests had drum parts flying into traffic areas with potential for causing severe evasive maneuvers. The sixth unacceptable test resulted from sandbag

ballast in an open-top drum scattering across the pavement, and causing a skidding hazard. Typical impact performance by plastic drums ballasted with sandbags at ground level consisted of the sandbag and base (if used) remaining near the point of impact, with the drum staying against the front of the car or under it. Even in several impacts with the front corner of the vehicle, drums wrapped around the car's front and stayed there or came to rest under it. Drums with detachable bases, external base tabs, or slotted base fingers all displayed similar behavior. Damage to plastic drums was variable, 11 tests resulting in only superficial damage. Seven drums were completely destroyed, and the other six experienced intermediate damage. Both open-top drums and one two-piece drum split at midheight were totally destroyed, as was one with slotted base fingers. This severe damage related to ballast being trapped inside the drum, thus offering increased resistance to movement by the drum on impact. It was also apparent that some brands of drums were more resilient than

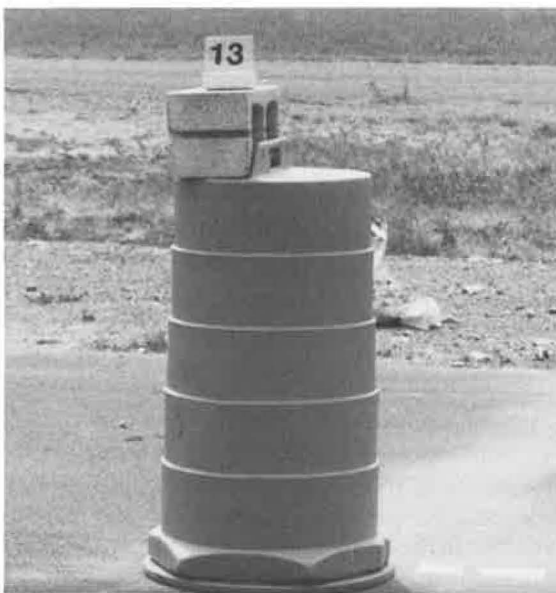
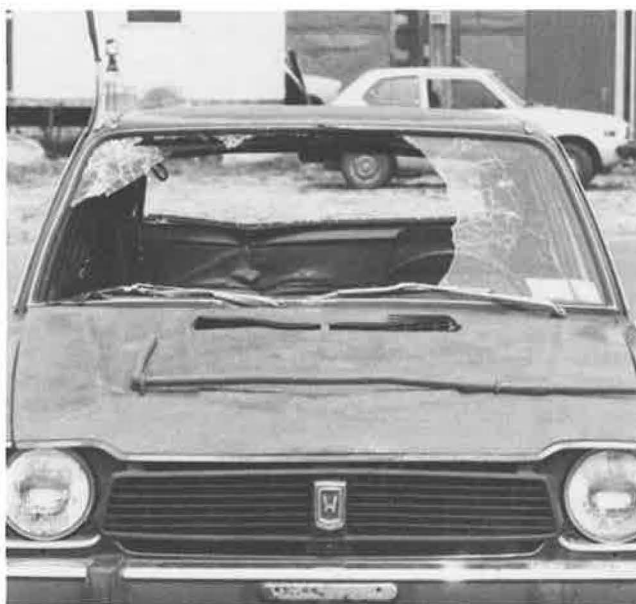
FIGURE 3 A 42-lb concrete-block ballast placed on a drum resulted in unacceptable intrusion into the passenger compartment.

age in a 60-mph test. The five other tests were considered unsatisfactory. Two tests used 42-lb concrete blocks on top of the drum as ballast. In the 30-mph test, the block entered the passenger compartment through the windshield, and nearly exited the rear window (Figure 3). In a similar test at 45 mph, the block impacted and severely crushed the leading edge of the roof, but did not enter the passenger compartment. Both of these tests represented potentially fatal injuries to vehicle occupants. A sandbag on top of a drum resulted in sand scattered over a wide area of pavement, considered unacceptable debris. An open-top drum, ballasted inside with 180 lb of gravel, was torn apart on impact, and the drum's top portion was thrown and could have threatened other traffic.

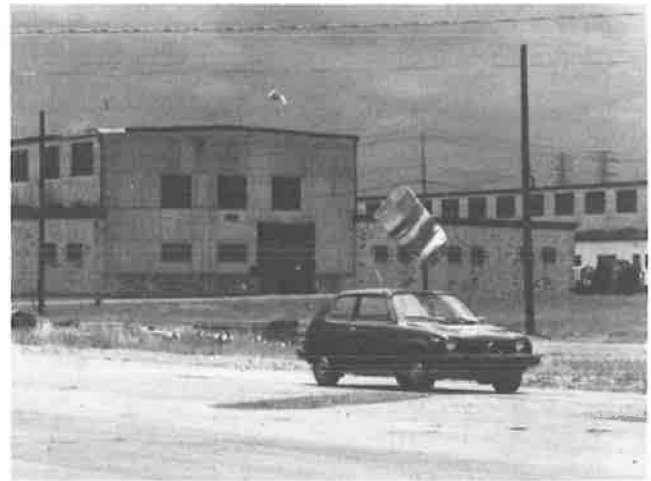
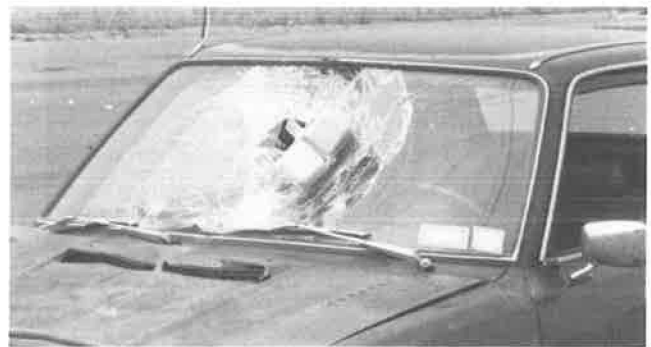
FIGURE 4 Attaching warning light to channelizing drums resulted in lights being thrown on impact and drums flying over the vehicle (top), with varying degrees of windshield damage (bottom).

Of 19 tests of plastic drums with Type A warning lights attached (Figure 4), only five met the primary evaluation criteria. Lights were attached to the drums by various methods. The primary problem was that the lights, weighing about 6 lb including lantern batteries, separated on impact and flew through the work zone, creating hazards to workers or other vehicles' windshields. In two 60-mph tests, batteries traveled about 250 ft from impact, and over 150 ft in several others. Several attachment methods were examined. In one test with an unbolted warning light set into a retainer pocket molded into the top of the drum, the light detached on impact as expected. In 11 tests, the light was attached using a 1/2-in. bolt without a washer. Attachment points to the drums included various retainer tabs and pockets, and on open-top drums the light was bolted to the side. In all but 2 of these 11 tests—both at 30 mph—the bolts pulled through the plastic and the lights detached on impact. In eight of the nine tests in which lights broke free, they were considered a hazard to workers, and in the ninth the light embedded in a windshield. In three other tests, lights impacted and damaged windshields, although there was no penetration, and then were thrown into the work zone.

In an attempt to avoid light detachment, seven additional tests were conducted with 1-in.-OD washers installed behind the bolt heads to prevent their pulling through the plastic. In three tests with 4,500-lb cars, two at 60 mph and one at 30 mph, the lights remained attached to the drums, and the drums stayed with the front of the car on impact, thus providing acceptable results.

None of the four tests with 1,800-lb cars at 60 mph were acceptable. In one, the bolt and washer pulled through the plastic and the light impacted the windshield. In the second, the top of the drum broke apart, throwing the light into the work zone. In the third, the light unit remained attached but the battery compartment ruptured, throwing the batteries into the work zone. In the fourth, the light remained attached but the increased weight of the light on the top of the drum, combined with the low frontal profile of the small car, resulted in the drum's flying over the car rather than staying in front, presenting a potential threat to other traffic and workers.

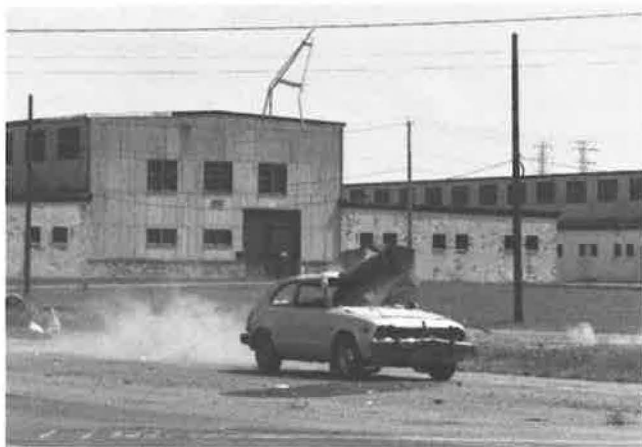
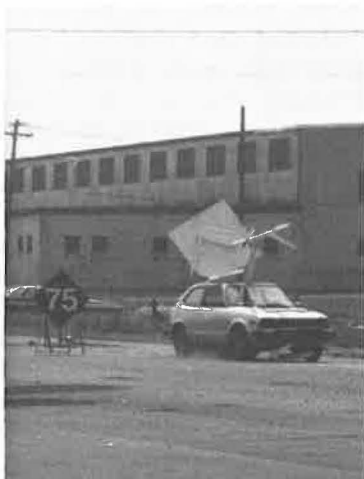
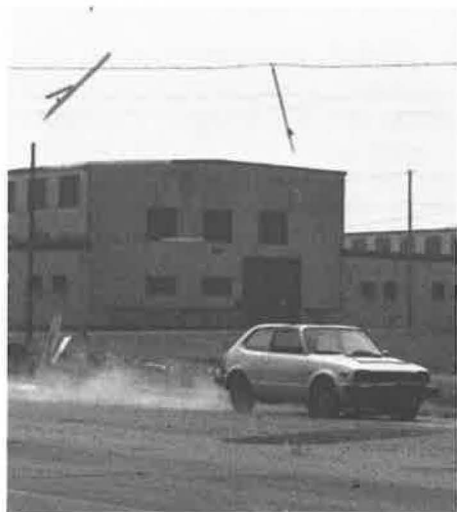
FIGURE 5 A portable low-mounted sign resulted in windshield penetration and debris (top). A tall portable sign resulted in unacceptable debris, although the panel cleared the car (bottom).

of the vehicle from windshield impacts or threatening debris, as well as debris considered a threat to workers or to the windshields of other vehicles (Figure 5). In four tests on low-mounted signs, with the bottom of the panel at bumper height, rigid wood or metal panels were flipped back into the car windshield, three of the four resulting in windshield damage. In addition, the steel tripod and wood supports were all thrown on impact, threatening other workers and traffic.

In four 60-mph tests on high-mounted signs on timber supports (panels were above the car roof) the panels presented no hazard. In every case the test vehicle passed under the panel, which dropped to the pavement near its original location. However, the 2- by 4-in. lumber braces were thrown on impact and presented a hazard to other vehicles and workers. In three out of four tests, debris from the support also impacted and damaged the test vehicle's windshield.

Use of a commercial metal tripod with a 4-ft diamond sign panel mounted 4 ft above the pavement, tested at 55 mph, resulted in the panel's being pulled down into the windshield on impact. The vertical support did not fracture or release on impact, but instead deformed against the front of the car. The panel broke free after striking the hood and windshield and was thrown over the car, presenting a hazard to workers and other traffic. Except for one leg that broke free but remained on the pavement, no harmful debris resulted from the support.

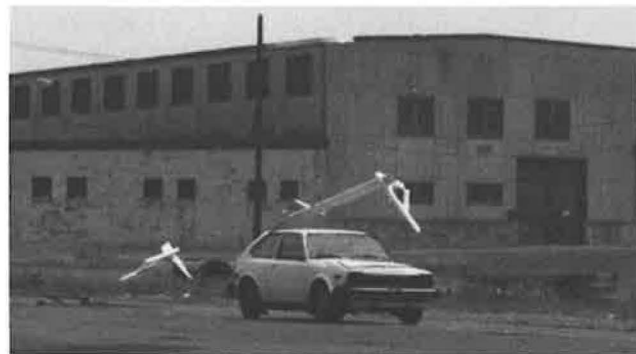
FIGURE 6 Collision with a Type I barricade resulted in unacceptable debris.

Four tests on Type I barricades resulted in debris being thrown into the work zone, threatening workers and other traffic (see Figure 6). In three 60-mph tests, debris was thrown from 102 to 172 ft, and in the single 30-mph test, 70 ft. Considering that these barricades weighed 18 to 32 lb and included various steel and wood members, this debris appears to present a significant hazard if it were to strike a worker or the windshield of another vehicle. In each case, debris was thrown high in the air, presenting a substantial risk that such contact would occur.

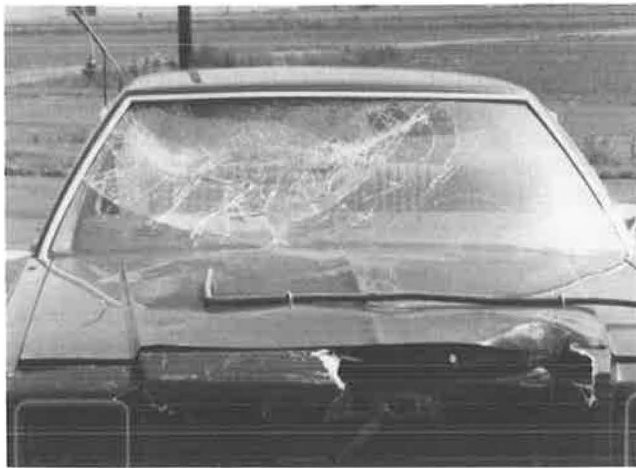
FIGURE 7 A 60-mph impact with a PVC Type III barricade resulted in a shattered windshield.

Three tests of PVC-plastic Type III barricades resulted in their shattering, with debris thrown up to 207 ft from impact at 60 mph. Resulting debris was light in weight, and did not appear to represent a significant hazard to workers or other traffic. All three tests resulted in broken windshields on the test vehicles. In two of the three tests, a warning light was attached to the top barricade rail that contributed to windshield damage. In the third (at 60 mph) the windshield of the large sedan was shattered by impact with the top barricade rail (Figure 7). All three tests with PVC barricades were thus considered unsatisfactory because of windshield damage. These barricades were all constructed using heavy grade pipe (ASTM D 2655) and a lighter grade might prevent this damage.
