# Improving Work Zone Delineation on Limited Access Highways

FRANK D. SHEPARD

The purpose of this study was to investigate vehicle guidance through work zones by evaluating the effectiveness of two primary components of traffic control relative to delineation. First, a comparison of the steady-burn lights now used on top of temporary concrete barriers was made with experimental reflectorized panels. Second, the addition of closely spaced, raised pavement markers as a supplement to the existing pavement markings was evaluated. The study was limited to work zones on Interstates and four-lane highways. The results of this investigation have led to the recommendation that (a) steady-burn lights on temporary concrete barricades should be replaced with reflectorized panels fabricated with high-intensity sheeting and placed along the tangent sections only and (b) closely spaced, raised pavement markers should be used as a supplement to existing pavement striping in areas where the roadway alignment changes.

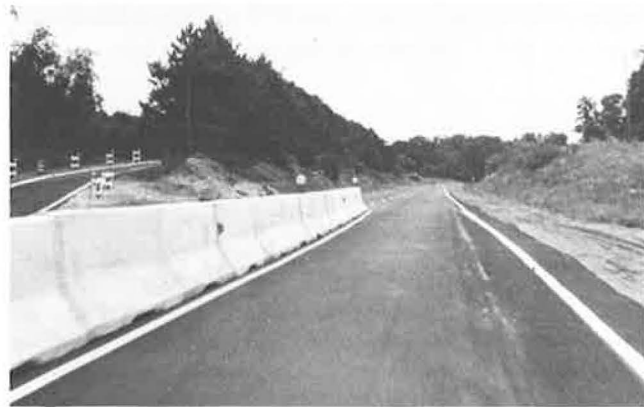
FIGURE 2 Site 1, Route 29, Leon, Virginia.

two lanes closed; therefore, the two southbound lanes carried two-way traffic separated by temporary concrete barriers on which the lights and panels were placed. The barrier was placed on the left side of traffic, and 37 delineators were spaced at 72-ft intervals.

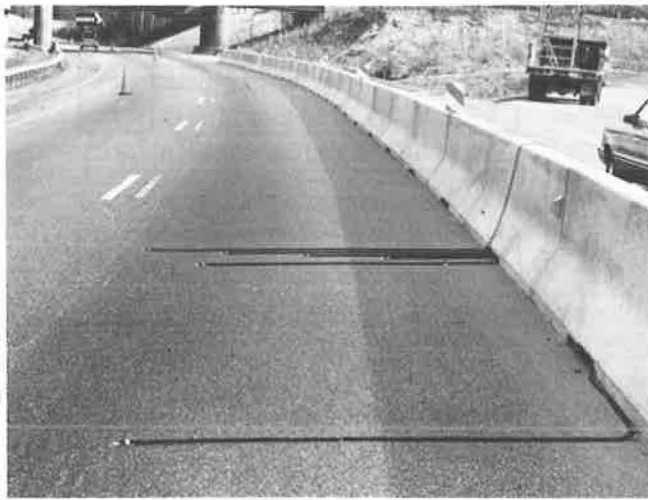
Site 2 (see Figure 3) was an Interstate highway that had temporary concrete barriers placed on the right shoulder. There were 17 delineators spaced 48 ft apart on top of the temporary concrete barricade. Old centerline markings, although partially visible during the day, were not expected to influence driver behavior at night.

FIGURE 3 Site 2, Interstate 85, Petersburg, Virginia.

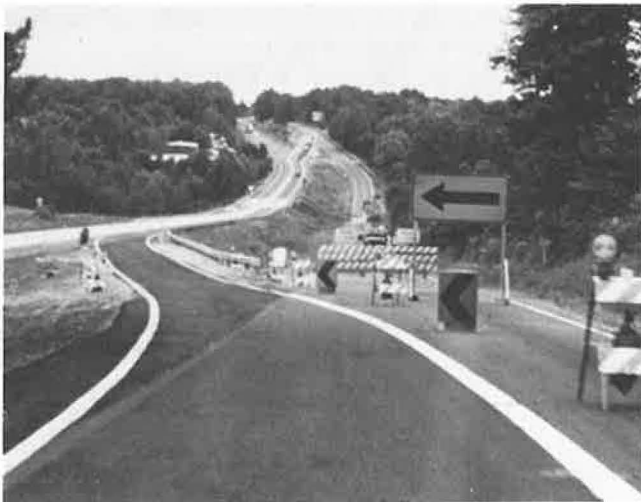
Site 1 was a detour for a four-lane divided highway; the northbound lanes were closed (see Figure 8). The S-shaped detour had preformed tape along the right edgeline and a

FIGURE 8 Site 1, Rt. 29, Leon, Northbound.

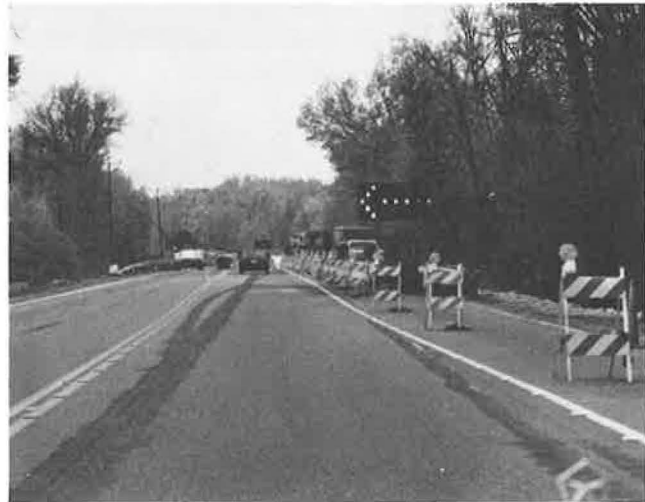
Site 2 was a four-lane highway with the right lane closed (see Figure 10). Raised pavement markers were added to the existing markings along both the right transition and left centerline. The schematic in Figure 11 shows the location and spacing of the markers.

FIGURE 10 Site 2, Route 1, Fredericksburg.

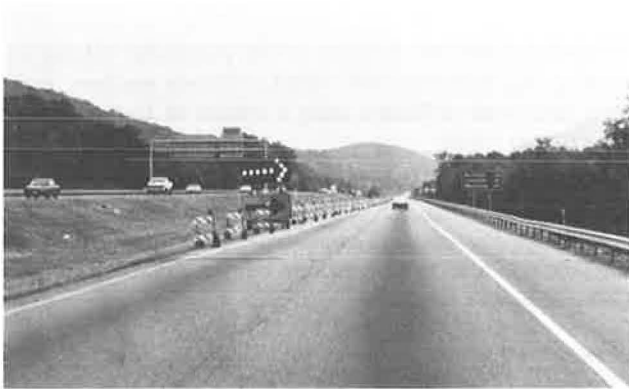
Site 3 was an Interstate, with left lane closure and raised markers supplementing the existing left edgeline transition (see Figure 12). The markers were placed directly on the new preformed tape. The schematic in Figure 13 shows the marker placement and data collection points.

FIGURE 12 Site 3, Interstate 81, Salem.
