Crash Test of Modified Texas C202 Bridge Rail

T. J. HIRSCH AND PERRY ROMERE

In 1980 a standard Texas traffic rail, C202, was modified to increase its height and strength to restrain and redirect an 80,000-lb (36 300-kg) van-type tractor-trailer under 50-mph (80.5-km/hr), 15-degree-angle impacts. The concrete parapet height was increased to 36 in. (91 cm), and an elliptical steel rail was mounted on steel posts to increase the rail height to 54 in. (137 cm). In 1980 one crash test was conducted on the bridge rail. The truck was restrained and smoothly redirected. This promising high-performance bridge rail was not tested at that time with passenger cars. The results of two successful crash tests with a 1,918-lb (871-kg) car traveling at 61.3 mph (98.6 km/hr) striking at a 21-degree angle and with a 4,400-lb (1998-kg) car traveling at 59.4 mph (95.6 km/hr) striking at a 25.9-degree angle are presented.

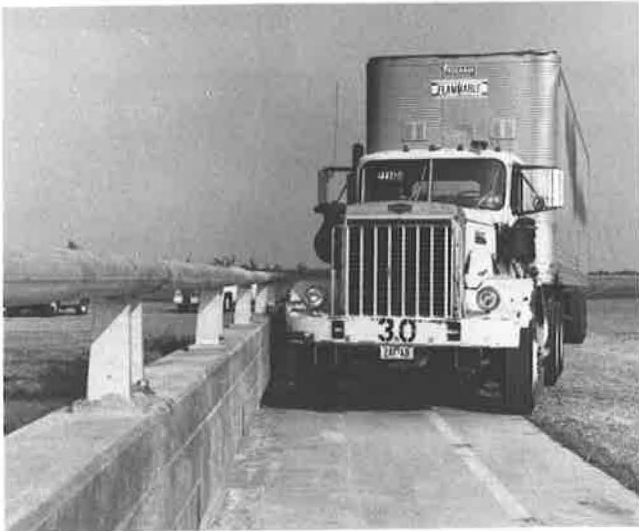
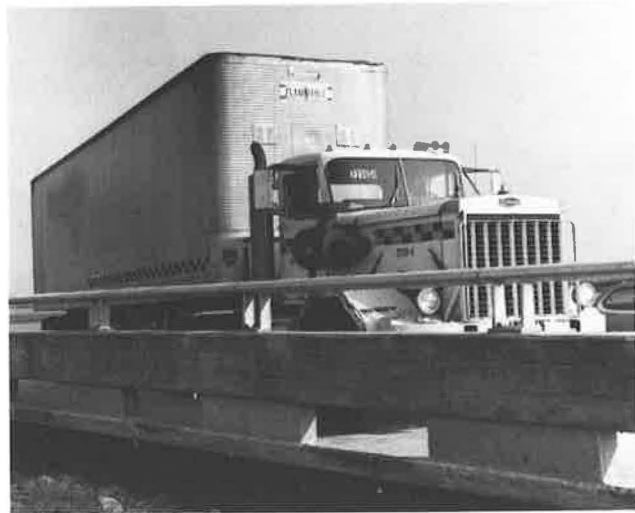
FIGURE 3 Comparison of 80,000-lb truck with modified combination rail.

Drawings of this rail are shown in Figures 1 and 2. Figure 3 contains photographs comparing the size of the combination bridge rail with the truck used in previous crash tests (1,2).

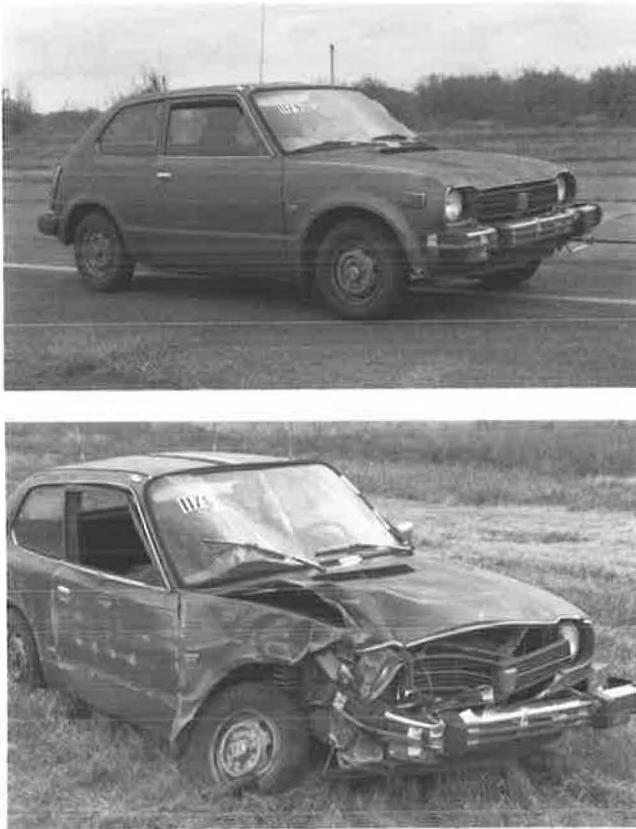
FIGURE 5 Vehicle before and after Test 1179-1.

lb (871 kg) including a dummy. Photographs of the Honda before and after the test are presented in Figure 5.

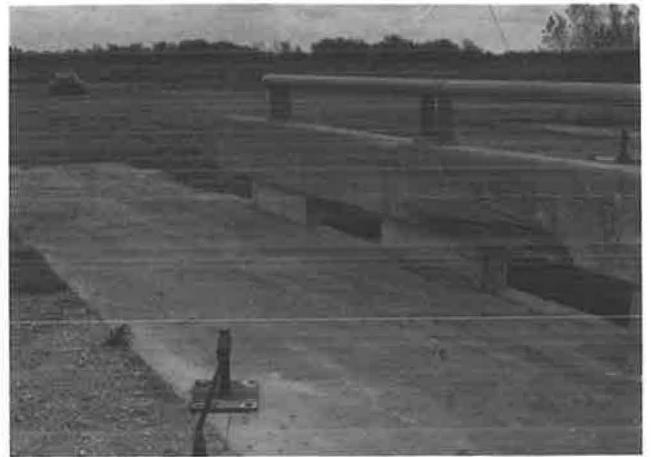
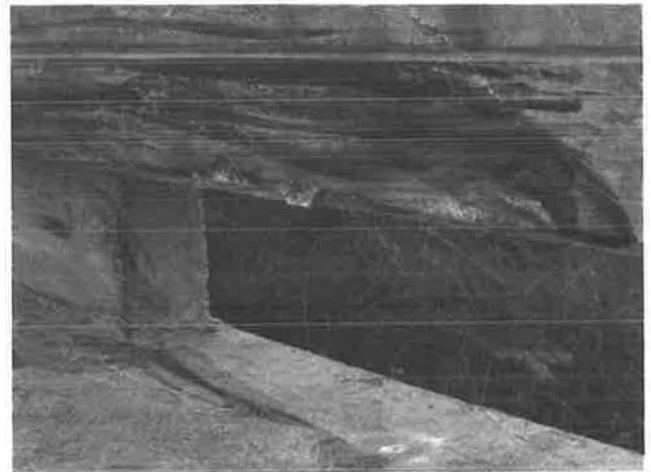
FIGURE 6 Bridge rail after Test 1179-1.

The Honda struck the rail at 61.3 mph (98.6 km/hr) at a 21-degree angle. The impact occurred 7.0 ft upstream of Post 11 and was smoothly redirected. The exit angle of the Honda was only 0.6 degrees, and the car would have remained on the right-hand shoulder and not reentered the traffic lanes. Figure 6 shows the bridge rail and test site immediately after Test 1179-1. The Honda sustained damage to the right front and right side. The right front tire came in contact with Post 11, which can be seen in Figure 6. This contact caused some damage to the front right wheel and suspension; however, the wheel was still rolling after impact. An anthropomorphic dummy was placed in the driver's seat for this test. A summary of the crash test data is shown in Figure 7.

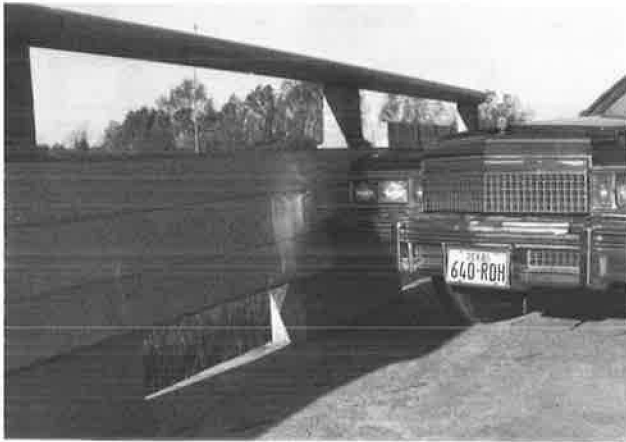
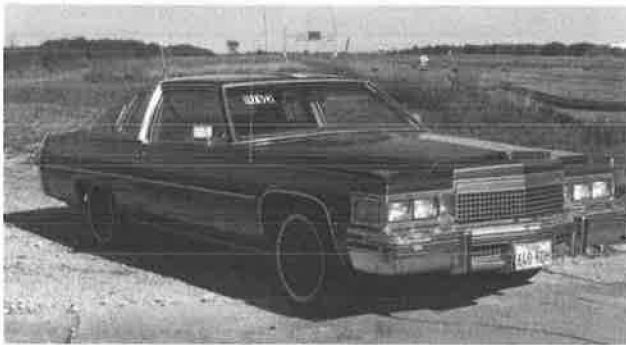
FIGURE 9 Vehicle before Test 1179-2.

This bridge rail was crash-tested with a 1979 Cadillac weighing 4,400 lb (1998 kg). Photographs of the Cadillac before and after the test are presented in Figures 9 and 10.

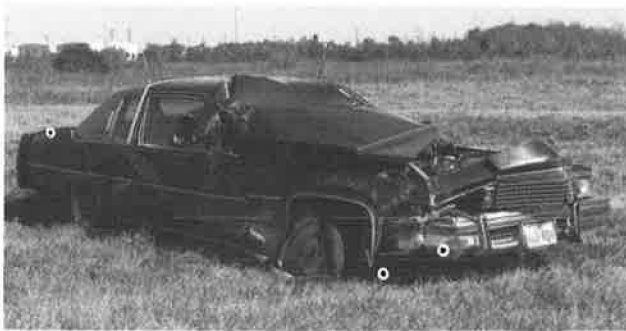
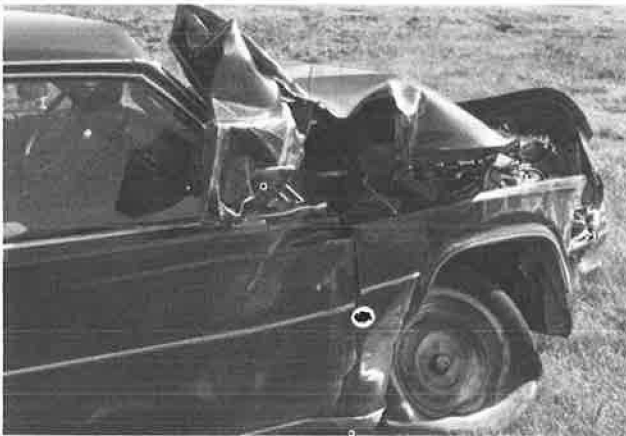
FIGURE 10 Vehicle after Test 1179-2.

The Cadillac struck the rail at 59.4 mph (95.6 km/hr) and at a 25.9-degree angle. Impact occurred 7.5 ft upstream of Post 11 and was smoothly redirected. Figure 11 shows the bridge rail and test site immediately after Test 1179-2. The Cadillac sustained damage to the right front and right side. The right front tire made light contact with concrete Post 11 and the hood came in contact with the metal post directly above concrete Post 11, as shown in Figure 12. This contact caused slight damage to the front right tire and suspension; however, the wheel was still rolling after contact. Severe damage to the hood resulted when it struck the steel post. The impact cracked the right front windshield, which is shown in Figure 10. The hood pushed the windshield inward several inches but did not penetrate the passenger compartment. A summary of the crash data is shown in Figure 13.

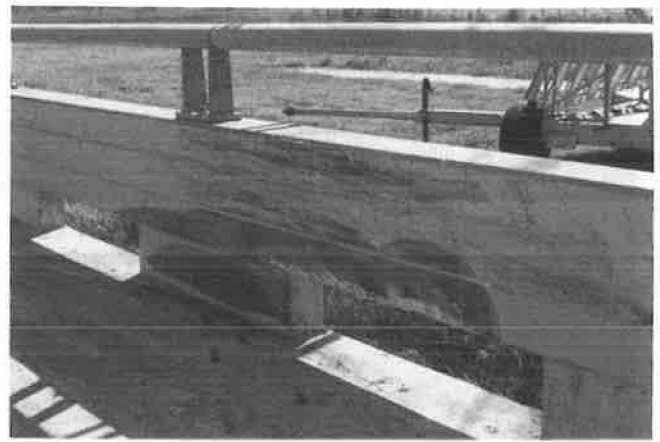
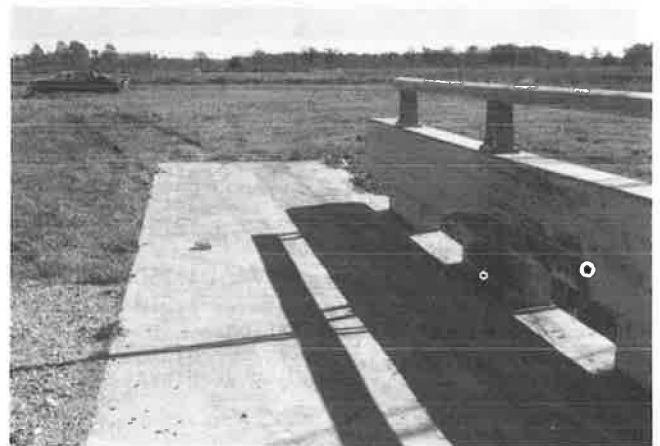
FIGURE 11 Bridge rail after Test 1179-2.

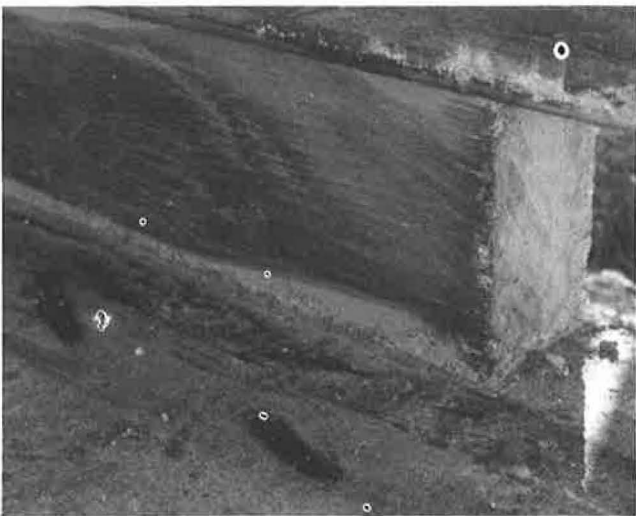
FIGURE 12 Damage to upper and lower Post 11 after Test 1179-2.

The Cadillac struck 5 ft upstream of the leading edge of the concrete post and 7 ft upstream of the leading edge of the steel post. The Cadillac wheel did not contact the concrete post, and the damage to the wheel and suspension was moderate. The wheel was still rolling after impact, and the vehicle trajectory was good with a departure angle of only 2.0 degrees. The hood contacted the steel post and was severely damaged. The hood pushed the right front windshield inward several inches but it did not intrude into the passenger compartment. Consequently, the Cadillac test was judged successful.
