Aesthetically Pleasing Concrete Beam-and-Post Bridge Rail

T. J. HIRSCH, C. E. BUTH, AND DARRELL KADERKA

DESCRIPTION OF TEXAS TYPE T411 BRIDGE RAIL

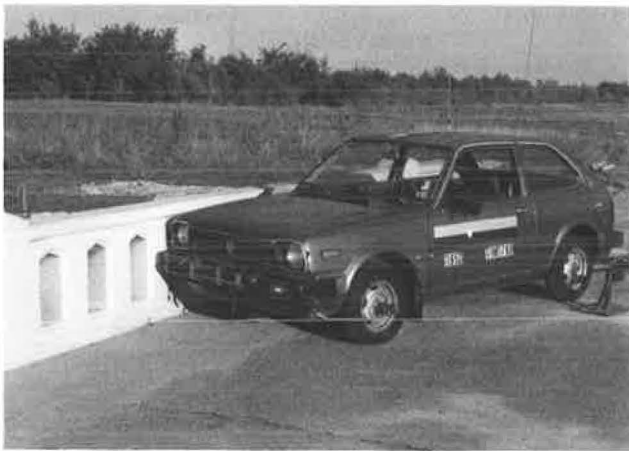
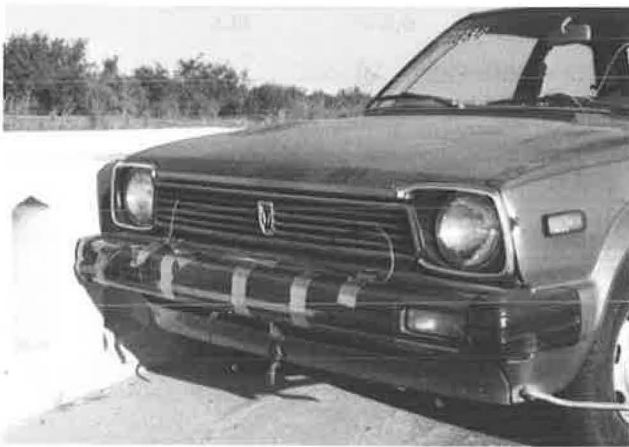
FIGURE 6 Vehicle-bridge rail geometrics for Test 1185-1.

The 1980 Honda Civic (Figure 6) was directed into the bridge rail using a reverse tow and guidance system. Test inertia mass of the vehicle was 1,800 lb. The lower edge of the vehicle bumper was 14.25 in. high, and the top of the bumper was 19.25 in. high. The vehicle was freewheeling and unrestrained just before impact.

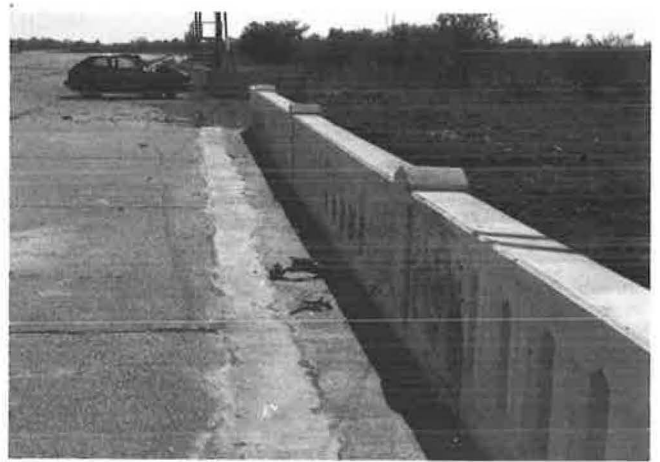
FIGURE 7 Test installation after Test 1185-1.

As can be seen in Figures 7 and 8, the rail sustained minimal cosmetic damage. Tire marks on the face of the bridge rail extended from the point of impact to the end of the rail. Some scraping and gouging along the edges of the portholes and of the first pilaster beyond impact occurred. The vehicle was in contact with the bridge rail for 53 ft. The vehicle sustained severe damage to the right side as shown in Figure 9. Maximum crush at the right front corner at bumper height was 11.0 in. The drive axle universal joint and right strut were damaged. The instrument panel in the passenger compartment was bent as well as the floor pan and roof, and the windshield was broken. The right front rim was bent and the tire was damaged. There was damage to the hood, grill, bumper, right front quarter panel, the right door and glass, the right rear quarter panel, and the rear bumper.

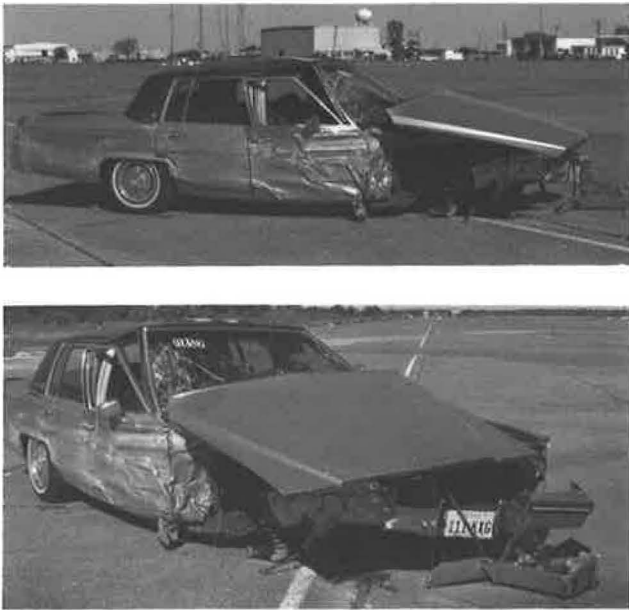
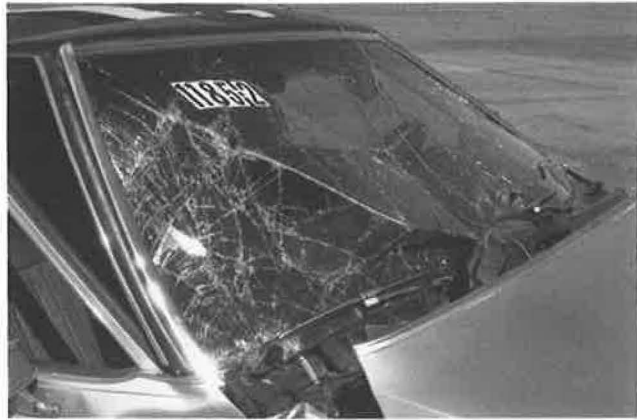
FIGURE 13 Vehicle after Test 1185-2.

The vehicle sustained moderate damage to the right side, as shown in Figure 13. Maximum crush at the right front corner at bumper height was 16.0 in. The right A-arm, the tie rod, and the upper and lower ball joints were damaged, and the subframe was bent. The instrument panel in the passenger compartment was bent as well as the floor pan and roof, and the windshield was broken. The right front and rear

rims were bent and the tires were damaged. There was damage to the hood, grill, bumper, right front quarter panel, the right front and rear doors, the right rear quarter panel, and the rear bumper.
