Wyoming Tube-Type Bridge Rail and Box-Beam Guardrail Transition

KING K. MAK, ROGER P. BLYGH, AND DAVID H. POPE

WYOMING TUBE-TYPE BRIDGE RAIL

BOX-BEAM GUARDRAIL TRANSITION

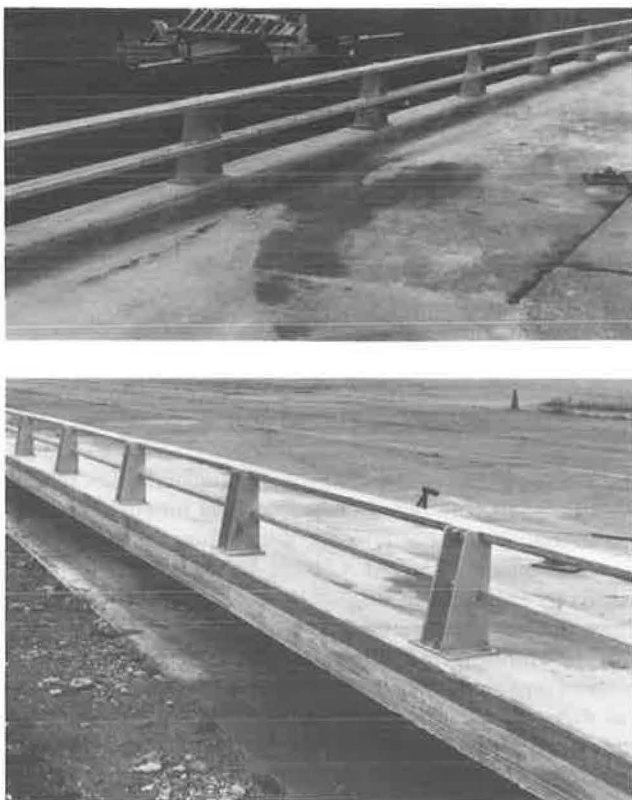
FIGURE 1 Wyoming tube-type bridge rail.

The Wyoming bridge rail consists of fabricated posts spaced 9 ft 3 in. apart with two TS 6 × 2 × 0.25 tube-type beams. The structural steel components of the bridge rail conform to the requirements of ASTM A 500 or ASTM A 501. The metal rail sits on top of a 6-in.-high curb for a total height of 29 in. above the pavement surface. The face of the curb was flush with the traffic face of the rails. The 77-ft bridge rail was installed on a simulated bridge deck of the same length, which was designed and constructed in accordance with standard bridge specifications used by the Wyoming State Highway Department. Photographs of the installation are shown in Figure 1.

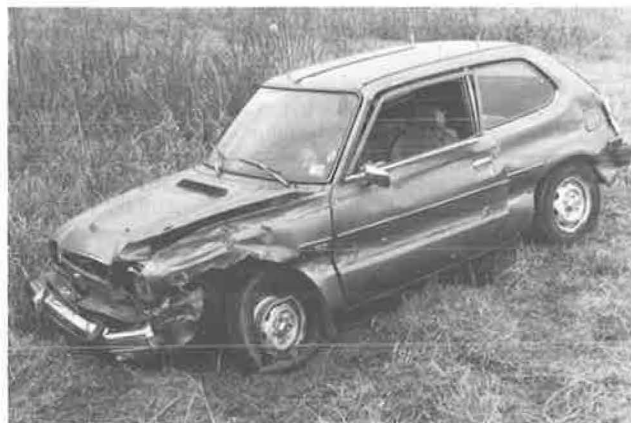
FIGURE 2 Barrier and vehicle damage after Test 0368-1.

The rail sustained minor damage, as shown in Figure 2. The permanent residual deformation was 0.25 in. vertically and laterally for both the top and bottom rails. The only repair necessary after the test was to loosen the bolts attaching the rail elements to two posts and realign the rail elements.

The vehicle sustained moderate damage, considering the severity of the impact. As shown in Figure 2, the damage consisted primarily of sheet metal crushing along the front left side of the vehicle. Maximum crush was 7.0 in. at the left front corner of the vehicle. There was also damage to the left front strut assembly and tire rim. In addition, the left door became ajar and the window glass was broken.

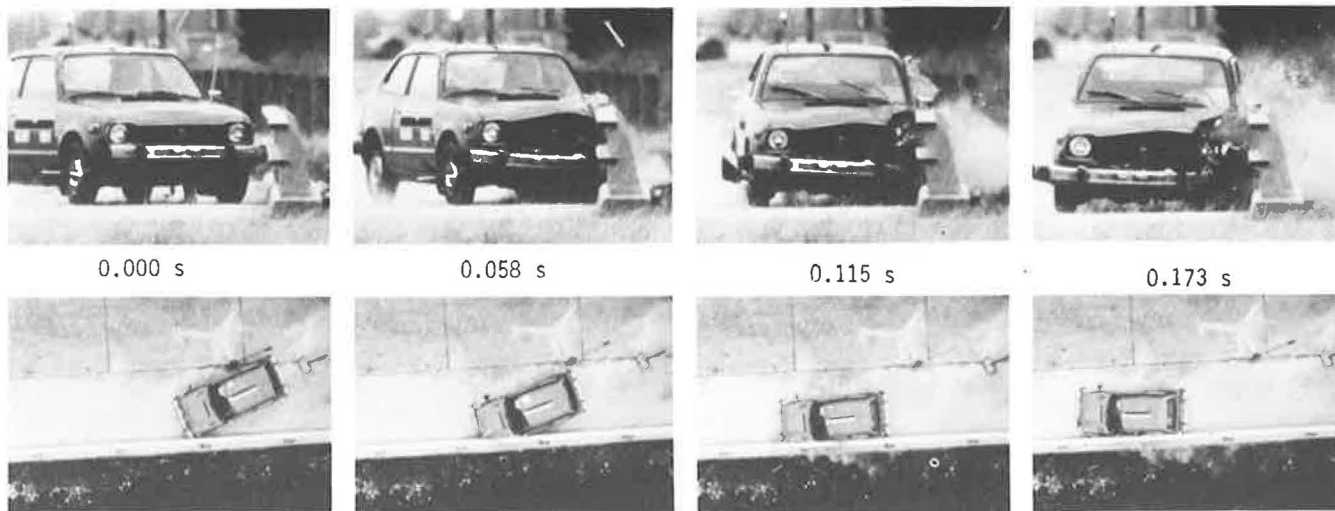
FIGURE 3 Summary of results for Test 0368-1.

Sequential photographs and a summary of the test results and other information pertinent to this test are given in Figure 3. The maximum 0.050-sec average acceleration experienced by the vehicle was $-8.0 g$ in the longitudinal direction and $-16.5 g$ in the lateral direction. Occupant impact velocities were 20.9 ft/sec and 30.9 ft/sec in the longitudinal and lateral directions, respectively. The highest 0.010-sec occupant ride-down accelerations were $-2.7 g$ (longitudinal) and $-10.1 g$ (lateral).

Test No 0368-1
 Date 02/09/88
 Test Installation Wyoming Tube-Type
 Bridge Rail
 Length of Installation 77 ft (23.5 m)
 Vehicle 1979 Honda Civic
 Vehicle Weight
 Test Inertia 1,800 lb (816 kg)
 Gross Static 1,968 lb (893 kg)
 Vehicle Damage Classification
 TAD 11LFQ5
 CDC 11FLES2 & 11LFES3
 Maximum Vehicle Crush 7.0 in (17.8 cm)
 Max. Perm. Rail Deformation 0.25 (0.64 cm)

Impact Speed 61.1 mi/h (98.3 km/h)
 Impact Angle 20.0 degrees
 Exit Speed 49.7 mi/h (80.0 km/h)
 Exit Angle 7.1 degrees
 Vehicle Accelerations
 (Max. 0.050-sec Avg)
 Longitudinal - 8.0 g
 Lateral -16.5 g
 Occupant Impact Velocity
 Longitudinal 20.89 ft/s (6.4 m/s)
 Lateral 30.89 ft/s (9.4 m/s)
 Occupant Ridedown Accelerations
 Longitudinal - 2.7 g
 Lateral -10.1 g

The lateral occupant impact velocity of 30.9 ft/sec was marginally higher than the limit of 30 ft/sec according to the guidelines on occupant risk criteria in *NCHRP Report 230*. However, once the occupant impact velocity is adjusted to account for the higher vehicle impact speed of 61.1 mph, it falls within the limit at 29.8 ft/sec. A comparison was made

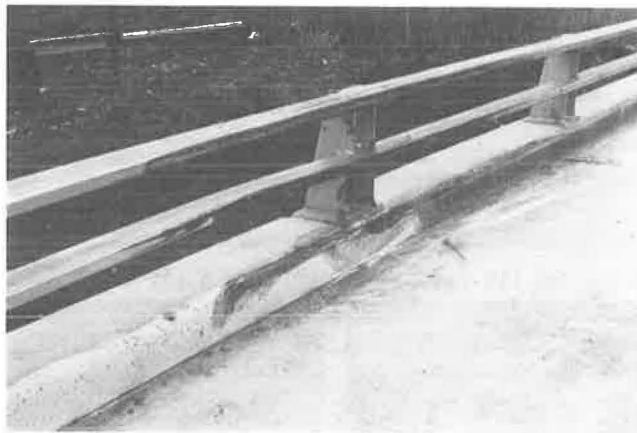
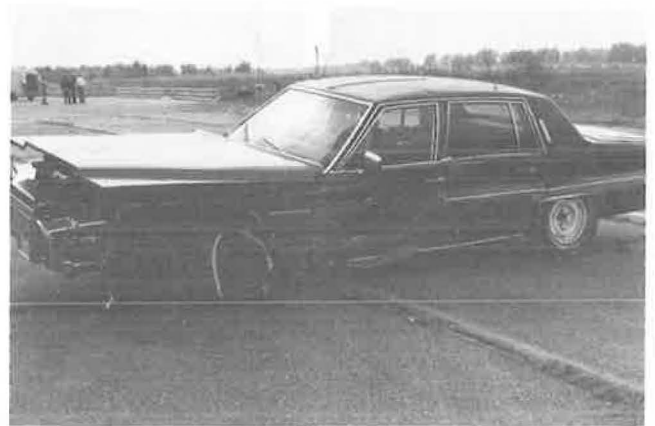
FIGURE 4 Barrier and vehicle damage after Test 0368-2.

The rail sustained minor damage, as shown in Figure 4. The permanent residual deformation was 1.25 in. vertically and 0.75 in. laterally for the bottom rail and approximately 0.50 in. both vertically and laterally for the top rail. Diagonal stress cracks were found on the concrete bridge deck around the post immediately downstream from the point of impact, and a small piece of concrete was broken off behind the post.

The vehicle sustained light to moderate damage, as shown in Figure 4. The front end of the car was shifted to the right and the subframe was bent. Maximum crush was 18.0 in. at the left front corner of the vehicle. The primary and secondary hood latches of the vehicle were disengaged by the impact, and part of the hood slid across the top of the top rail element.

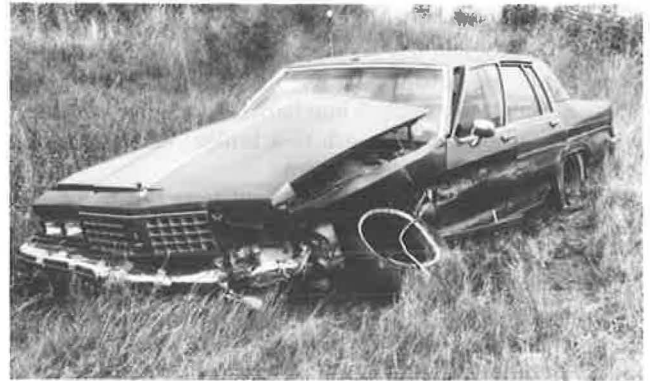
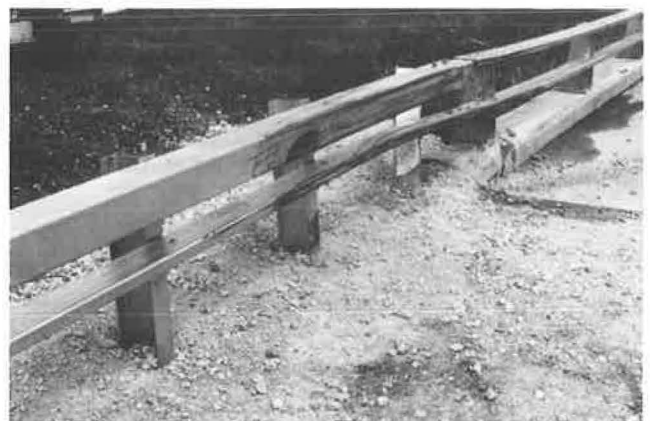
FIGURE 7 Barrier and vehicle damage after Test 0382-1.

The transition installation and bridge railing sustained moderate damage, as shown in Figure 7. The first post in the transition (i.e., Post 1 immediately upstream of the bridge railing end) became completely detached from the upper and lower rails and was displaced a maximum of 4.0 in. rearward and 7.0 in. laterally. Maximum permanent rail deformation was 5.0 in. for the upper rail at the first transition post and 4.8 in. for the lower rail at the second post in the transition. The maximum dynamic rail deflection was 12 in. Maximum displacement at the first bridge rail post was 3.8 in.

Damage to the vehicle is shown in Figure 7. The damaged areas included the left side of the vehicle and the left front tire and rim. The left front wheel was pushed rearward a total of 9.5 in., causing the floor of the passenger compartment to be deformed slightly. The maximum crush was 12.0 in. at the front left corner of the vehicle.

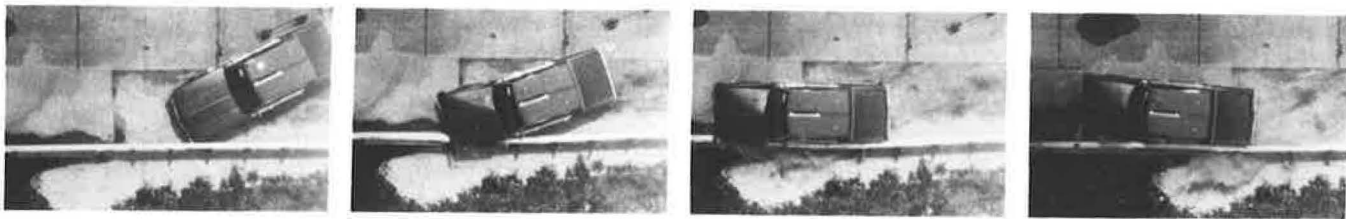
FIGURE 8 Summary of results for Test 0382-1.

Test No.	0382-1	Impact Speed	62.8 mi/h (101.1 km/h)
Date	07/11/89	Impact Angle.	25.5 deg
Test Installation.	Wyoming Bridge Rail Transition	Exit Speed.	44.4 (71.4 km/h)
Installation Length	168.3 ft (51.3 m)	Exit Trajectory	9.7 deg
Vehicle.	1980 Oldsmobile Ninety-Eight	Vehicle Accelerations (Max. 0.050-sec Avg)	
Vehicle Weight		Longitudinal.	-8.4 g
Test Inertia	4,500 lb (2,043 kg)	Lateral	-12.6 g
Vehicle damage Classification		Occupant Impact Velocity	
TAD.	11LFQ-4 & 11LD-2	Longitudinal.	28.0 ft/s (8.5 m/s)
CDC.	11FLEK2 & 11LFES	Lateral	27.7 ft/s (8.4 m/s)
Maximum Vehicle Crush.	12.0 in (30.5 cm)	Occupant Ridedown Accelerations	
Maximum Dynamic Rail Deflection.	12.0 in (30.5 cm)	Longitudinal.	-6.1 g
		Lateral	-14.2 g

Sequential photographs and a summary of the test results and other information pertinent to this test are given in Figure 8. The maximum 0.050-sec average accelerations experienced by the vehicle were -8.4 g in the longitudinal direction and -12.6 g in the lateral direction. Occupant impact velocity was 28.0 ft/sec in the longitudinal direction and 27.7 ft/sec in

lateral direction. The maximum 0.010-sec occupant ride-down accelerations were -6.1 g (longitudinal) and -14.2 g (lateral). Although not required for the evaluation of a transition test, the occupant impact velocities and ridedown accelerations were all within the maximum acceptable limits.

The vehicle velocity change of 18.4 mph was higher than the limit of 15 mph recommended in *NCHRP Report 230*. However, because the exit angle of 9.7 degrees was substantially less than 60 percent of the impact angle and the vehicle trajectory indicated a minimal potential for intrusion into the adjacent traffic lanes, the 15-mph criterion was not considered applicable.

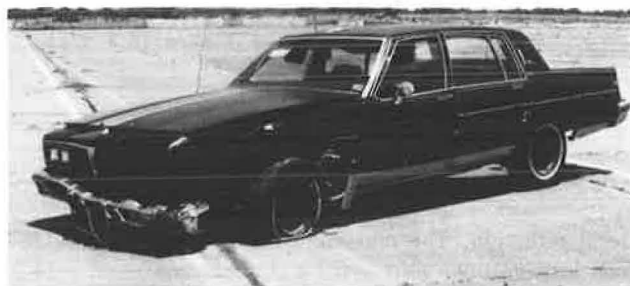
FIGURE 9 Barrier and vehicle damage after Test 0382-2.

The box-beam guardrail and transition treatment sustained only minor damage, as shown in Figure 9. The first seven posts downstream from the point of impact (Posts 5 through 9 of the transition treatment and Posts 10 and 11 of the box-beam guardrail) were bent over and separated from the upper and lower rails. The next four posts (Posts 1 through 4 of the

transition) remained upright, and the upper rail remained attached to these posts. Post 6 of the transition was completely pulled out from the soil. Maximum dynamic rail deflection was 5.8 ft at the eighth post of the transition. The vehicle remained in contact with the guardrail and transition treatment for a distance of approximately 62 ft.

The vehicle sustained only minor damage, as indicated in Figure 9. The damage was confined to the left side of the vehicle and the left front tire and rim. The maximum crush was 12.5 in. at the front left corner of the vehicle. Although slightly damaged, the left front wheel was not displaced rearward.
