# Performance Evaluation of a Movable Concrete Barrier

DORAN L. GLAUZ

A series of crash tests and operational demonstrations of a precast movable concrete barrier (MCB) were performed. Four crash tests of the MCB showed that it can successfully redirect both light and heavy passenger cars at various angles of impact. The crash tests involved two large cars weighing 4,370 lb and 4,300 lb, traveling 59.3 and 59.4 mph, and striking at 24 degrees and 16 degrees, respectively; and two small cars weighing 2,000 lb and 1,895 lb, traveling 57.7 and 58.6 mph, and striking at 15½ degrees and 20½ degrees, respectively. The crash tests satisfied the requirements for structural adequacy and occupant risk in *NCHRP Report 230*. Vehicle trajectory requirements were not satisfied because of large exit angles. The demonstrations consisted of (a) a transfer vehicle straightening a deflected barrier after the last crash test; (b) a transfer vehicle transporting, assembling, and transferring a barrier on a 1,400-ft radius with a 12 percent cross-slope; (c) a transfer vehicle transferring a barrier on a 4 to 5 percent longitudinal grade; and (d) manual movement of the barrier to adjust minor misalign

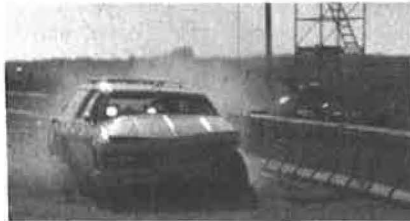
FIGURE 6 Summary of data for Test 443.

The left front bumper of the test vehicle struck the 100-segment barrier at the midpoint of Segment 62 at 59.3 mph (26.5 m/sec) and an angle of 24 degrees. The length of vehicle contact with the barrier was about 39 ft (12 m), from Segments 62 to 74. The car was smoothly redirected and lost contact with the barrier at an exit angle of 14 3/4 degrees. The car

experienced a maximum roll of  $-10\frac{1}{4}$  degrees. The maximum rise of the car was 4 in. (100 mm) 0.73 sec after impact, measured at the right rear corner of the roof. Figure 6 shows sequential photographs and a trajectory diagram.

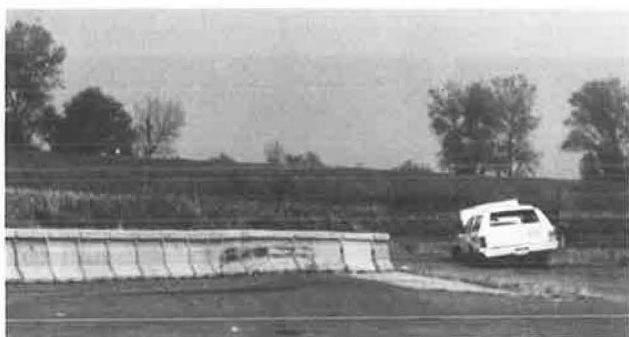
FIGURE 7 Car and barrier after impact, Test 443.

The trajectory of the car after impact was back toward the line of the barrier. A second impact with the barrier occurred at Segment 93. The car came to rest about 30 ft (9.1 m) beyond the downstream end of the barrier and approximately in line with its face (Figure 7).

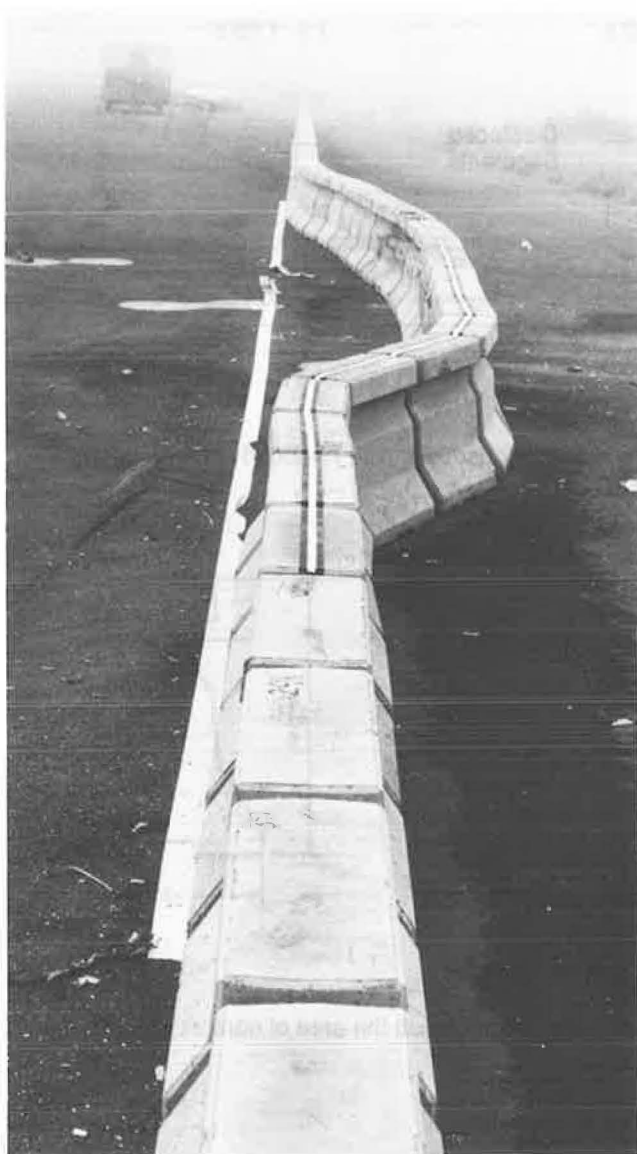
FIGURE 8 Deflected barrier after impact, Test 443.

The barrier was displaced laterally along a distance of about 66 ft (20 m) (Segments 54 through 75). The maximum lateral displacement was 3.74 ft (1.3 m) at Segment 66 (Figure 8). There was longitudinal movement in the barrier from Segments 22 to 100. The maximum longitudinal displacement in the downstream direction was 0.5 ft (140 mm) at Segment 54. The maximum longitudinal displacement in the upstream direction was 0.15 ft (45 mm).

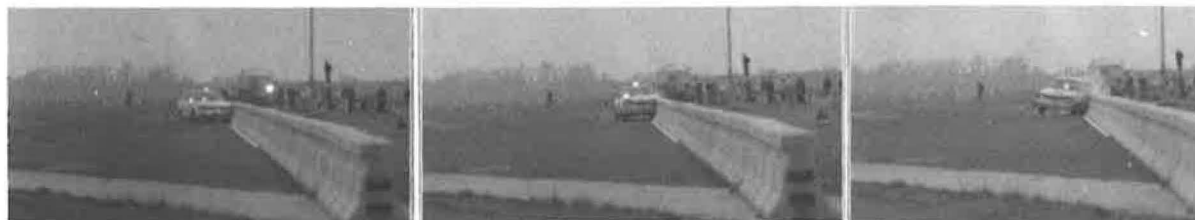
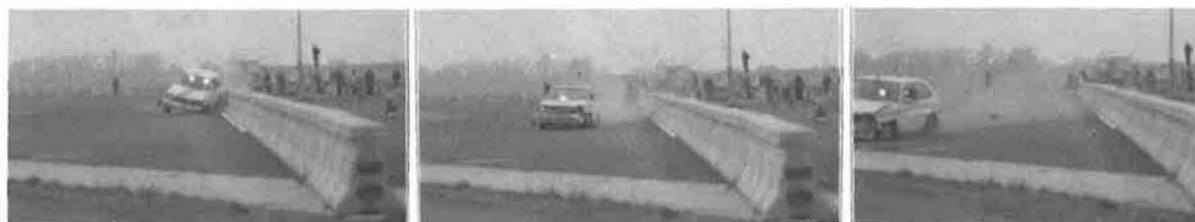
FIGURE 9 Summary of data for Test 444.

The left front bumper of the test vehicle struck the 100-segment barrier at the midpoint of Segment 48 at 57.7 mph (25.8 m/sec) and an angle of  $15\frac{1}{2}$  degrees. The length of vehicle contact with the barrier was about 16 ft (5 m), from Segments 48 to 52. The car was smoothly redirected and lost contact with the barrier at an exit angle of  $10\frac{1}{4}$  degrees. The car experienced a maximum roll of  $-14\frac{1}{2}$  degrees and a pitch of  $+10\frac{1}{4}$  degrees. The maximum rise of the car was 17 in. (430 mm) 0.36 sec after impact, measured on the right rear tire. Figure 9 shows sequential photographs and a trajectory diagram.

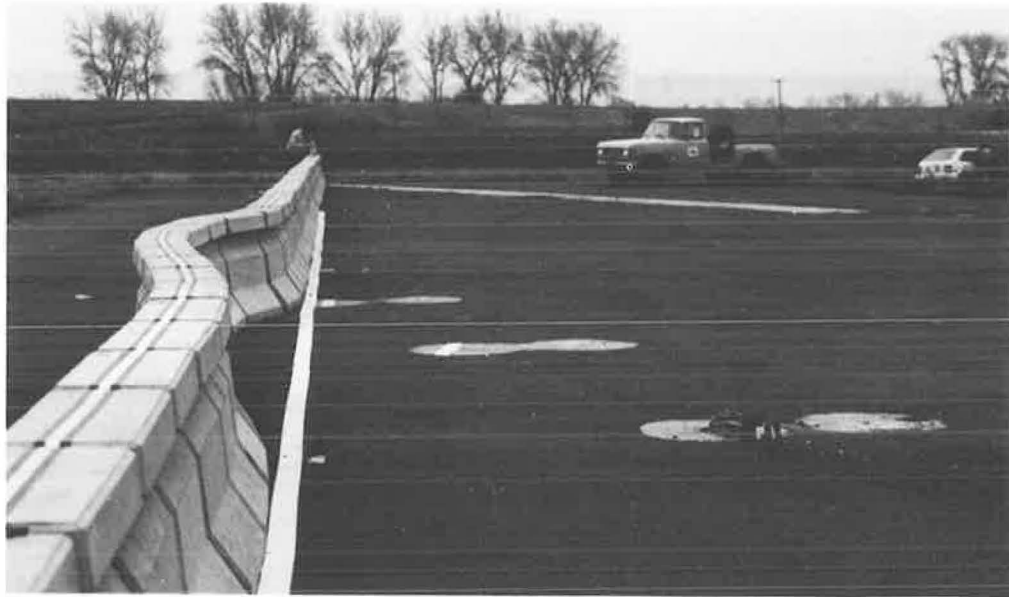
FIGURE 10 Car and barrier after impact, Test 444.

The trajectory of the car after impact was away from the barrier. The car came to rest off the paved area about 15 ft (4.6 m) beyond the downstream end of the barrier and 60 ft (18 m) from its face (Figure 10).

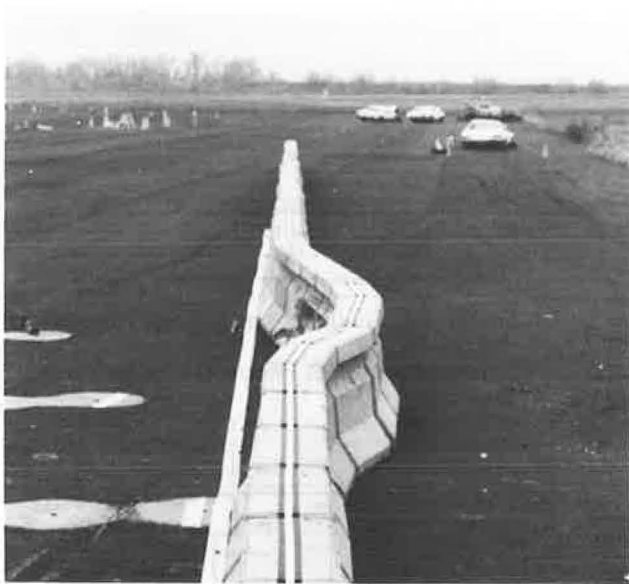
FIGURE 11 Deflected barrier after impact, Test 444.

The barrier was displaced laterally along a distance of about 30 ft (9 m) (Segments 47 through 55) (Figure 11). The maximum lateral displacement was 1.78 ft (542 mm) at Segment

51. There was longitudinal movement in the barrier from Segments 36 to 65. The maximum longitudinal displacement in the downstream direction was 0.1 ft (30 mm) at Segment 47. The maximum longitudinal displacement in the upstream direction was 0.1 ft (31 mm) at Segment 55.

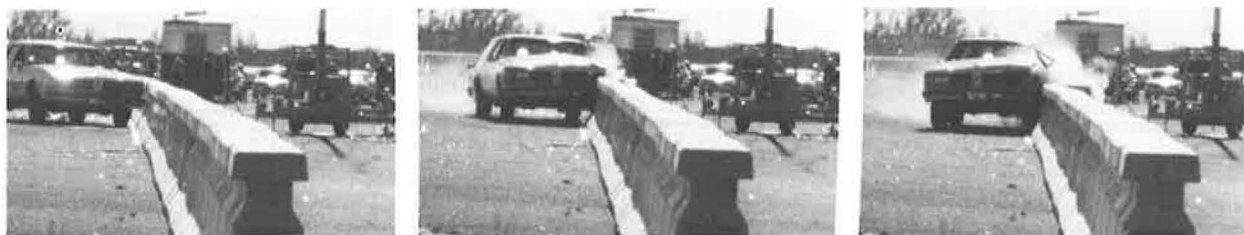
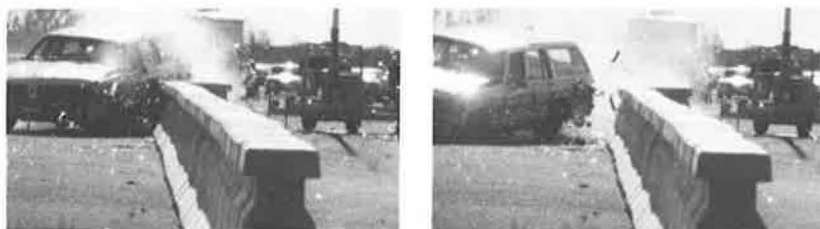
FIGURE 12 Summary of data for Test 445.

The left front bumper of the test vehicle struck the 100-segment barrier at the midpoint of Segment 52 at 59.4 mph (26.6 m/sec) and an angle of 16 degrees. The length of vehicle contact with the barrier was about 33 ft (10 m), from Segments 52 to 61. The car was smoothly redirected and lost contact with the barrier at an exit angle of  $16\frac{1}{2}$  degrees. The car experienced a maximum roll of  $+6\frac{1}{4}$  degrees and a pitch of  $+5\frac{3}{8}$  degrees. The maximum rise of the car was 19 in. (490 mm) 0.54 sec after impact, measured on the right rear bumper. Figure 12 shows sequence photographs and a trajectory diagram.

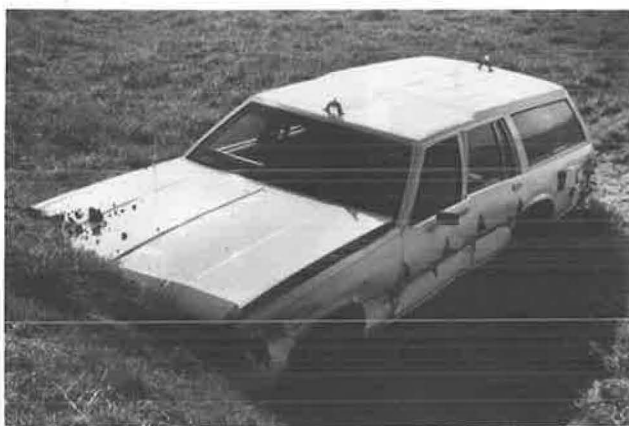
FIGURE 13 Car after impact, Test 445.

The trajectory of the car after impact was away from the barrier. The car came to rest off the paved area at the toe of an earth berm about 79 ft (24 m) beyond the downstream end of the barrier and 41 ft (12.5 m) from its face (Figure 13).

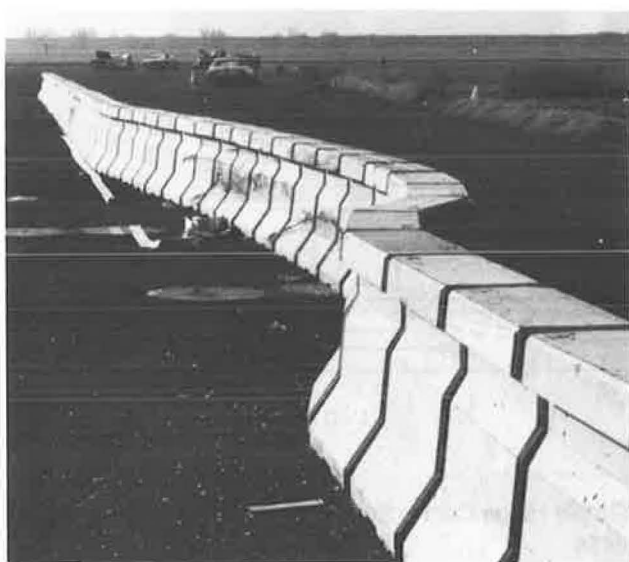
FIGURE 14 Deflected barrier after impact, Test 445.

The barrier was displaced laterally along a distance of about 59 ft (18 m) (Segments 47 through 65). The maximum lateral displacement was 2.85 ft (870 mm) at Segment 59 (Figure 14). There was longitudinal movement in the barrier from Segments 26 to 81. The maximum longitudinal displacement in the downstream direction was 0.4 ft (110 mm) at Segment 58. The maximum longitudinal displacement in the upstream direction was 0.1 ft (34 mm) at Segment 70.

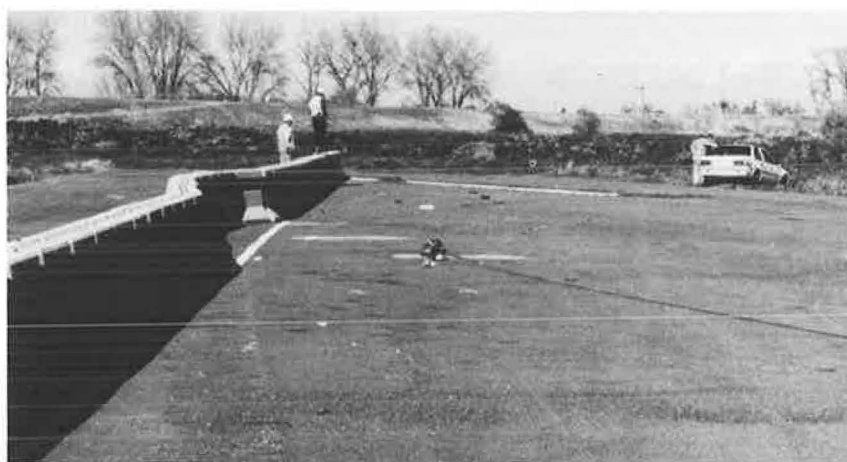
FIGURE 16 Car and barrier after impact, Test 446.

The trajectory of the car after impact was away from the barrier. The car came to rest about even with the downstream end of the barrier 37 ft (11 m) away from its face (Figure 16).

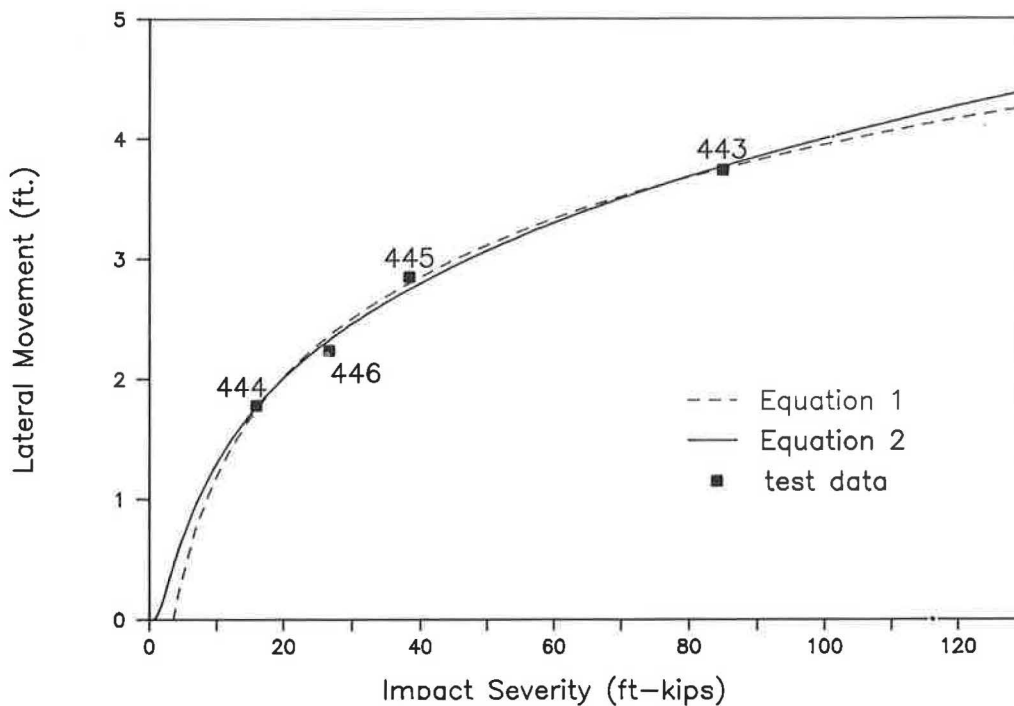
FIGURE 18 Plot of predictive equations and test data.

Two equations (Table 2) were found to fit the experimental data. These equations are represented in graphical form with the experimental data in Figure 18. The correlation is significant at the 5 percent level (2, pp. 462–463). Data from other tests were also used in deriving these equations (1; E. F. Nordlin, unpublished data).

For very small values, up to 3.8 ft-kips (5.2 kJ), no deflection is predicted by Equation 1. Although the second equation approaches a zero displacement as IS approaches zero, it can be considered to evaluate to zero for IS less than 1 ft-kip (1.4 kJ).

For small impacts, up to 15 ft-kips (20 kJ), it is believed that Equation 1 understates the displacement that might be expected. Within this impact severity range, Equation 2 probably gives a better value of lateral displacement. The reason why the lateral displacement is probably larger than that predicted by Equation 1 lies in the action within the hinge during impact. In high-IS impacts, like those used to derive Equation 1, many of the barrier segments move. For each segment that moves, the entire longitudinal clearance in the hinge is taken up, effecting a lengthening of the barrier to allow lateral movement. During low-energy impacts many fewer segments are brought into the movement zone, down to the limiting case where only two segments move at all. In an impact when only two or three segments move, all the longitudinal clearance in the hinge may not be used, thus allowing movement with very low energy input.

In the range of 15 to 130 ft-kips (20 to 175 kJ), the two equations give the same answer within the accuracy that can be expected from such an estimator. Caution must be exercised when using these equations to extrapolate beyond 100 ft-kips (135 kJ), because that is beyond the value of any data used to derive the equations. At some unknown value of impact severity some structural elements of the barrier may fail, thus invalidating any attempt at predicting deflection.

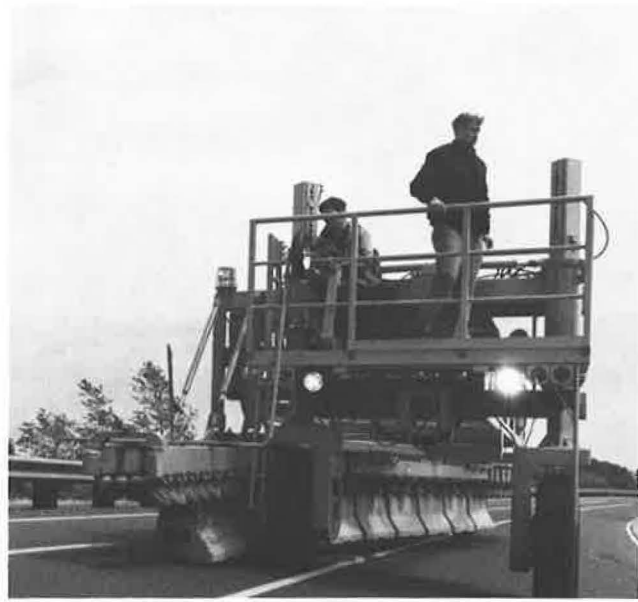
**FIGURE 20** Transfer vehicle carrying barrier.

The second demonstration showed how lengths of barrier can be transported and reattached to a standing barrier. (Such an operation might be performed to move the lane closure zone of a progressing construction site.) A length of barrier, 10 segments, was loaded onto the conveyor of the transfer vehicle, carried to the location of the third demonstration, and reassembled (Figure 20). The transport distance was about 0.5 mi (800 m), and the travel speed on the paved road was about 10 mph (4.5 m/sec). To reassemble the MCB, the barrier on the ground was aligned with the barrier within the vehicle and a hinge pin was inserted. Alignment was accomplished by loading the portion on the ground partway into the conveyor (Figure 21) until it came in contact with the

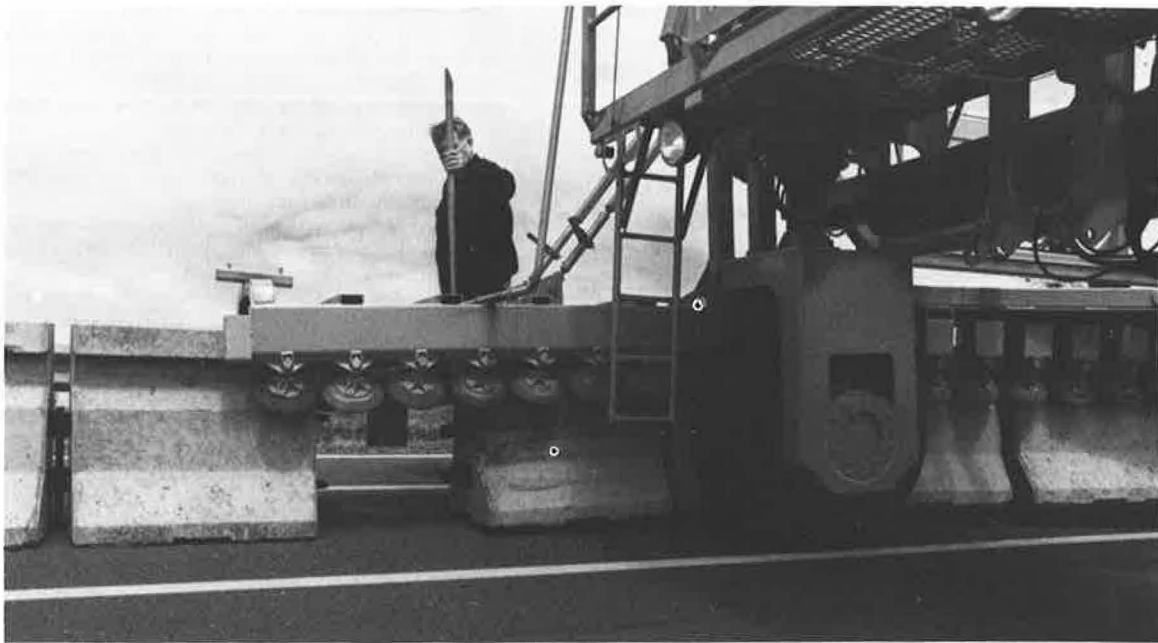
**FIGURE 21** Aligning barrier for connecting carried barrier and placed barrier.

carried barrier. There was some difficulty inserting the pin because the joint to be connected was sometimes pushed too far into the vehicle, to a place that hampered insertion. Even with that problem, though, assembly of the barrier was much faster than if it had been set one segment at a time.
