# Temporary Asphalt Medians for Two-Lane, Two-Way Operation

The objectives of this research were to evaluate the performance of temporary asphalt medians for use in two-lane, two-way operations as an alternative to portable concrete barriers and, if appropriate, to develop guidelines for the use of temporary asphalt medians. Use of the temporary asphalt median was evaluated at one site. The median was installed and removed at least twice as fast as concrete barriers, thereby reducing the time traffic was exposed to such activities by at least 50 percent. There was no difference in the cost per linear foot between the median and the concrete barrier because of the relatively high contract cost for the median compared with median costs in other states. However, use of the median will save a minimum of \$40,000 (\$80,000 on this project) by eliminating the use of impact attenuators at the concrete barrier end sections. It is expected that the costs will decrease as more medians are used; the cost per linear foot of the median was 40 percent lower on the second project in Virginia using the median. There is no evidence to suggest that the temporary asphalt median directly contributed

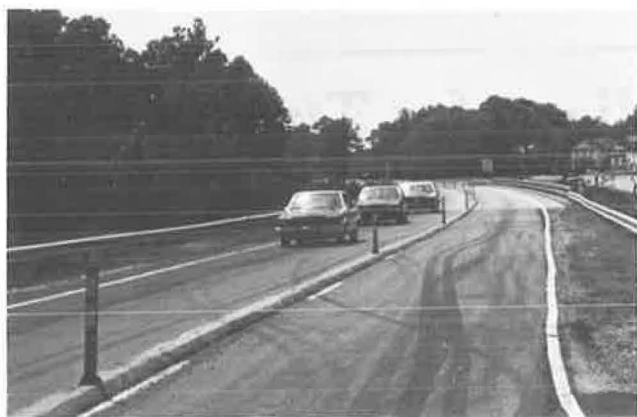
**FIGURE 1** Temporary asphalt median.

A typical temporary asphalt median (also called an island) is 12 in. to 18 in. wide and 4 in. high, is painted with reflectorized yellow paint, and has orange tubes with reflectorized white collars mounted about 50 ft apart as shown in Figure 1 (2). The median is highly visible and provides more positive delineation than the concrete barrier, especially at night. Because the median is narrower than the barrier, it occupies less of the travel lane. Several state departments of transportation, including those of North Carolina, Florida, Ohio, and Pennsylvania, have successfully used the medians, typically on roads with average daily traffic (ADT) volumes under 30,000. The medians are generally not recommended where physical (protective) separation of the opposing lanes is required or where the traffic volume is high, for example, where the ADT is above 50,000.

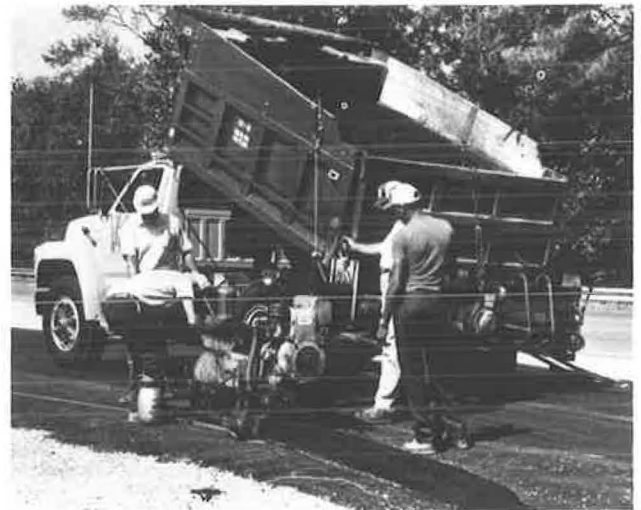
FIGURE 3 Median installation process.

A temporary asphalt median was installed on August 10–11, 1987. The length of the median was 2,280 ft. About one-half of the median was installed on the first day before the asphalt curb machine malfunctioned. It was noted that the asphalt mixture (VDOT Type I-2) was crumbling. Consequently, on the second day, a finer, modified Type I-2 asphalt mixture was used. Four workers were involved in the median installation: (a) the curb machine guider, (b) the dump truck driver, (c) the monitor of the asphalt entering the machine, and (d) the inspector of the median and cleaner of loose asphalt (Figure 3). The asphalt median was installed at a rate of 420 ft/hr.

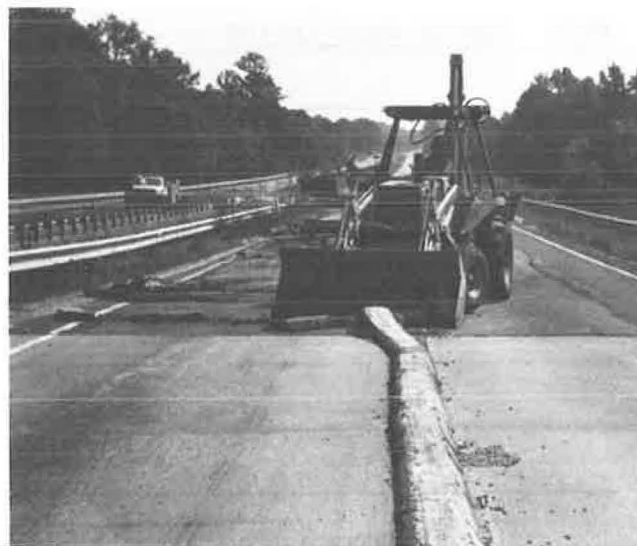
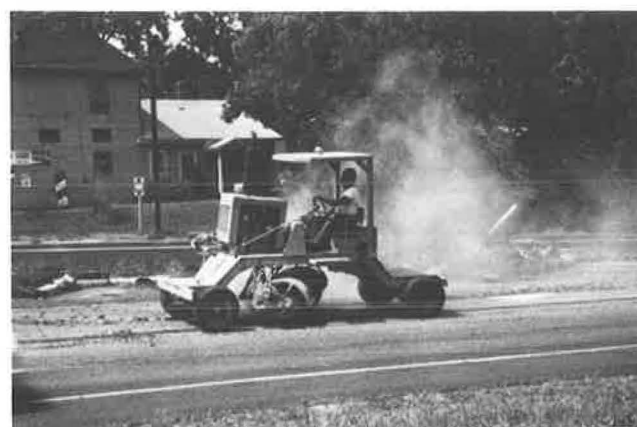
**FIGURE 5** Median removal: *top*, front-end loader removing median; *bottom*, sweeping loose gravel.

TLTWO ended on August 8, 1988, with the opening of the new westbound bridge. The median was removed on August 8–9, 1989, in three phases (Figure 5): a front-end loader was

used to push the asphalt median into a pile toward the left shoulder, a tractor with a sweeper attachment swept the loose asphalt from the travel lane toward the shoulder, and a second front-end loader loaded the asphalt from the median onto a dump truck for transport to a storage area. During the first two phases, the second front-end loader was removing the median crossover pavement.

into the closed left lane during gaps in the traffic stream. The median was then pushed into piles about 500 ft apart. The average rate of removal by the loader was 606 ft/hr (with a standard deviation of 144 for four samples).
