# Effectiveness of Epoxy Coatings in Minimizing Corrosion of Reinforcing Steel in Concrete

ALI AKBAR SOHANGHPURWALA AND KENNETH C. CLEAR

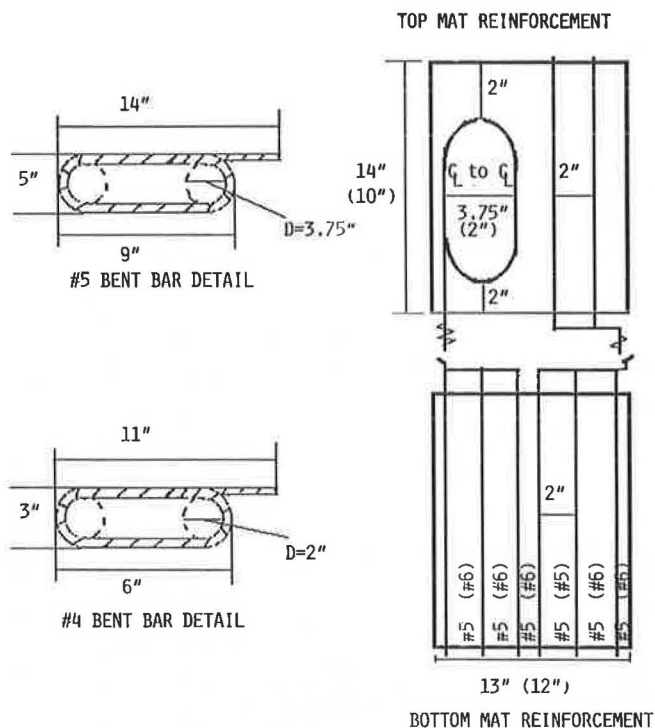
FIGURE 1 Slab and bent-bar fabrication details.

Three slabs were fabricated per variable. Each slab contained a coated set of one bent and two straight bars as top steel (see Figure 1). The bottom mat consisted of No. 5 and No. 6 black bars. The slabs were designed so that each slab effectively comprised two specimens. One-half of the slab was a bent-bar specimen and the remainder was a straight-bar specimen of the same variable. The bottom mat steel was sized to provide the same ratio of steel area between the top mat and the bottom mat for both halves of the slab. Thus, the ratio of epoxy-coated steel areas (top mat) to black steel areas (bottom mat) was the same for both halves of each epoxy-coated bar slab.

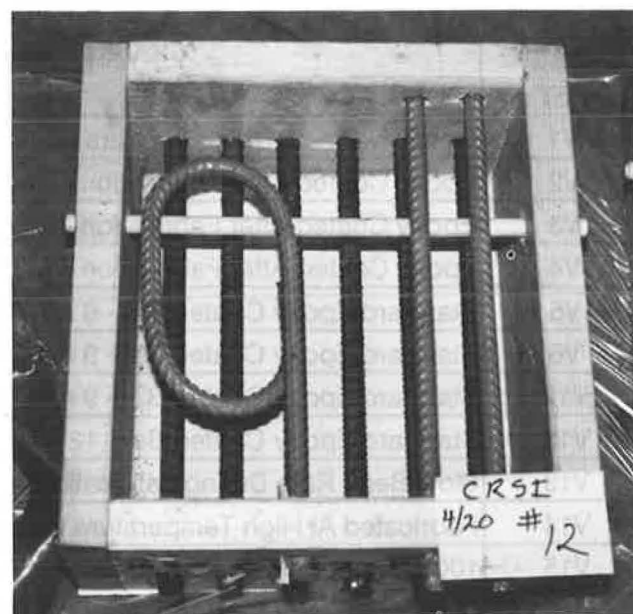
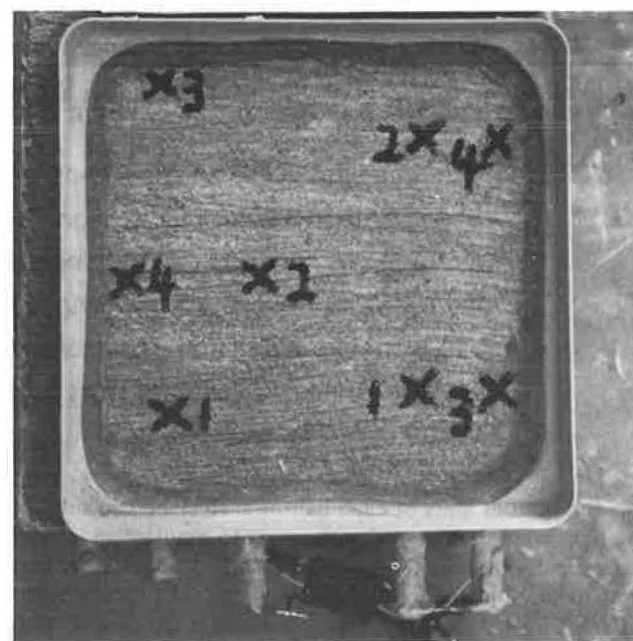
FIGURE 2 Top: epoxy-coated bars in forms before concrete placement. Bottom: completed slab before SE cycling.

top and bottom mats of each half of each slab. The sides of the slabs were then coated with epoxy to simulate an infinite slab. Finally, ponding dams were installed on all slabs that were to be subjected to southern exposure (SE) testing as per *NCHRP Report 244 (13)*. Figure 2 shows a typical slab with the ponding dam in place.

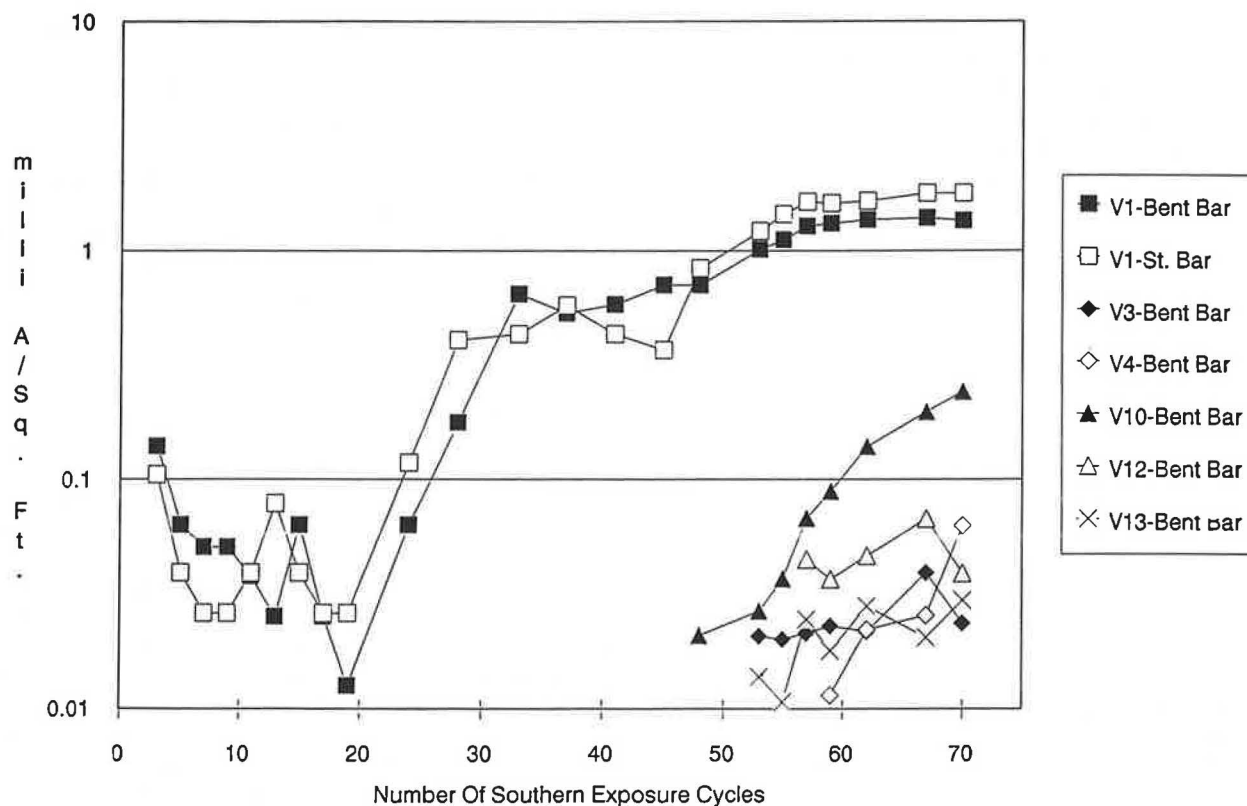
FIGURE 3 Large-bend study—controls and epoxy-coated bar specimens: macrocell current versus time.

square foot of the top mat steel. Figures 3 and 4 present macrocell current data for all slabs that have values greater than 0.01 mamp/ft<sup>2</sup>. Also, the data for each variable are an average of several slabs (see Table 1 for number of slabs representing each variable).

Out of the 36 sets of epoxy-coated specimens tested, only seven showed macrocell corrosion currents in excess of 0.01 mamp/ft<sup>2</sup>. Of these seven sets, three (V10-Bent Bar, V13-Bent Bar, and V19-Bent Bar) had visibly identifiable coating damage such as nicks, scrapes, and cuts before placement in the concrete. The data in Figures 3 and 4 clearly highlight the difference in the rate of corrosion of the controls versus the epoxy-coated bars. The corrosion rate of the controls is more than an order of magnitude larger than the epoxy-coated bars (controls averaged 1.62 mamp/ft<sup>2</sup>, and all the epoxy-coated bars averaged 0.018 mamp/ft<sup>2</sup> while the average of the 7 sets presented was 0.072 mamp/ft<sup>2</sup>). The data indicate that epoxy-coated rebars are less susceptible to corrosion than uncoated rebars under accelerated corrosion conditions. Work performed in Finland also indicated that electrostatically epoxy-coated bars provide corrosion protection even in an aggressive environment (5). Corrosion initiation in the control specimens occurred after only about a maximum of 20 SE cycles, whereas in the epoxy-coated bar specimens (with macrocell currents greater than 0.01 mamp/ft<sup>2</sup>) it occurred between 45 and 60 SE cycles except for one set of specimens (V19-bent) where it occurred at about 28 SE cycles.

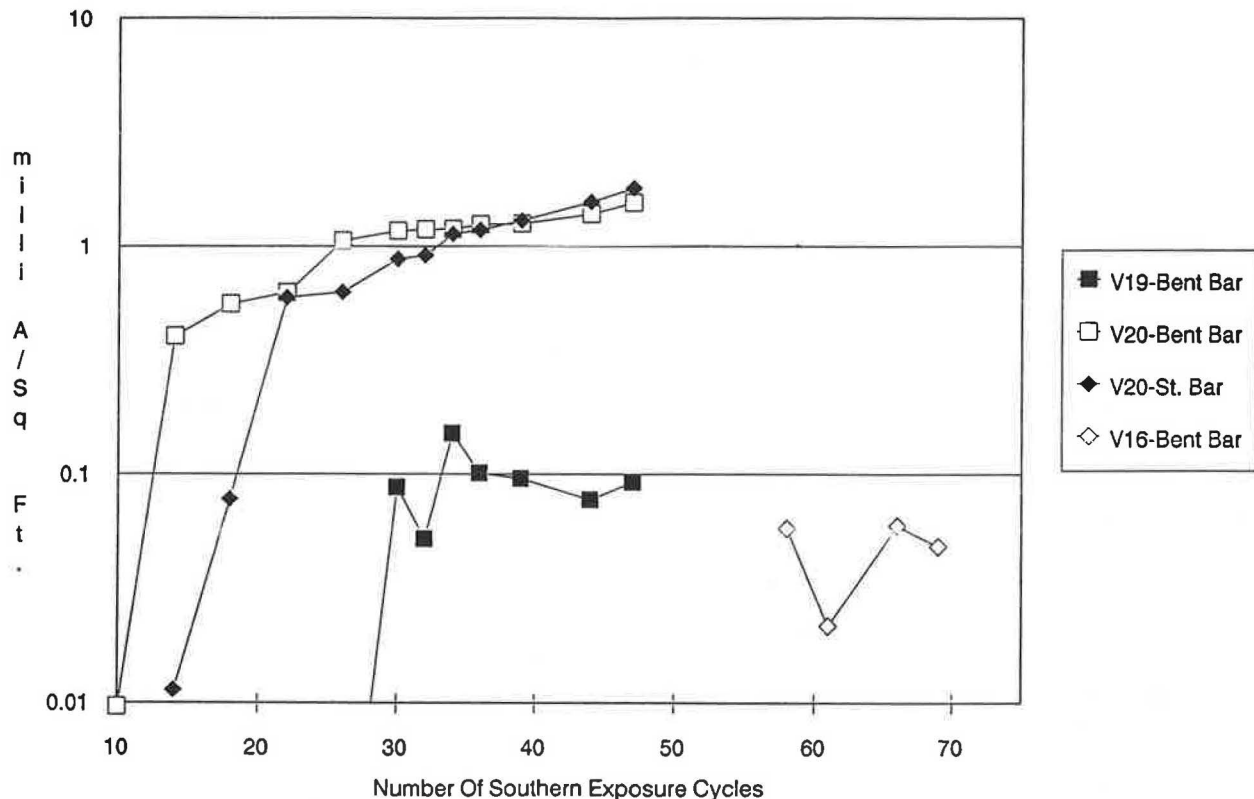
FIGURE 4 Small-bend study—controls and epoxy-coated bar specimens: macrocell current versus time.

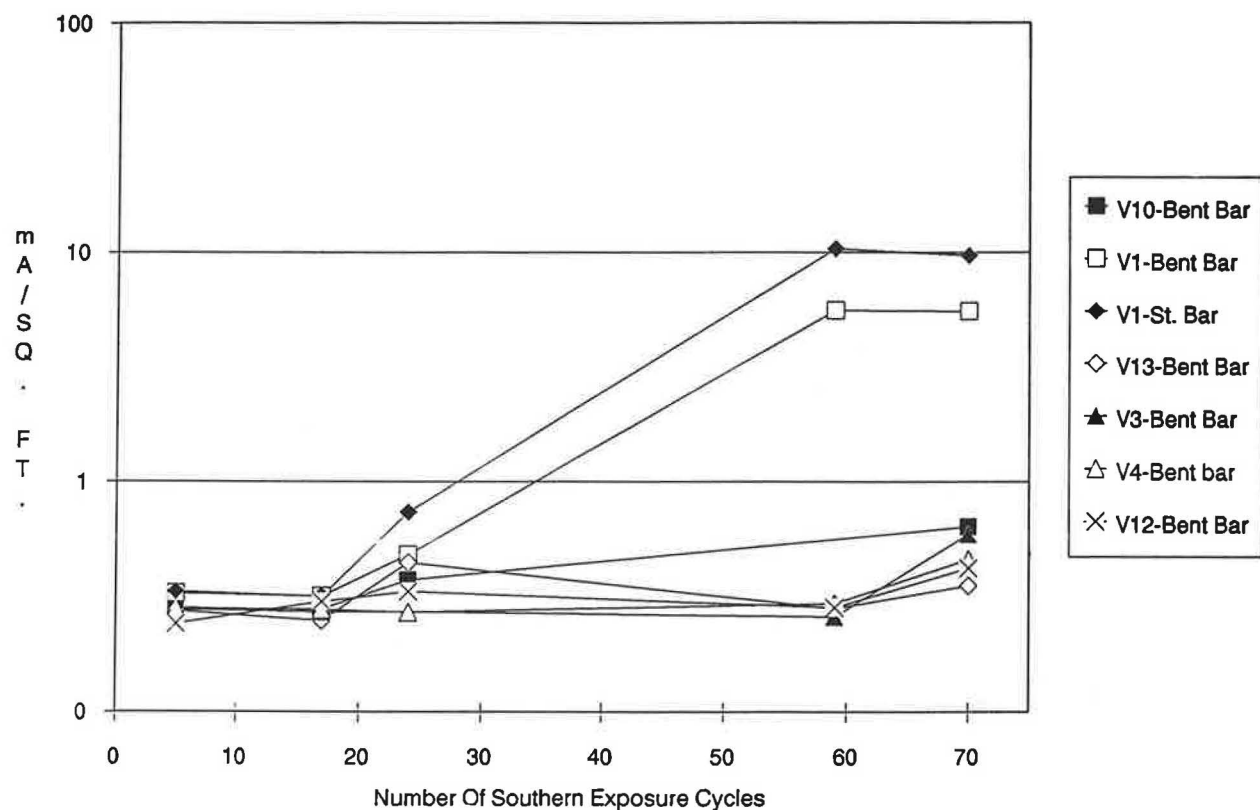
FIGURE 5 Large-bend study—controls and epoxy-coated bar specimens: corrosion rate versus time.

Corrosion rate data obtained from the same seven sets of specimens for which macrocell current data were presented are shown in Figures 5 and 6 and were calculated from the results of three-electrode linear polarization testing. The data reflect about an order of magnitude difference between the controls and the epoxy-coated bars, which was also indicated by the macrocell corrosion current data, but the data appear at present to fail to differentiate between epoxy-coated bar specimens.

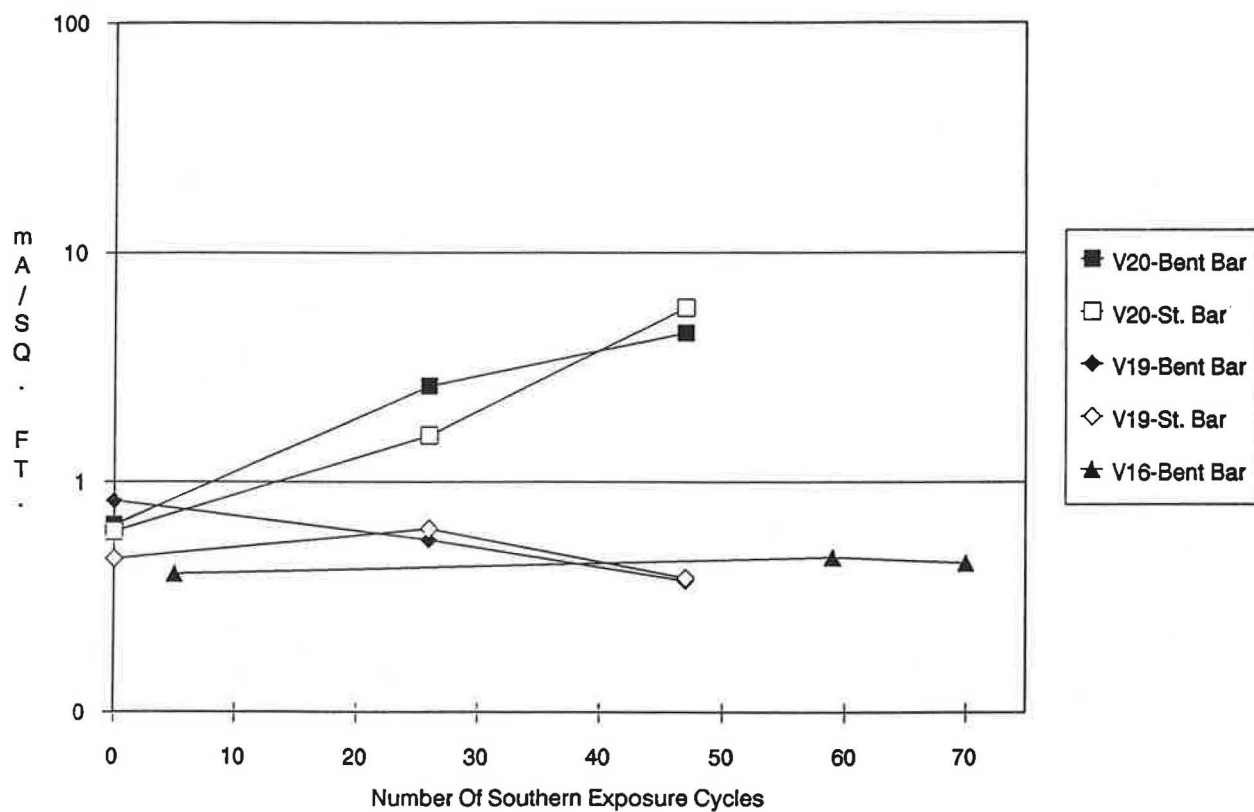
FIGURE 6 Small-bend study—controls and epoxy-coated bar specimens: corrosion rate versus time.

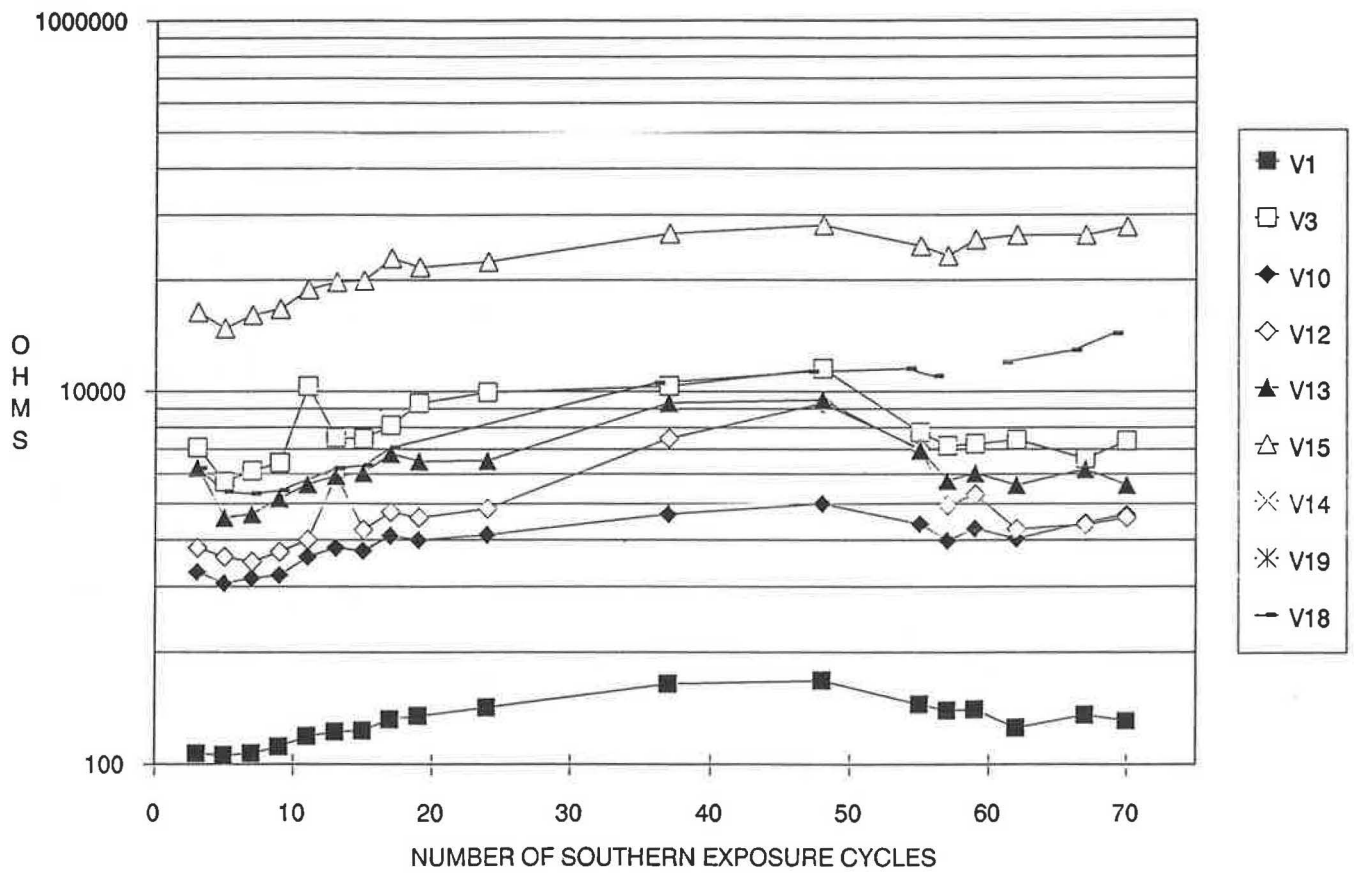
FIGURE 7 All bent bars—controls and epoxy-coated bar specimens: resistance versus time.

The electrical resistance between the top mat and the bottom mat through the concrete, with the mats electrically isolated from each other, significantly affects the phenomenon of macrocell corrosion. The magnitude of the ionic flow is inversely proportional to the electrical resistance between the mats. Also, the electrical resistance provides information regarding coating defects when epoxy-coated bars have been used in either or both mats. Figures 7 and 8 present typical resistance data obtained in this study. As expected, the epoxy-coated bars have a much higher electrical resistance between the mats, ranging from 1,300 to 129,500 ohms, compared to the controls that have electrical resistance in the range of a few hundred ohms. Although the mat-to-mat electrical resistance

of the epoxy-coated bars varies significantly from one specimen to another, the general trend is to remain constant with time. This observation indicates that the coating is not deteriorating or becoming disbonded with time. The concrete moisture content and temperature were about the same at the end of each SE ponding cycle when all data were collected. All epoxy-coated bars that had documented coating damage before installation in the concrete slabs demonstrated lower electrical resistance than those of the same variable with no damage. The epoxy-coated straight bars had a higher average electrical resistance (40,654 ohms) than the epoxy-coated bent bars (12,265 ohms). This difference may be partially because of the difference in geometry of the bars.

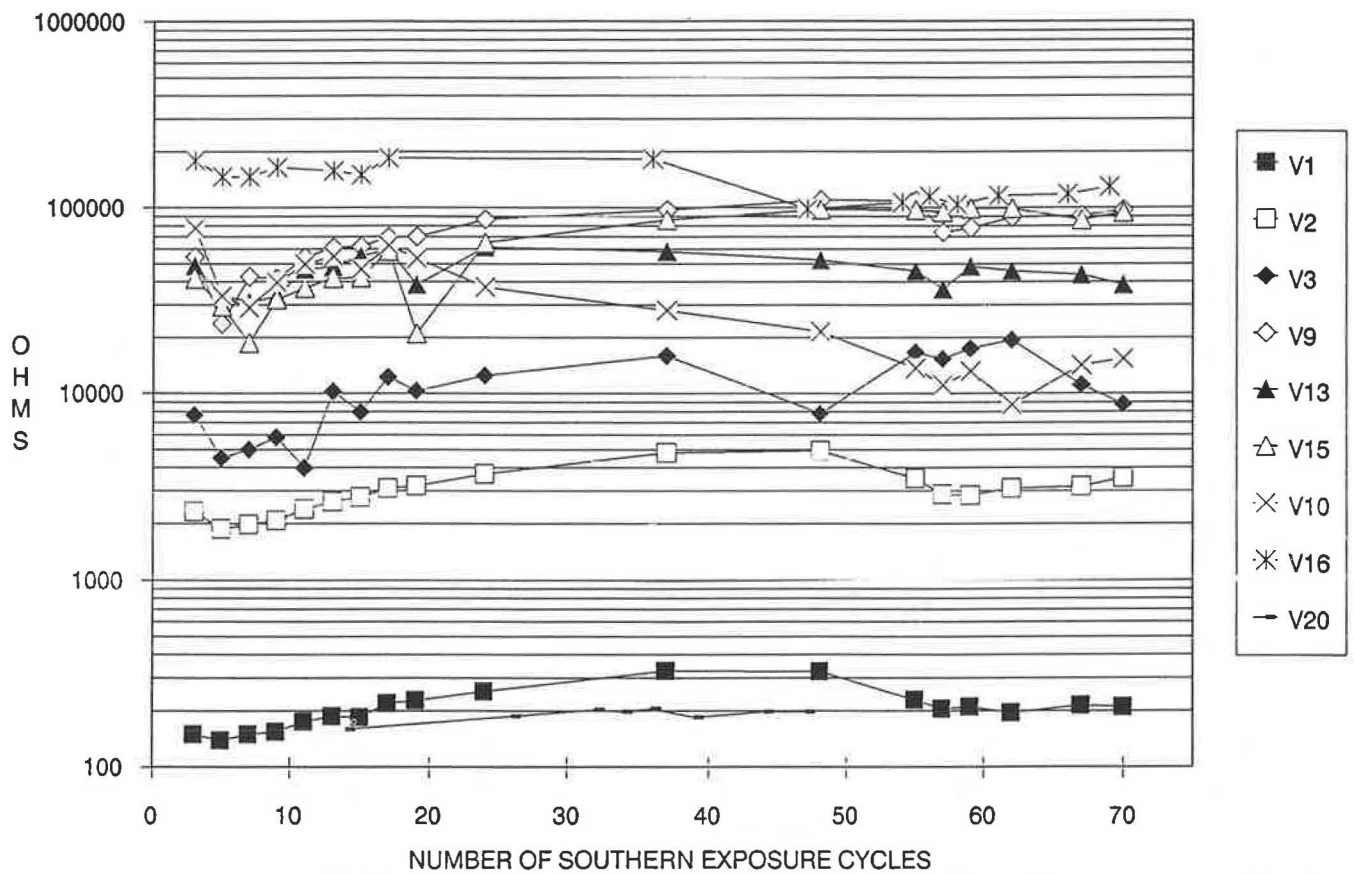
FIGURE 8 All straight bars—controls and epoxy-coated bar specimens: resistance versus time.

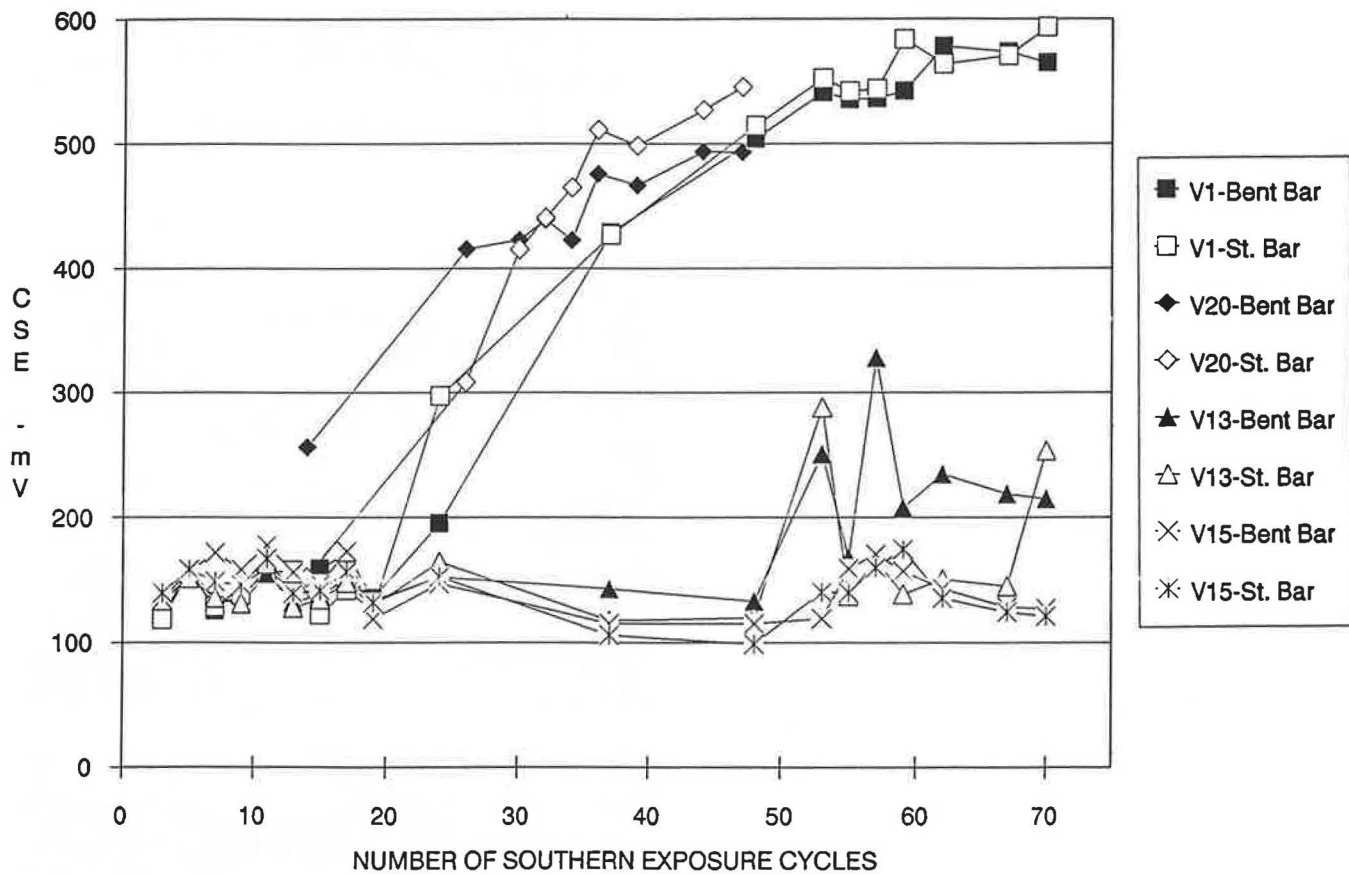
FIGURE 9 Controls and the highest and lowest epoxy-coated bar specimens: rebar potential versus time.

Figure 9 shows half-cell potential data for the control slabs and the coated bar specimens that exhibited the highest and lowest potentials. Except for the control slabs, the half-cell potentials are less negative than  $-350$  mV for the copper sulfate electrode. Potential measurements on epoxy-coated rebars are difficult to interpret. In this case, the less negative potentials are probably the result of the large uncoated bottom mat and the lack of cathodic polarization thereon. One should, therefore, concentrate on within-variable changes with time rather than absolute magnitude. When this is done, these findings correlate well with the macrocell corrosion current data. A summary of all potential data is presented in Table 3.

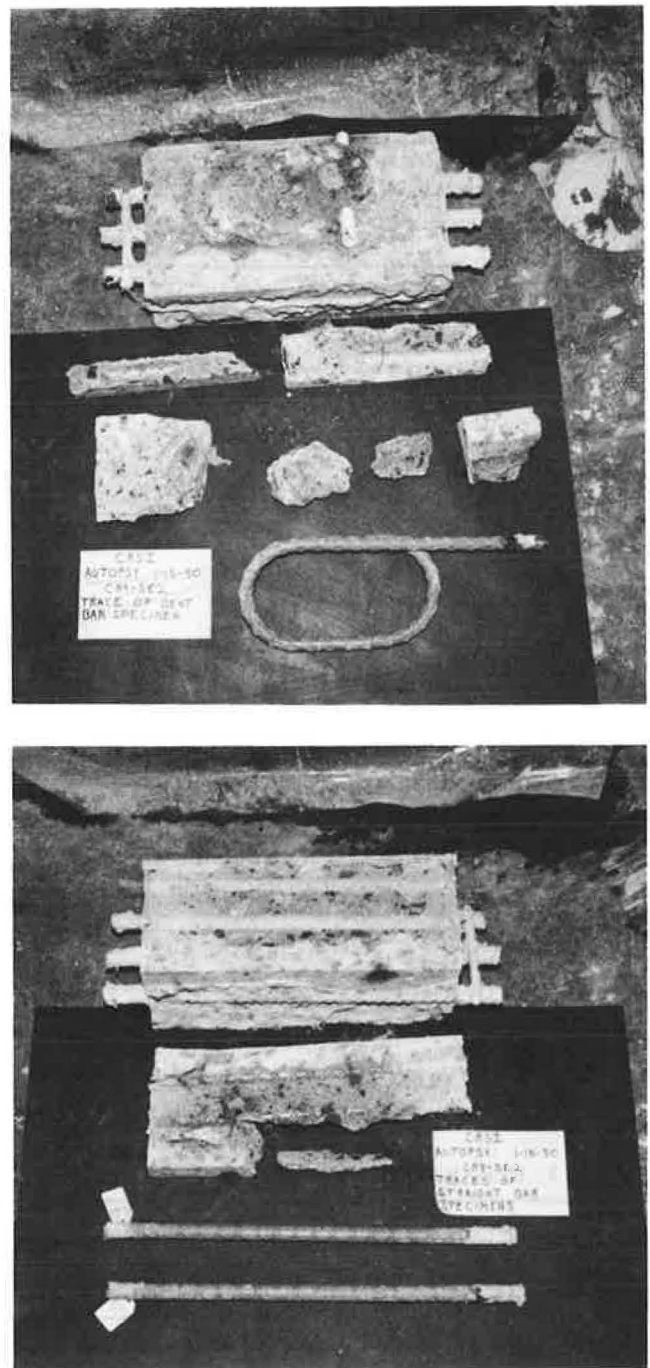
FIGURE 10 Rebars after completion of a typical autopsy.

Saw cuts were made along the sides of the slabs parallel to the top mat steel. The concrete was then chiseled along the saw cuts to force failure in the top mat rebar plane and expose the bars. Additional chipping allowed complete removal of the bars from the concrete without damaging the coating or the bars. Figure 10 shows a typical slab after completion of autopsy testing. After removal of the rebars from the concrete slabs, any visual coating damage, rusting, or changes in coating parameters (such as softening or disbondment) were documented. The visual condition of the bar traces left on the concrete was also documented.

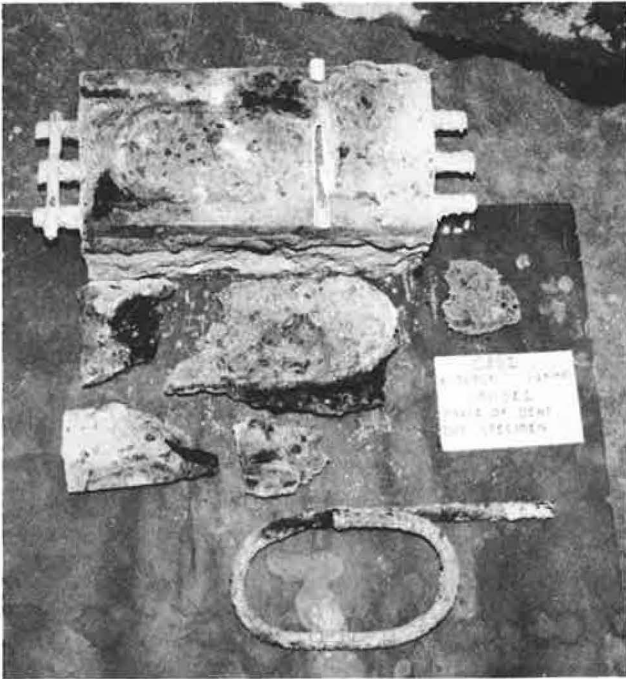
**FIGURE 11** Rebars after completion of autopsy of a slab representing black bar controls.

Photographs of black bars from the control slab are presented in Figure 11. Figure 12 shows photographs of epoxy-coated rebars obtained from the slab representing Variable 10. This slab exhibited the maximum corrosion current for epoxy-coated rebar slabs at the end of 70 SE cycles. Figure 13 shows photographs of epoxy-coated rebars obtained from the slab representing Variable 11. This slab exhibited the minimum corrosion current for epoxy-coated rebar slabs at the end of 70 SE cycles.

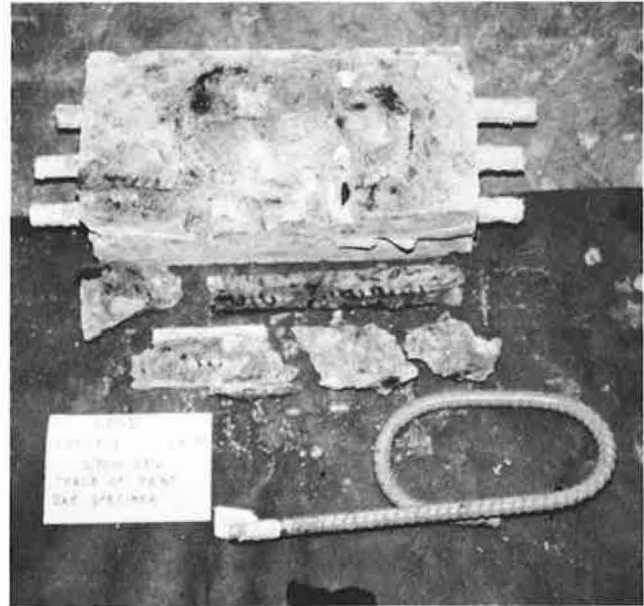
**FIGURE 12** Rebars after completion of autopsy of a slab representing Variable 10.

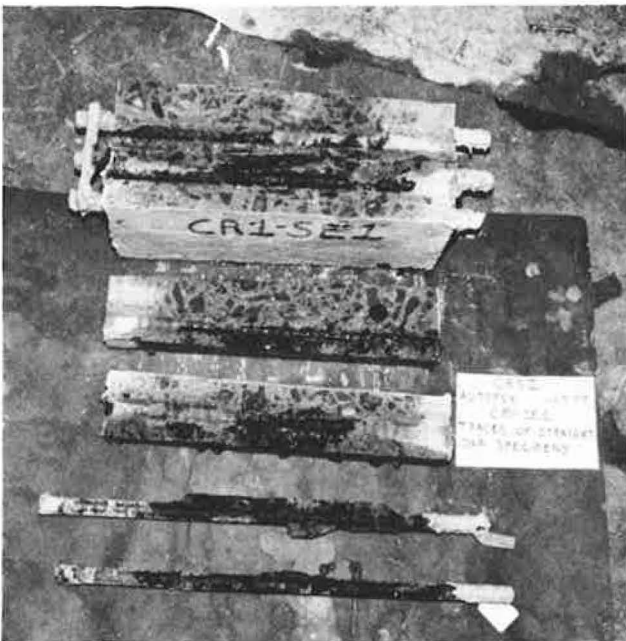
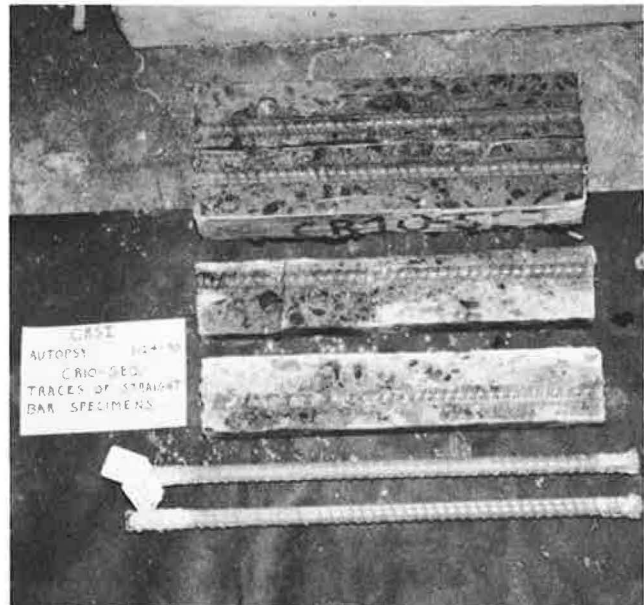
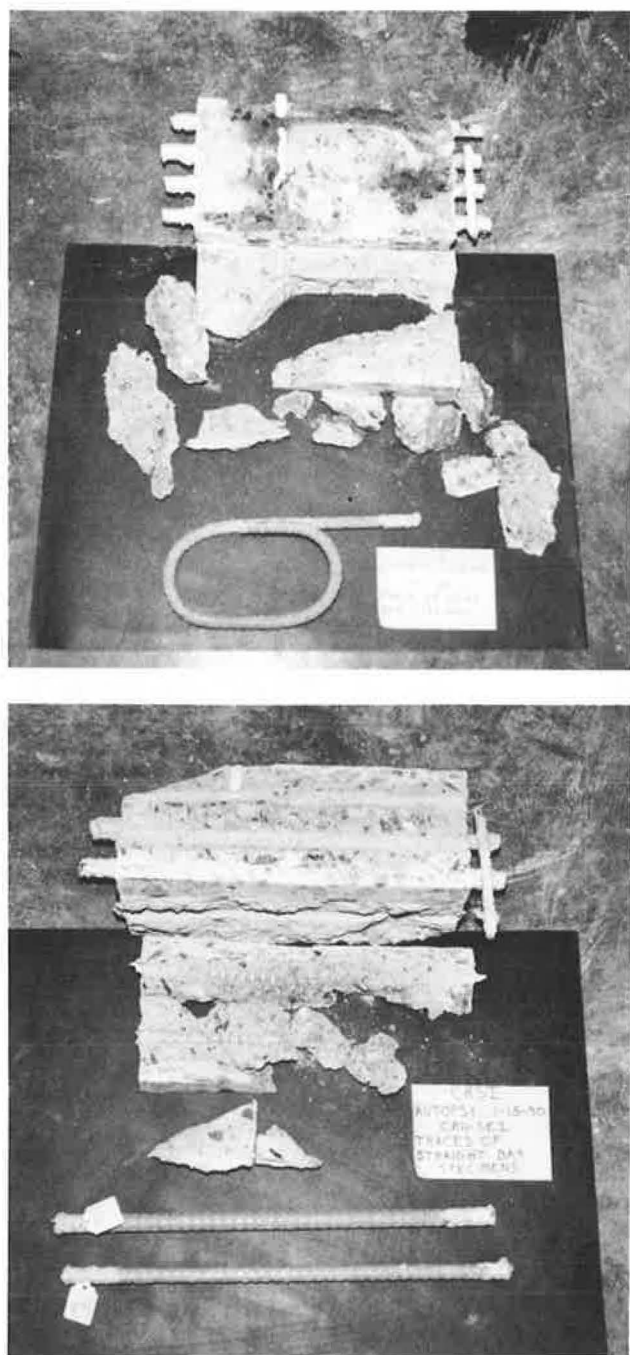
**FIGURE 13** Rebars after completion of autopsy of a slab representing Variable 11.
