TRANSPORTATION RESEARCH  
**RECORD**

No. 1268

**Highway Maintenance  
Operations and Research  
1990**

**Transportation Research Record 1268**

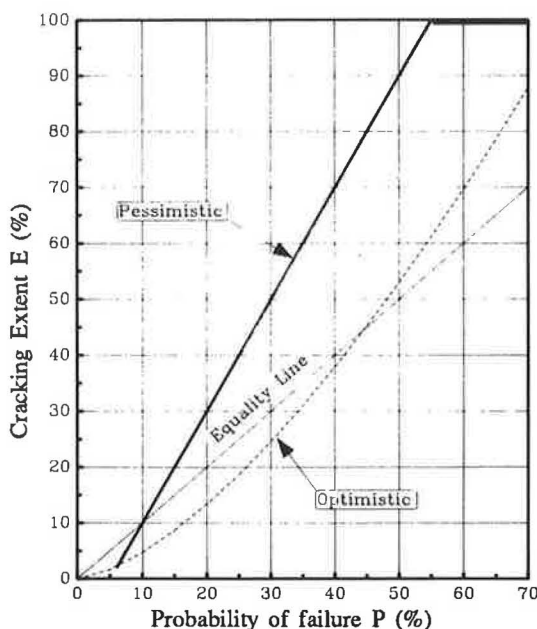
**FIGURE 2** Relation between failure probability  $P$  and cracking extent  $E$ .

$$E = 2P - 10 \tag{3}$$

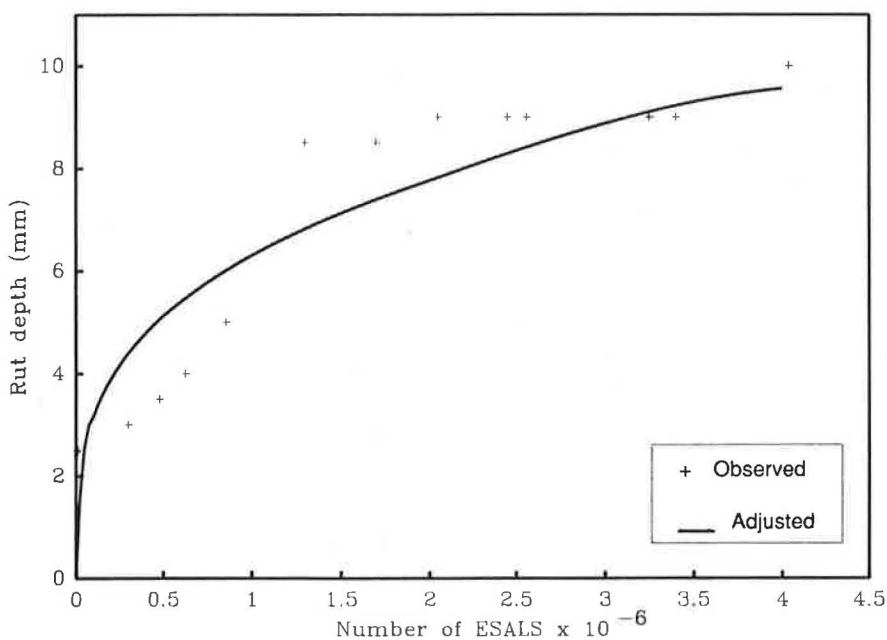
**FIGURE 3** Example of rut depth evolution versus  $N$  on one cross section (LCPC CTT results).

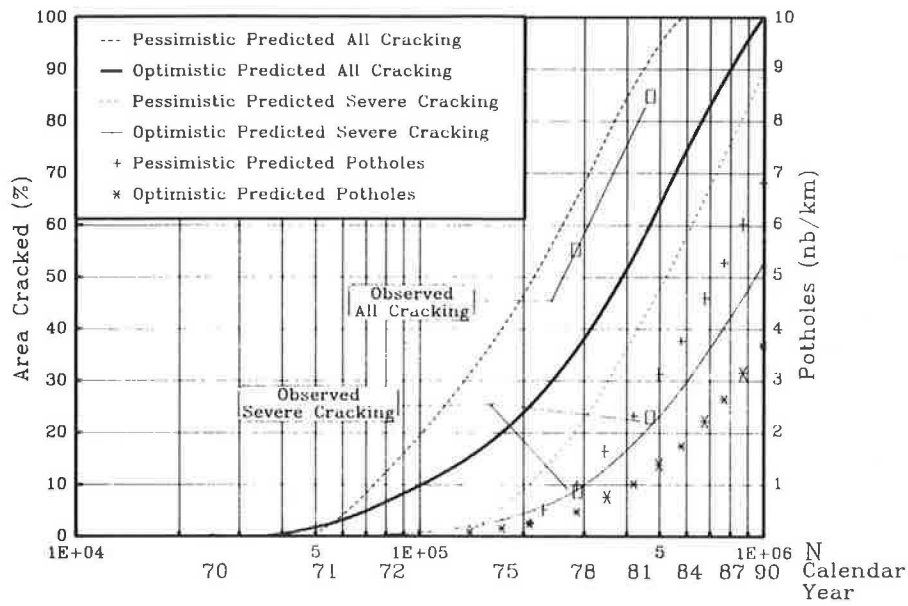
FIGURE 5 Observed and predicted cracking and potholes.

**Patching** From 1979 to 1985, cumulative predicted cost of patching on severe cracking (\$10/m<sup>2</sup>) was between \$25,000/km and \$50,000/km, i.e., \$4,200/year-km to \$8,400/year-km. Predicted potholes were between 0/km and 1/km in 1978,

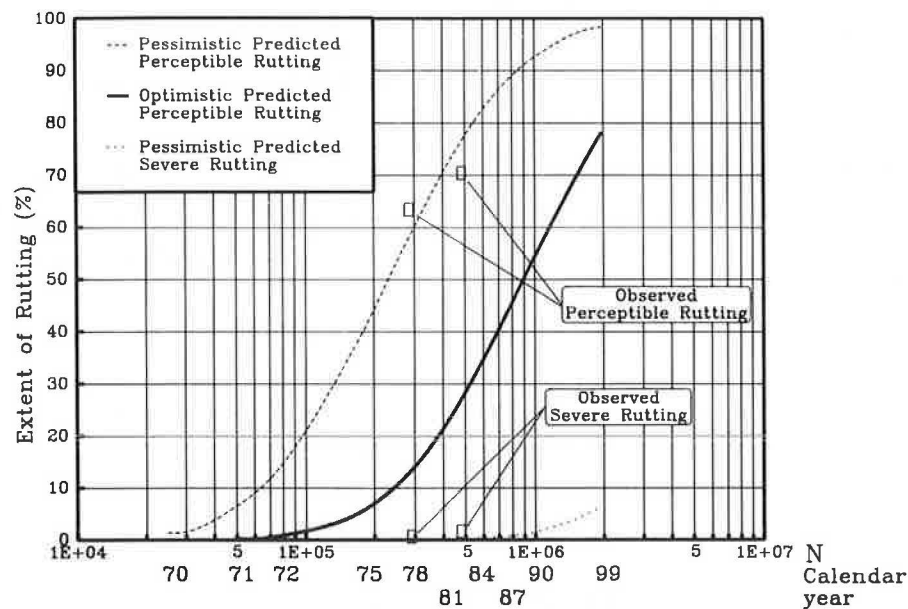
FIGURE 6 Observed and predicted rutting.

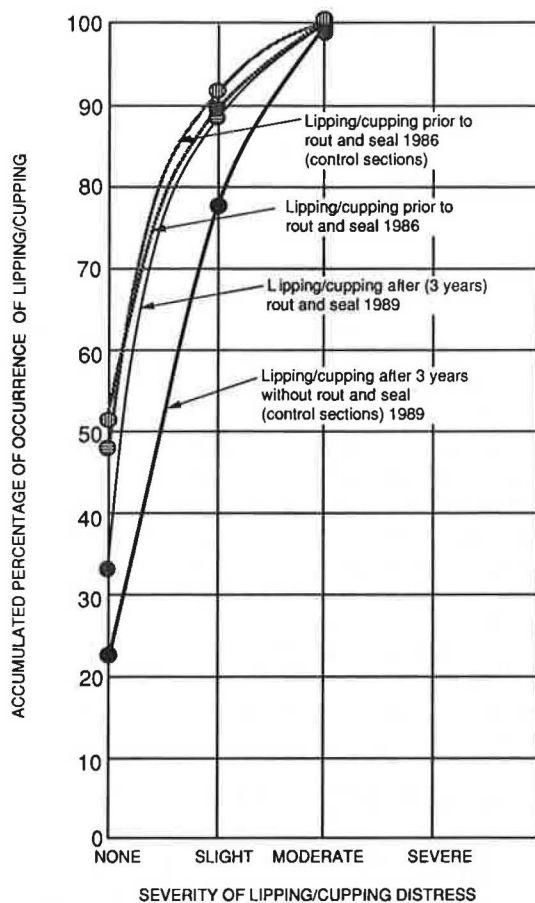
FIGURE 9 Crack deterioration after three winters.

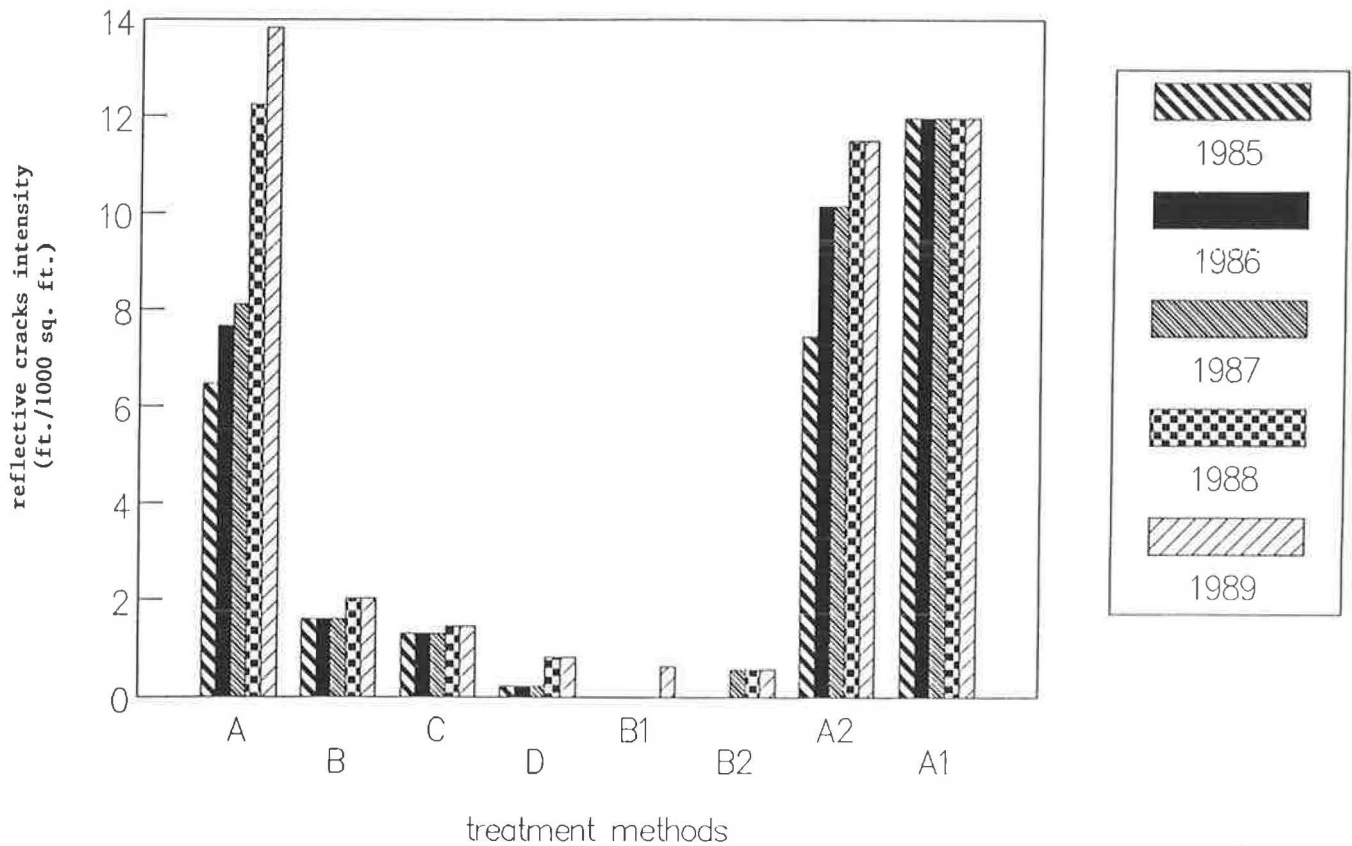
FIGURE 2 Development of reflective cracks with time for several treatments.

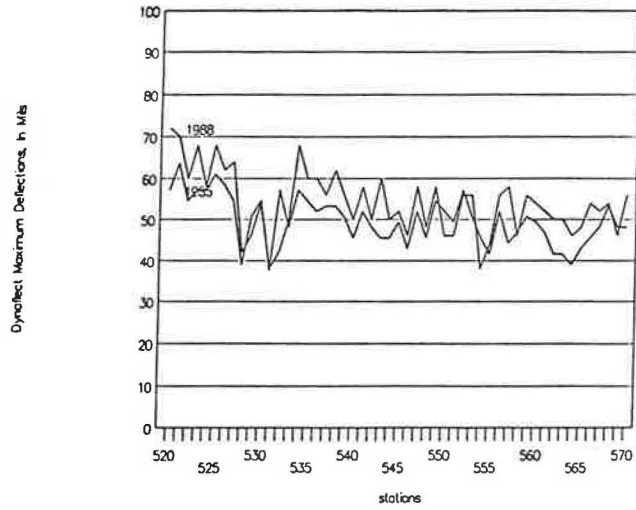
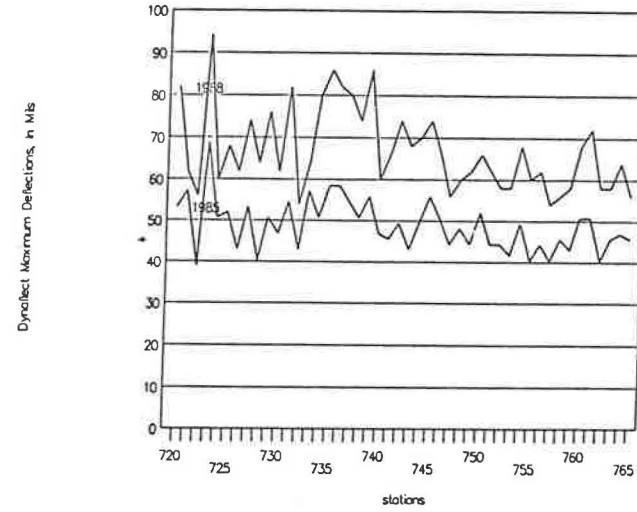
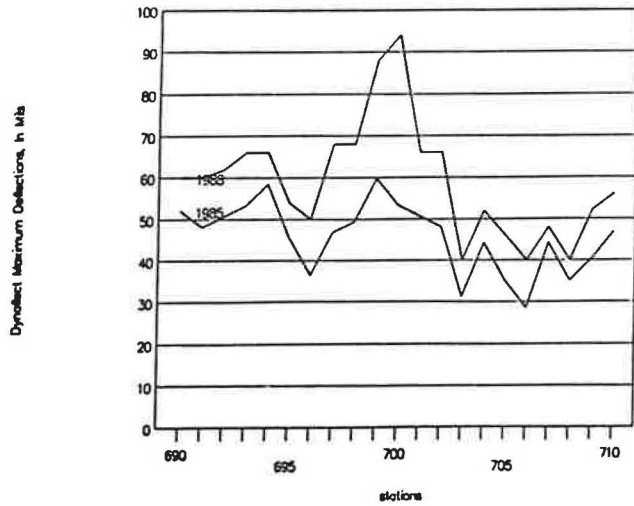
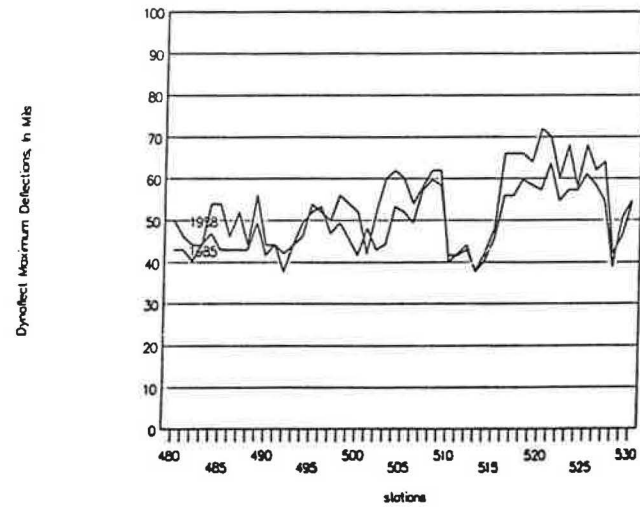
Treatment: underseal, 4.25 in. overlay

Treatment: Crack&Seat, 5 in. overlay

Treatment: Crack&seat, 6.5 in. overlay

Treatment: Crack&seat, 8.5 in. overlay

FIGURE 3 Dynaflect maximum deflections.

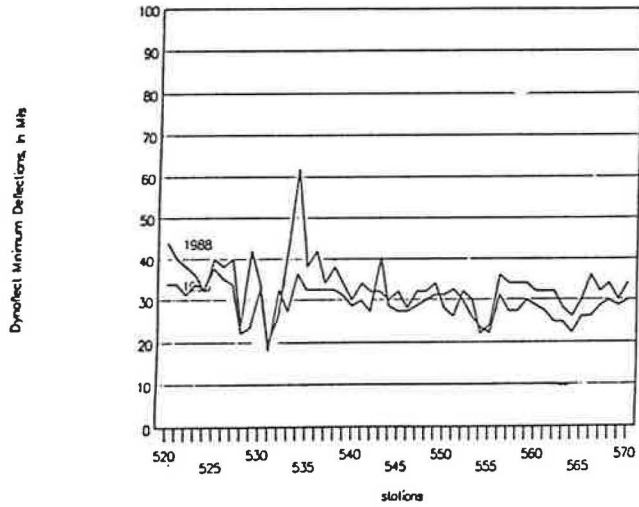
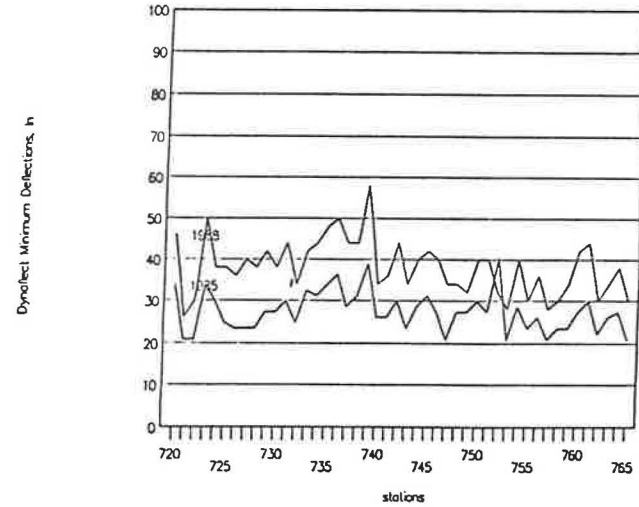
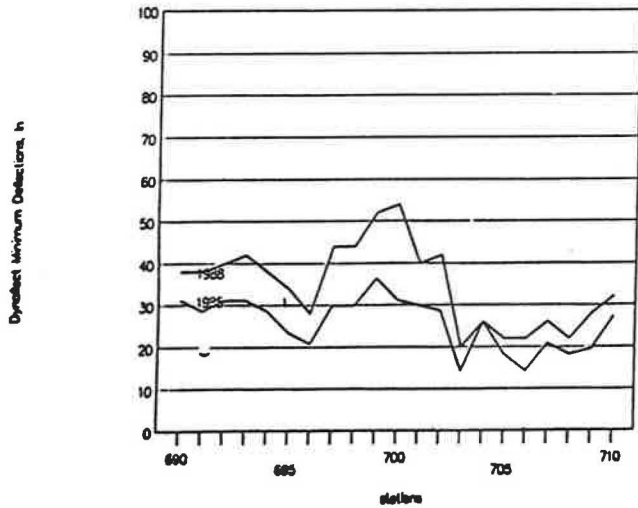
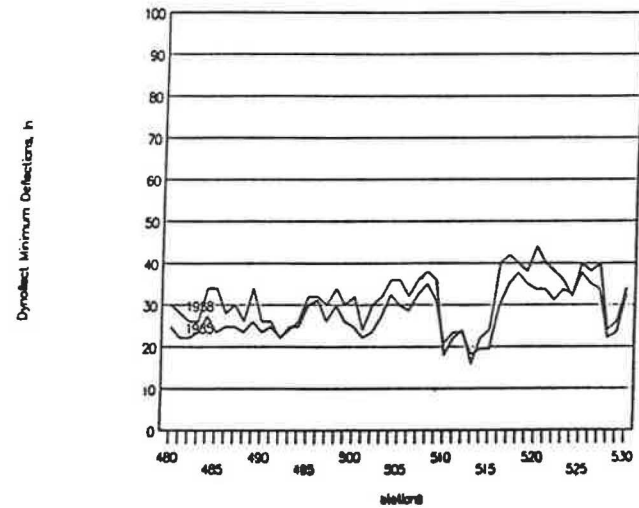
Treatment: underseal, 4.25 in. overlay

Treatment: Crack&Seat, 5 in. overlay

Treatment: Crack&seat, 6.5 in. overlay

Treatment: Crack&seat, 8.5 in. overlay

FIGURE 5 Dynaflect minimum deflections.

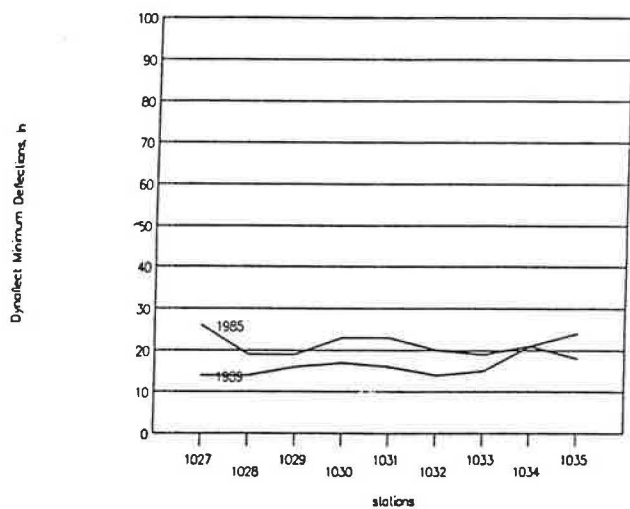
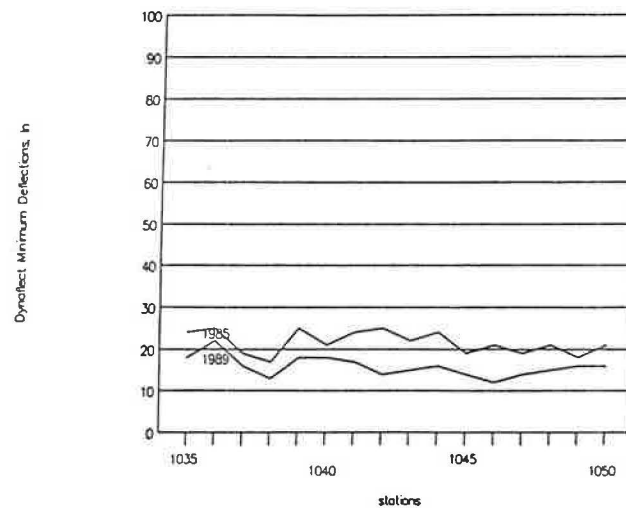
Treatment: Crack&seat - 5.0 in. - fb

Treatment: Crack&seat - 5 in.- fbb

FIGURE 6 Dynaflect minimum deflections with fibers added.

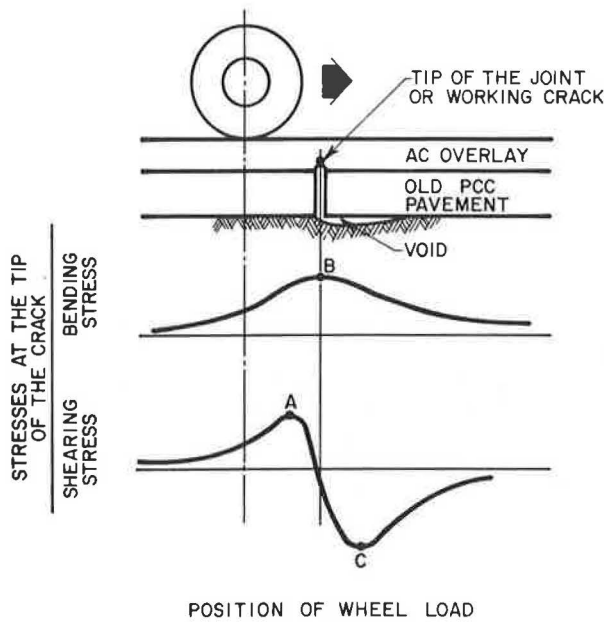
FIGURE 2 Shearing and bending stresses in an AC overlay resulting from a moving traffic load (7).

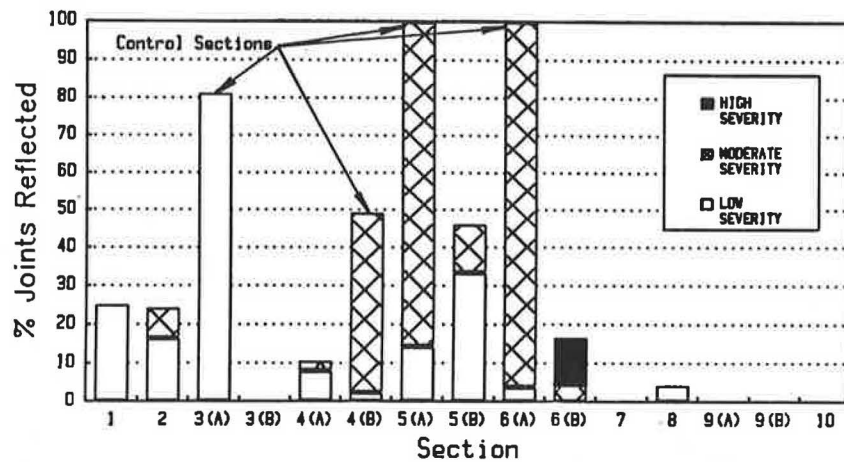
FIGURE 8 Distribution of transverse joint reflection cracking on the 15 pavement sections.

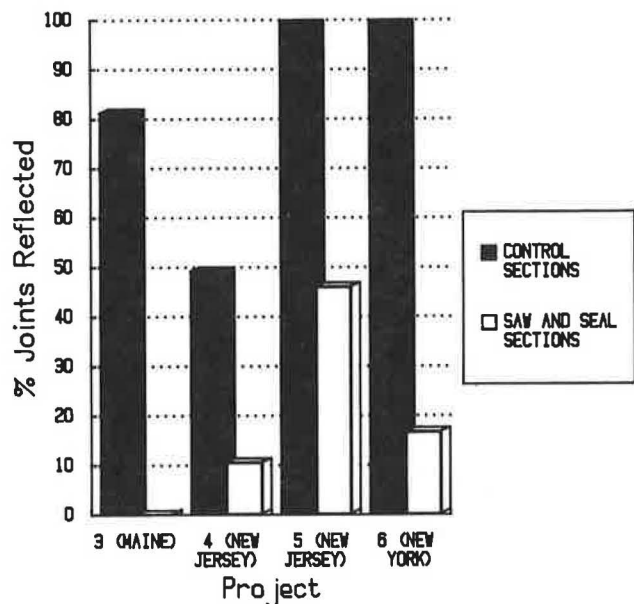
FIGURE 9 Comparison of transverse joint reflection cracking observed on the four saw-and-seal overlays with control sections.

Variables such as age, joint spacing normalized by thickness, field thickness, and roughness were plotted against transverse reflection cracking to determine which, if any, trends were present. The plot of transverse reflection cracking versus age (Figure 12) shows that more cracking occurred in the control sections than on the saw-and-seal overlays, as was discussed previously. The amount of reflection cracking observed on the saw-and-seal overlays remained constant with age, suggesting that if reflection cracking is to occur on a saw-and-seal overlay because of missawed joints or secondary

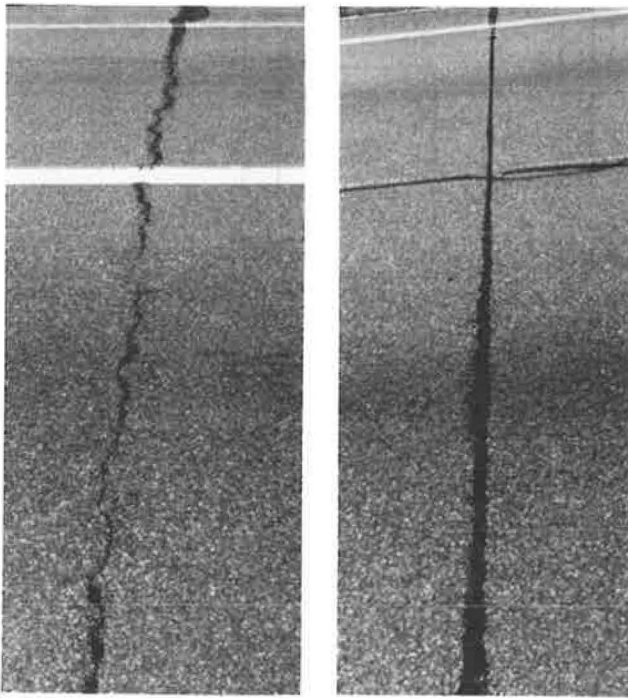
**FIGURE 10** Overlay condition of control section (*left*), and of saw-and-seal section (*right*) on I-95, Falmouth, Maine.

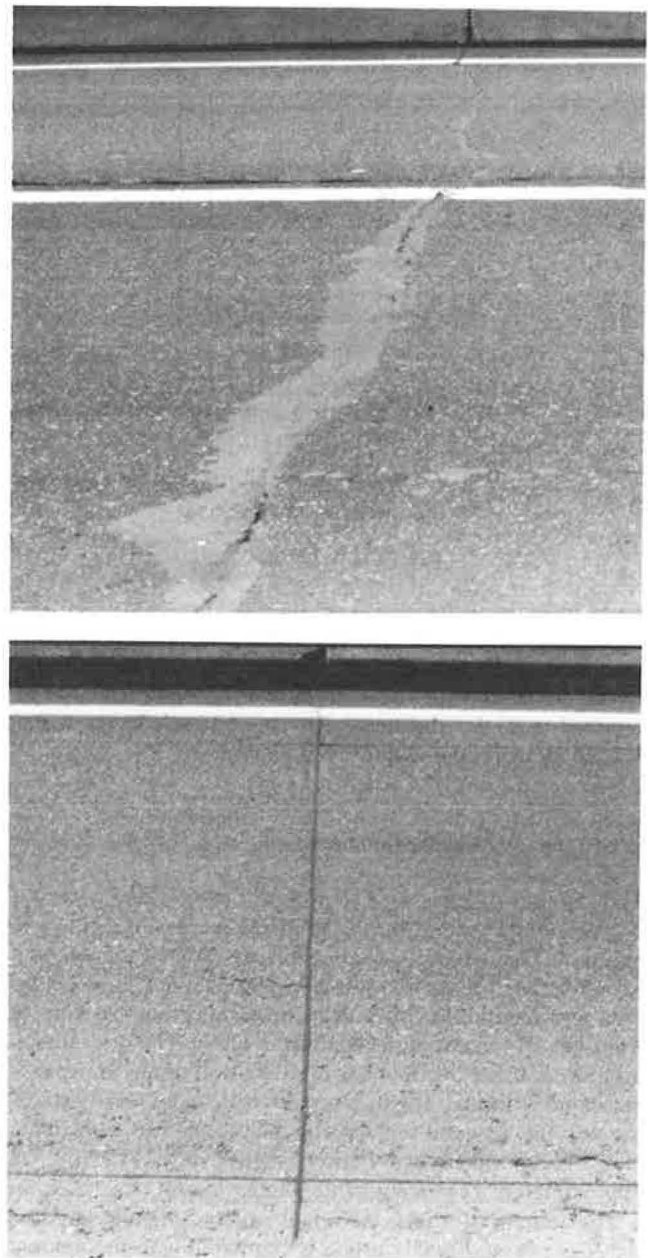
**FIGURE 11** Overlay condition of control section (*top*), and of saw-and-seal section (*bottom*) on US-22, Somerville, N.J.

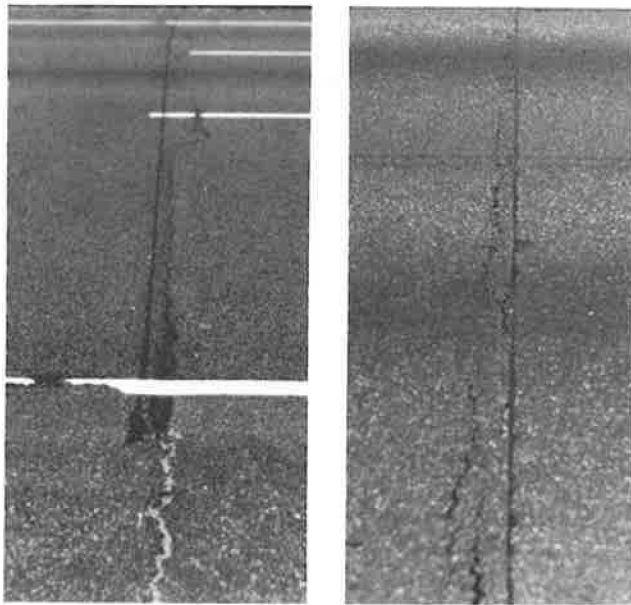
FIGURE 14 Secondary cracking: on I-84, New Britain, Conn. (left), and on I-80, West Paterson, N.J. (right).

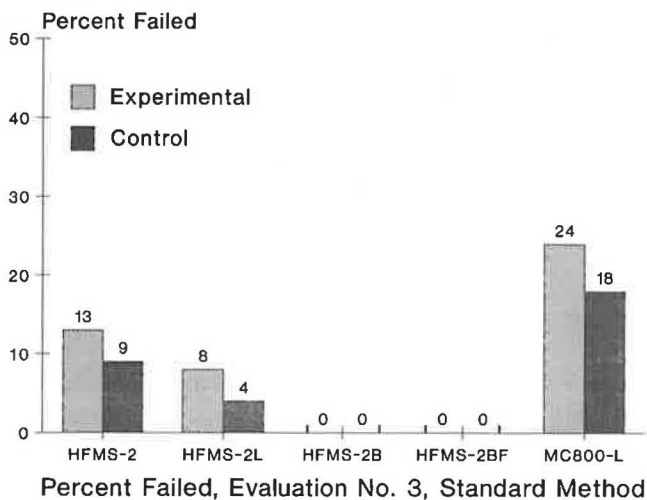
FIGURE 1 Performance of mixes, standard procedure, Evaluation 3.

Raveling and shoving were the primary failure modes for all mixes. In no case was failure associated with stripping of the mix. In many cases, the failures occurred in locations where there was poor drainage or severe reflection cracking, and a recurrence of the pothole was inevitable. Other failure modes were not observed on a recurring basis.

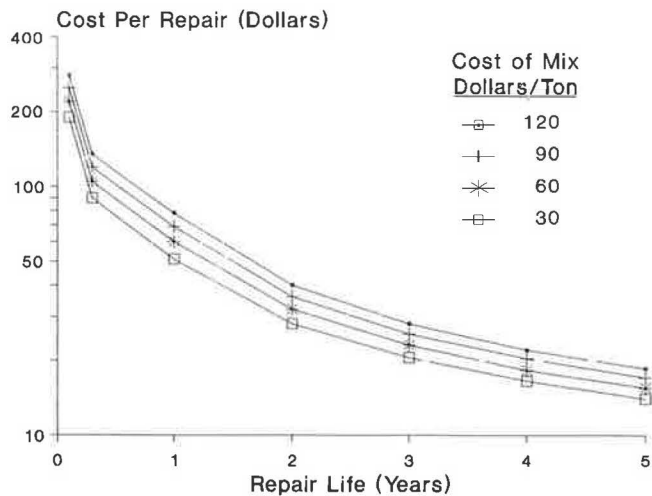
FIGURE 3 EUAC (dollars per repair) for the standard method when repairs can be conducted on a production basis.

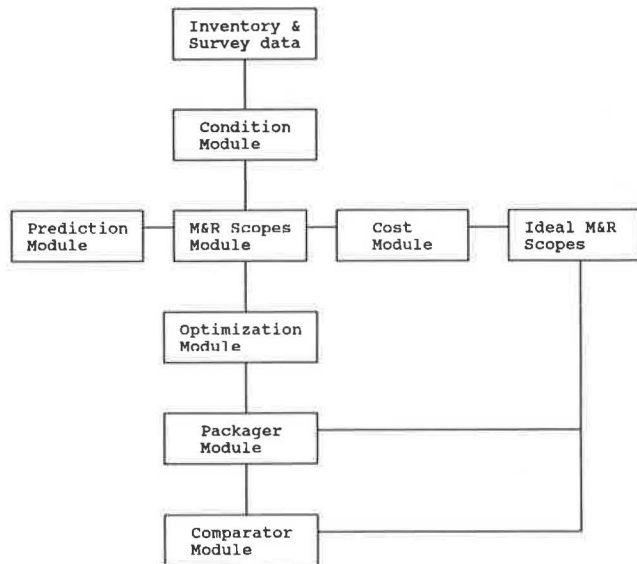
**FIGURE 1** Structure of a modular bridge management system.

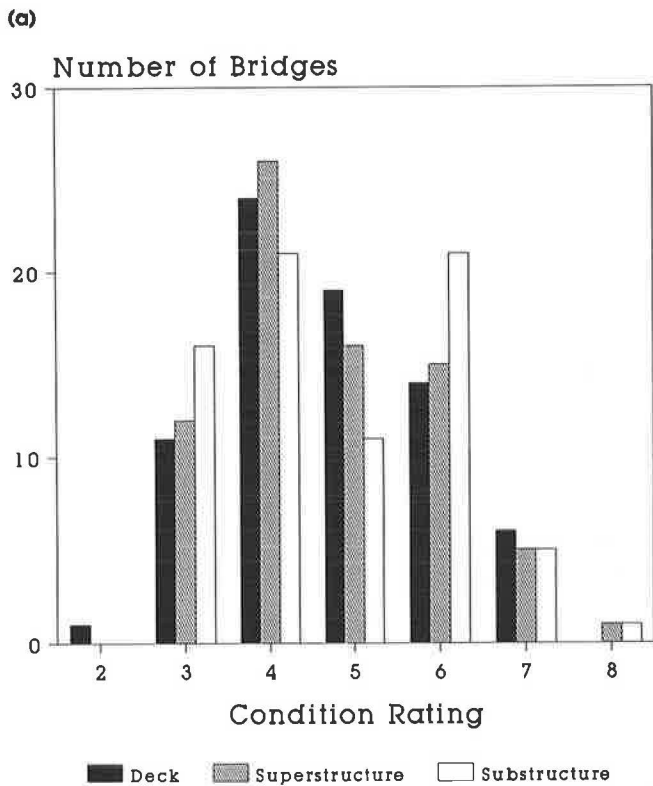
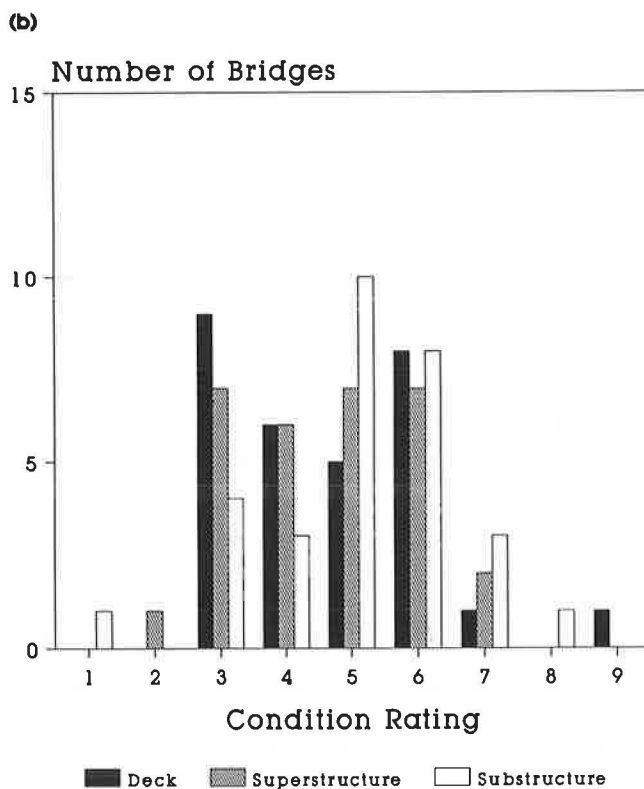
FIGURE 2 Distribution of condition ratings at the time of bridge replacement: a, concrete bridges; b, steel bridges.

However, caution is needed in interpreting these condition-rating distributions, because the plots shown in Figure 2 include the effects of rehabilitation and maintenance work. Decisions for replacing bridges may not only be affected by the condition rating but by some other factors, such as bridge age and realignment of the approach road. It was difficult to establish a conclusive relationship between the condition rating and timing of replacement. Nevertheless, this analysis indicated that the current practice of assuming 50 years as the bridge service life may be appropriate for network-level bridge management to ensure the structural safety of bridges in the system. The mean life span of all the bridges in the data set was found to be approximately 53 years with 95 percent confidence interval between 52 and 54 years.

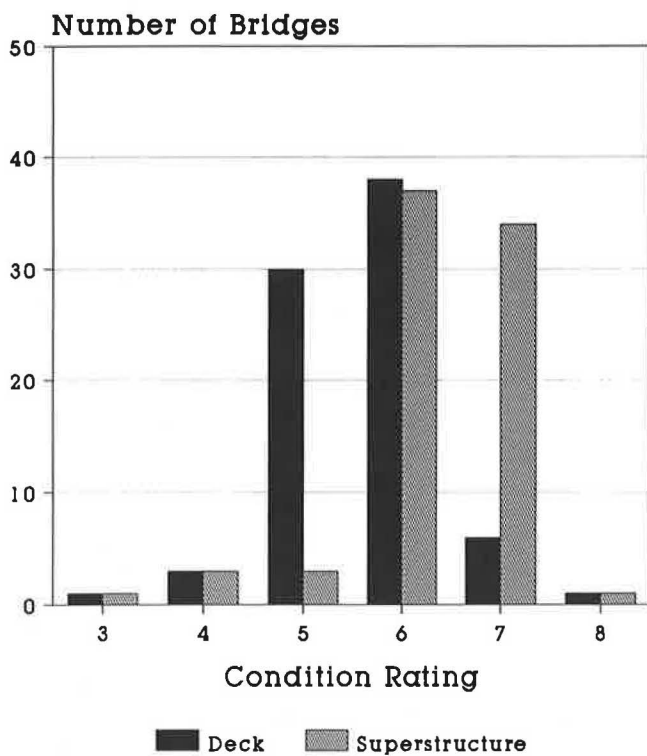
**FIGURE 3** Condition ratings at the time of first deck reconstruction.

distresses that exist on bridge structures. Because deck reconstruction is closely related to the condition ratings of the deck and superstructure, these two condition ratings were checked. Figure 3 shows the difference in condition-rating distributions of the deck and the superstructure. Condition ratings of decks were mostly 5 and 6 when the deck was reconstructed. However, condition ratings of the superstructure were mostly 6 and 7 at the time of deck reconstruction, implying that the speed of deterioration of a superstructure would be slower than that of a bridge deck.

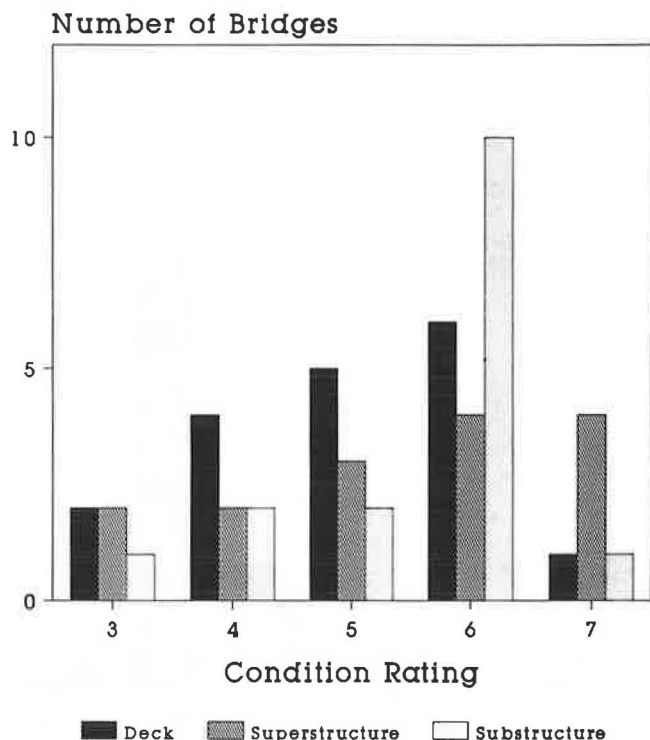
FIGURE 5 Condition ratings at the time of first deck replacement.

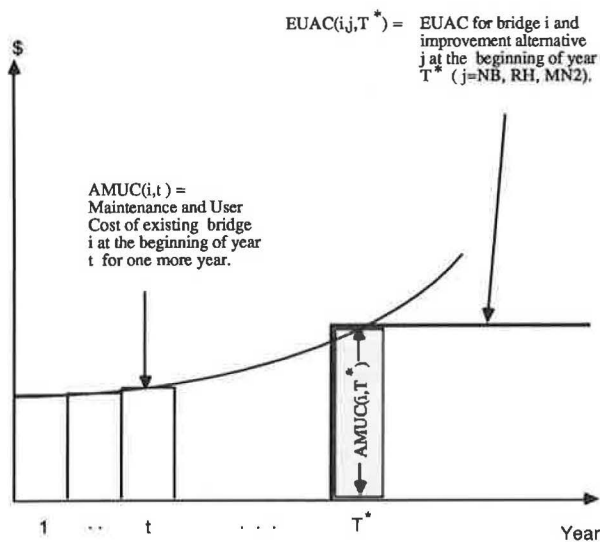
**FIGURE 6** Comparison of  $AMUC(i,t)$  and  $EUAC(i,j,t)$  at the beginning of every year in the analysis horizon to determine optimal time for improving existing bridge.

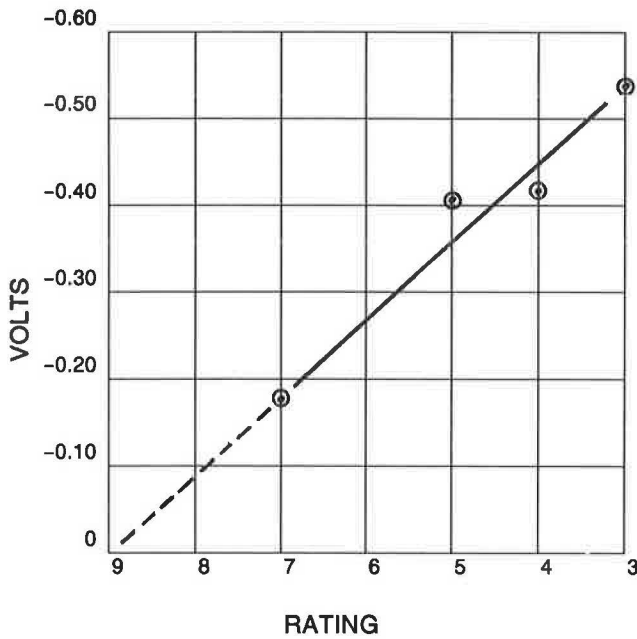
FIGURE 9 Corrosion potential.

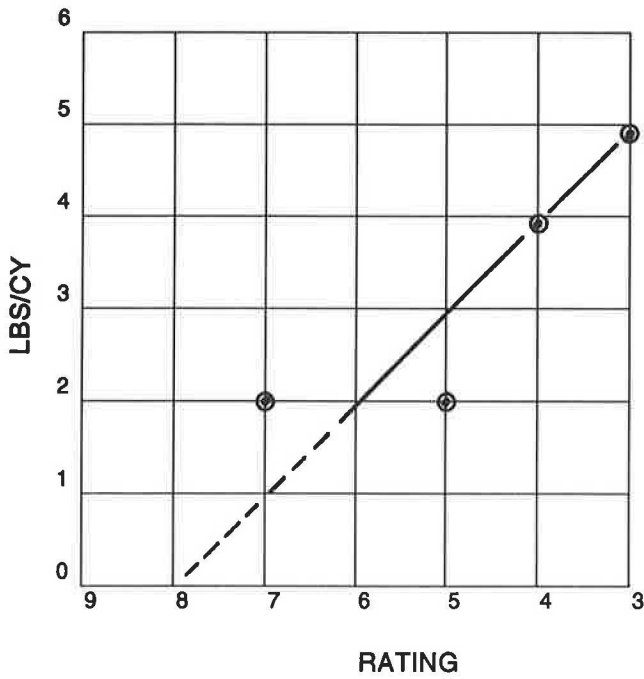
FIGURE 12 Chloride content near surface.

Figure 11 shows the data that resulted from the chemical analysis of dust samples, which shows a fair amount of scatter. Averages have been plotted in Figure 12. A correlation exists, however, between the crack severity and level of associated chloride ion content. After extensive data manipulation, the plot shown in the graph was developed. This plot passes to the right of the origin of the graph indicating that, near a

The chloride ion content measured near the concrete surface was in the contaminated range for cracks rated 6 or less on the basis of the FHWA breakpoint of  $2$  lb/yd<sup>3</sup> for plain reinforced concrete bridge decks. It has been previously recommended that for prestressed-concrete beams, "... permissible water soluble chloride ion content ... not exceed 0.10 percent by weight of portland cement" (1). This amount translates into a value of approximately  $4$  lb/yd<sup>3</sup>.

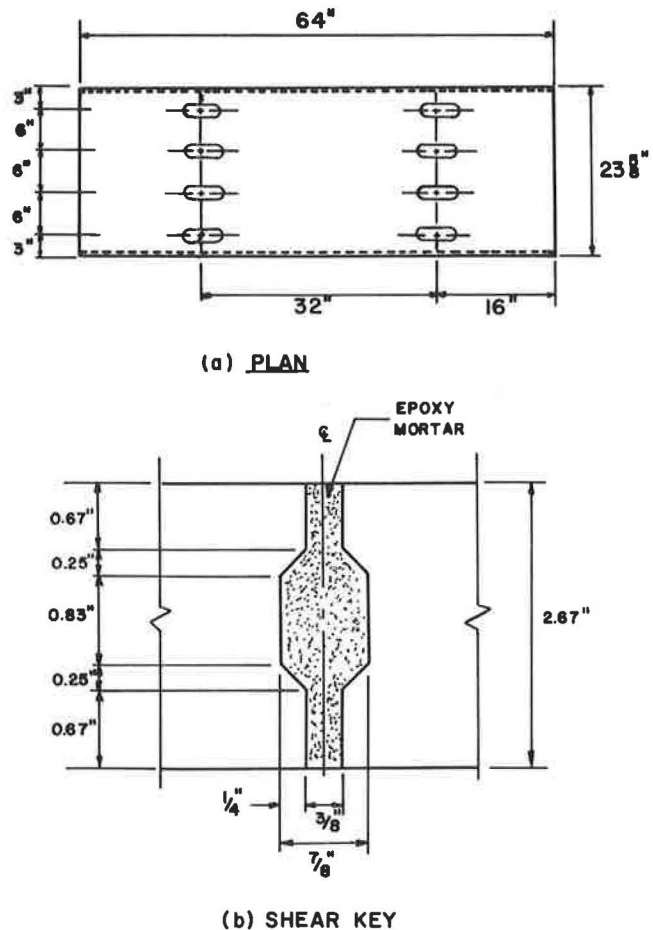
FIGURE 3 (a) Typical precast panels and (b) shear keyway.

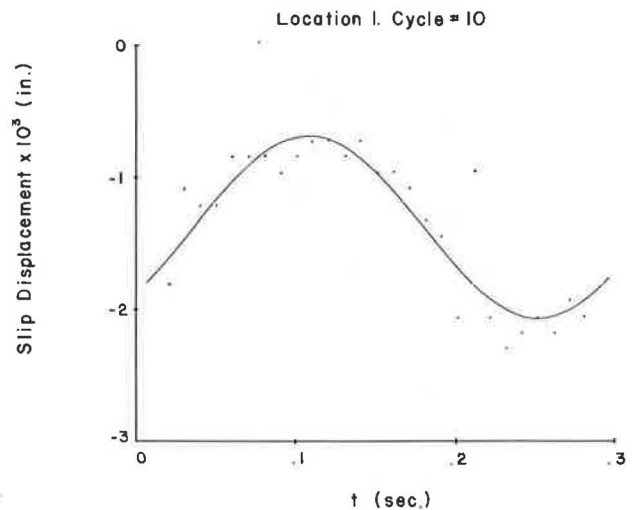
FIGURE 11 Typical relative deck-beam horizontal displacement.

The measured relative deck-beam horizontal displacements were severely contaminated with noise because these displacements were of the order of 0.001 in. The major function of these measurements was to detect failure or debonding of the interface connection. Failure of the interface should have reflected dramatic increases in the relative deck-beam displacements. Figure 11 shows the relative displacement measured at Location 1 at the high-shear end of the south beam. The solid line represents a curve-fitted sinusoidal curve with a frequency of 3.5 Hz.

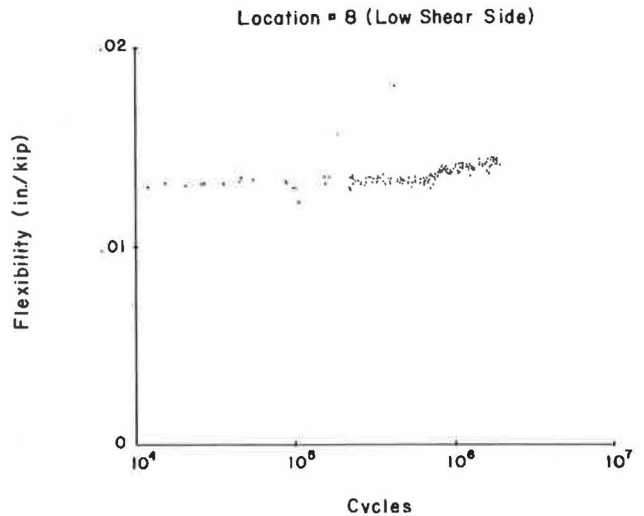
**FIGURE 14 Flexibility at quarter points of north beam: low-shear side.**

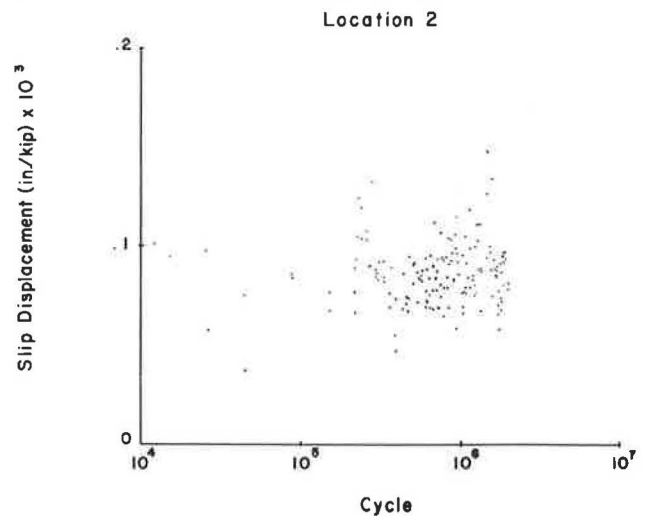
FIGURE 18 Relative normalized deck-beam horizontal displacement at Location 2.

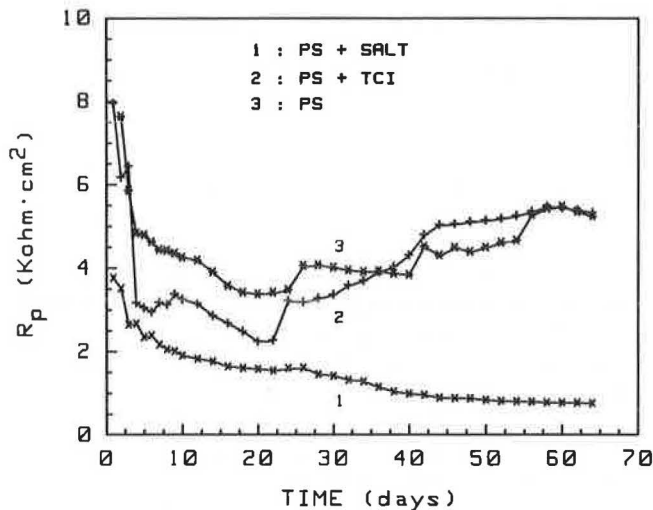
FIGURE 5 Polarization resistance of steel immersed in pore solution for 65 days.

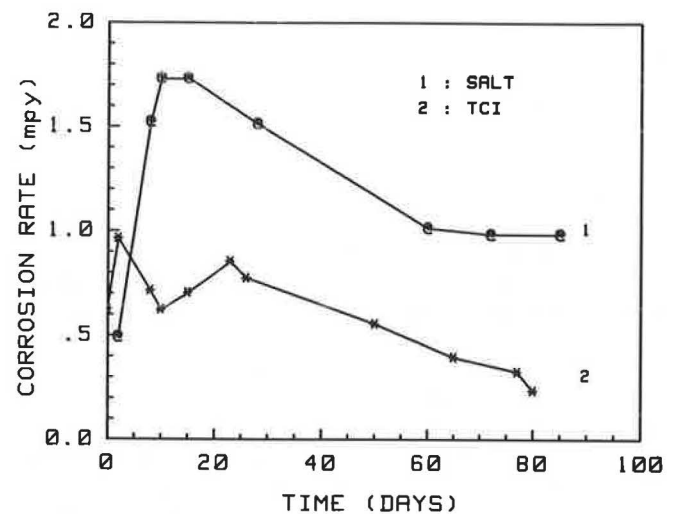
FIGURE 6 Corrosion rate of mortar lollipops.

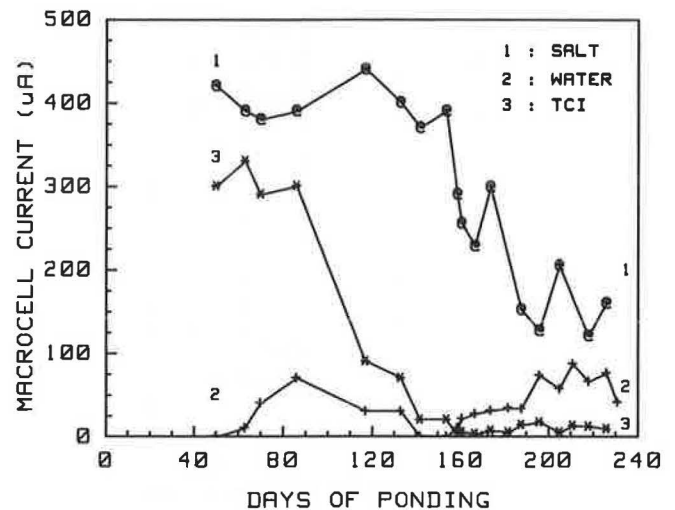
FIGURE 7 Macrocell current obtained with three slabs not contaminated with NaCl and ponded for 8 months.

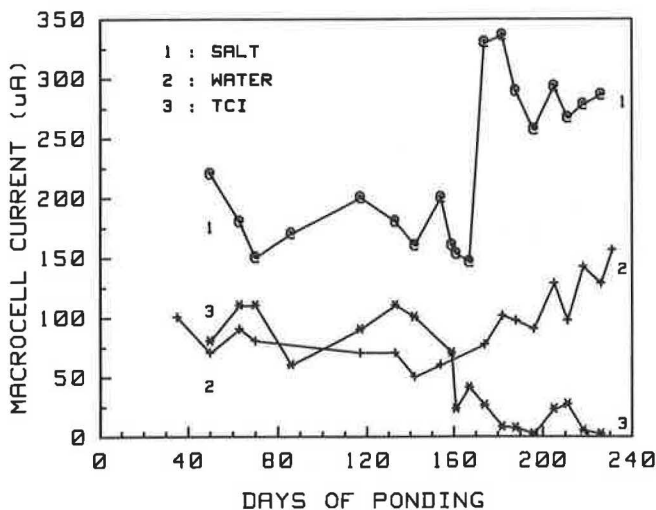
FIGURE 8 Macrocell current obtained with three slabs of which the top layer of concrete was contaminated with 15 lb/yd<sup>3</sup> of chloride and ponded for 8 months.

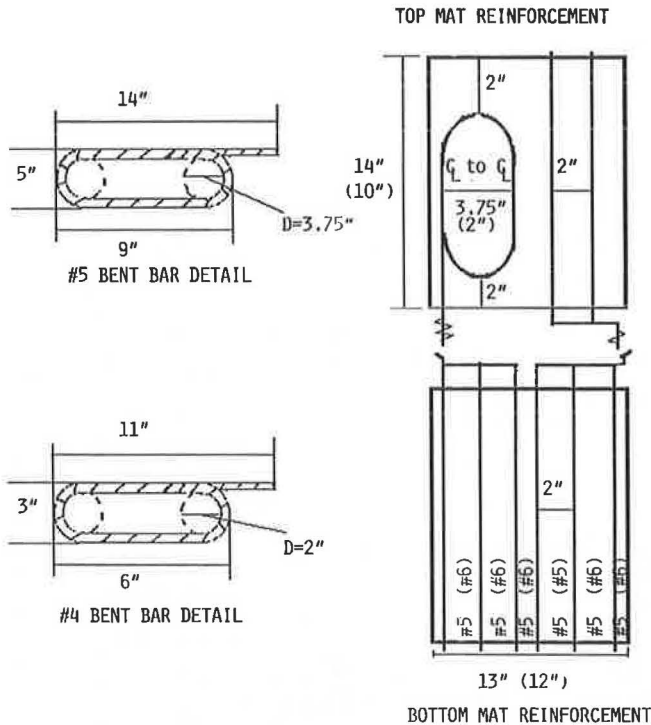
FIGURE 1 Slab and bent-bar fabrication details.

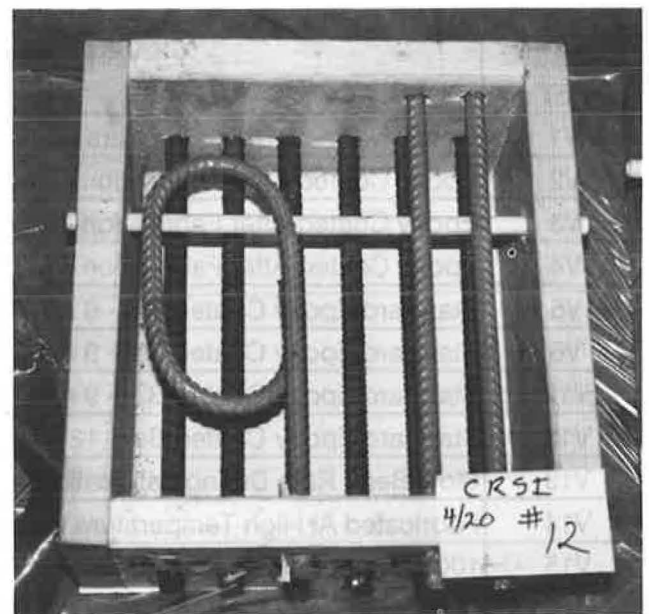
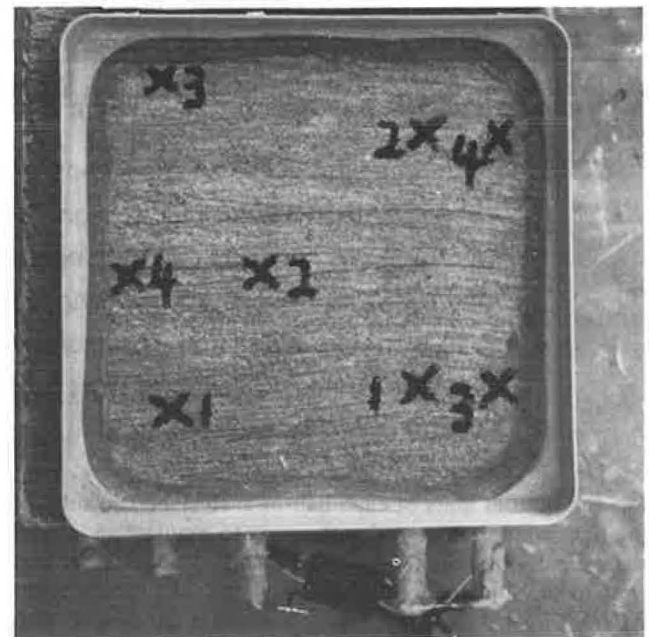
FIGURE 2 Top: epoxy-coated bars in forms before concrete placement. Bottom: completed slab before SE cycling.

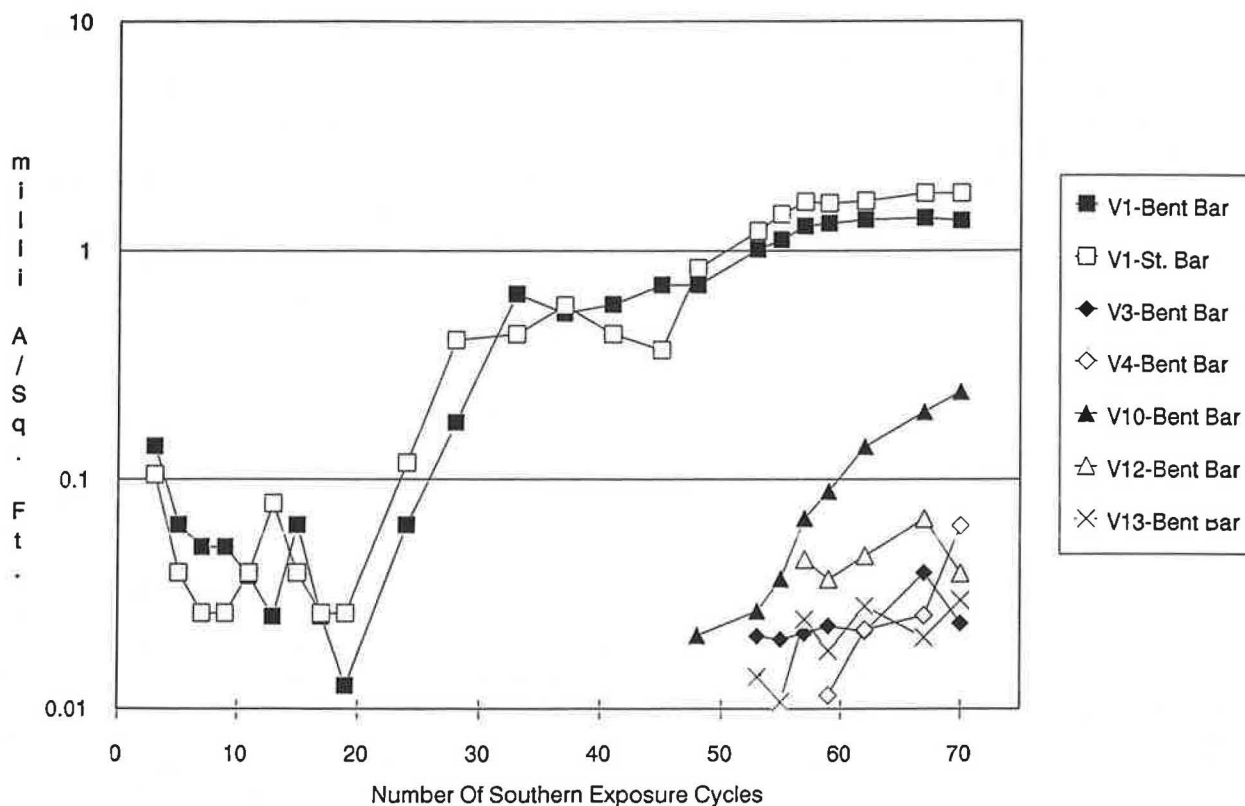
FIGURE 3 Large-bend study—controls and epoxy-coated bar specimens: macrocell current versus time.

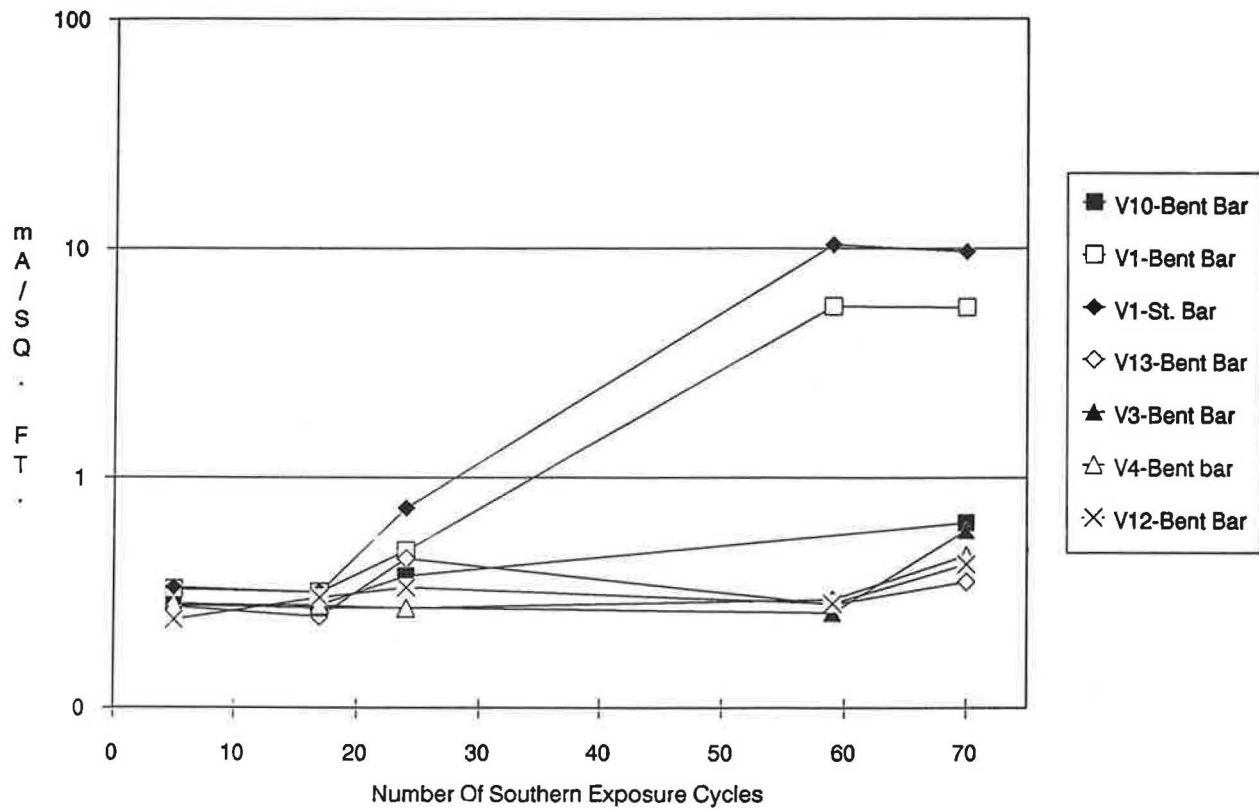
FIGURE 5 Large-bend study—controls and epoxy-coated bar specimens: corrosion rate versus time.
