TRANSPORTATION RESEARCH  
**RECORD**

No. 1268

**Highway Maintenance  
Operations and Research  
1990**

**Transportation Research Record 1268**

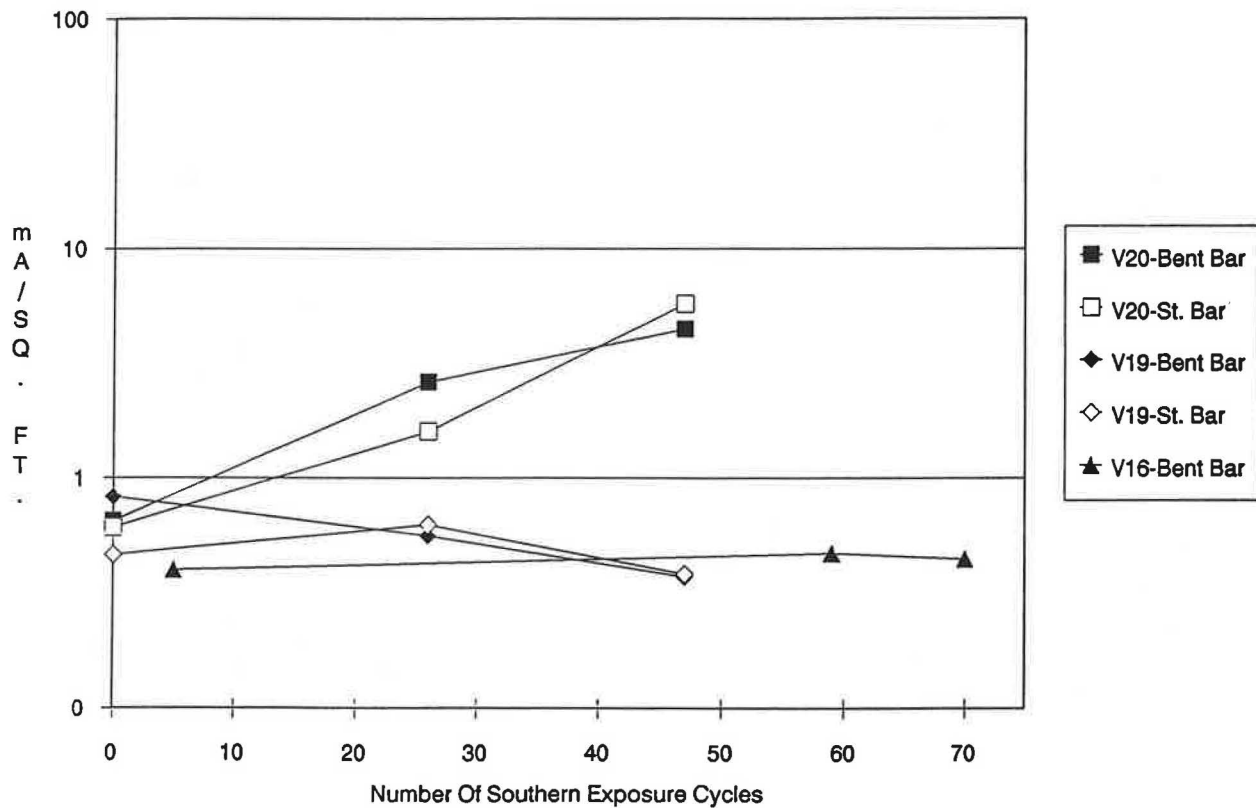
FIGURE 6 Small-bend study—controls and epoxy-coated bar specimens: corrosion rate versus time.

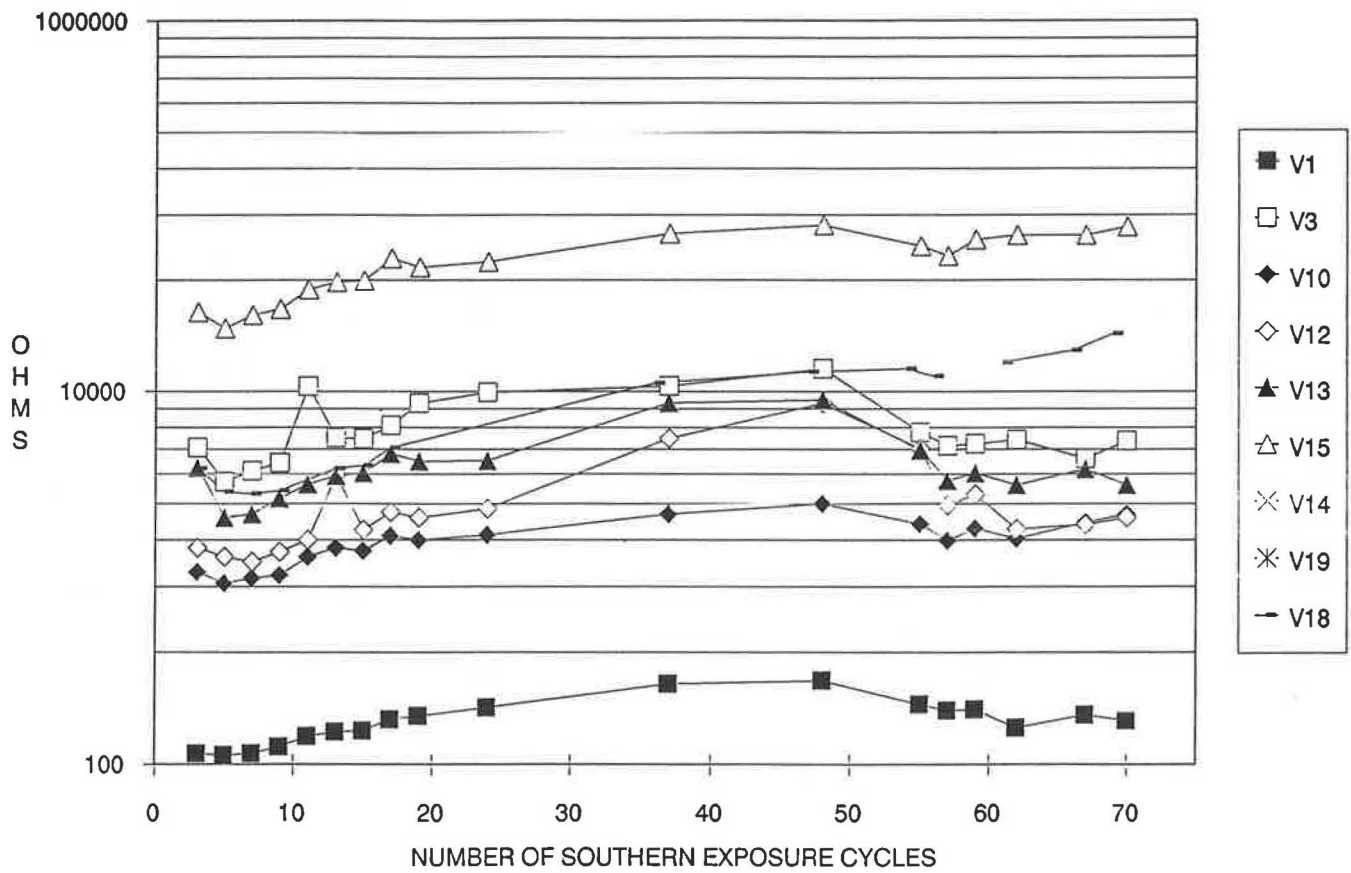
FIGURE 7 All bent bars—controls and epoxy-coated bar specimens: resistance versus time.

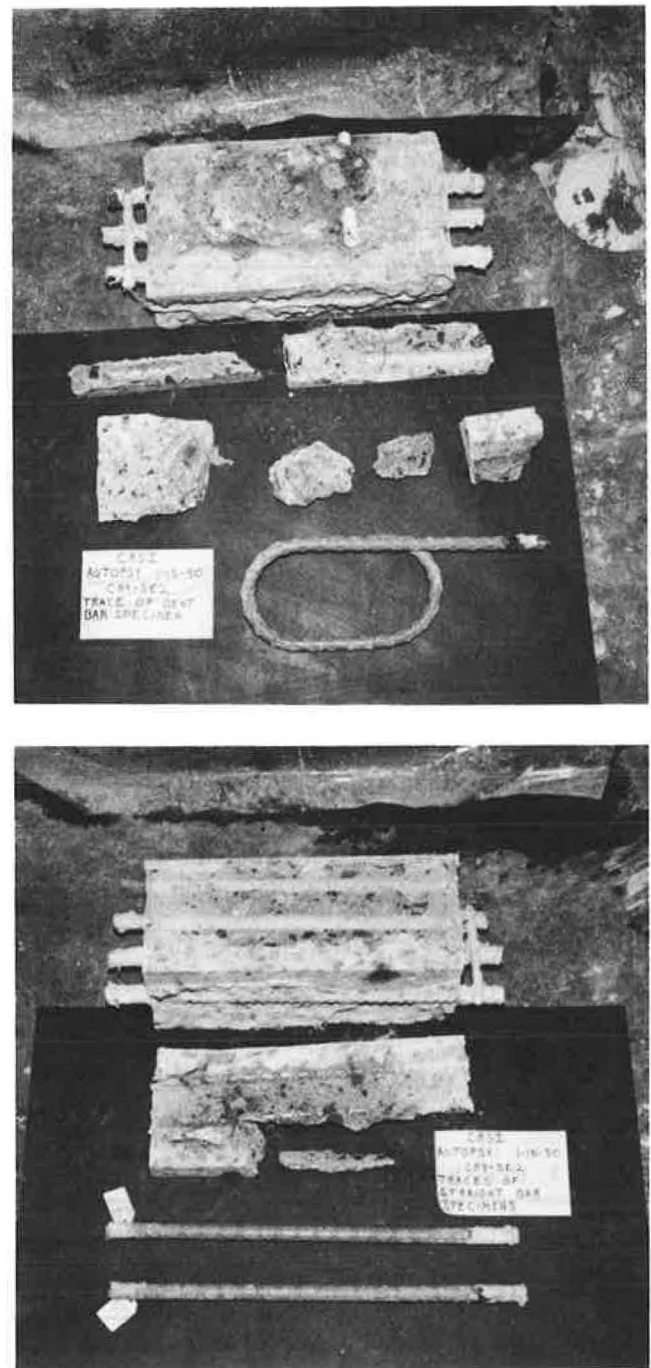
FIGURE 10 Rebars after completion of a typical autopsy.

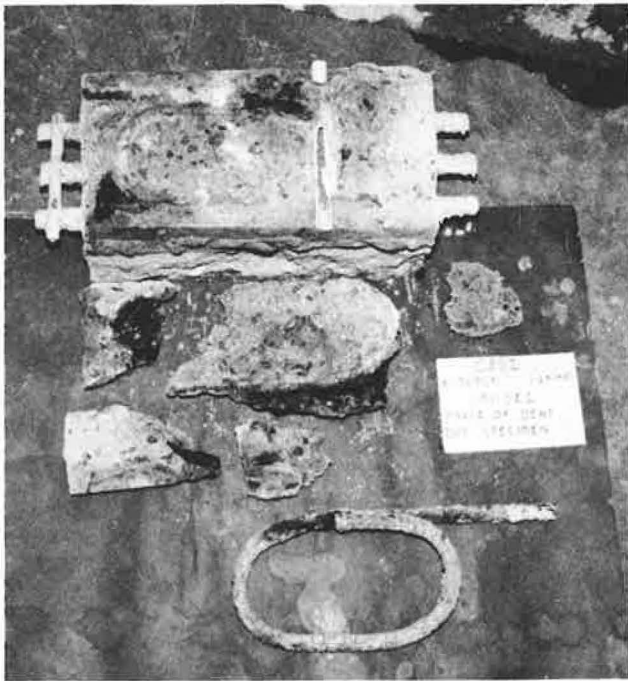
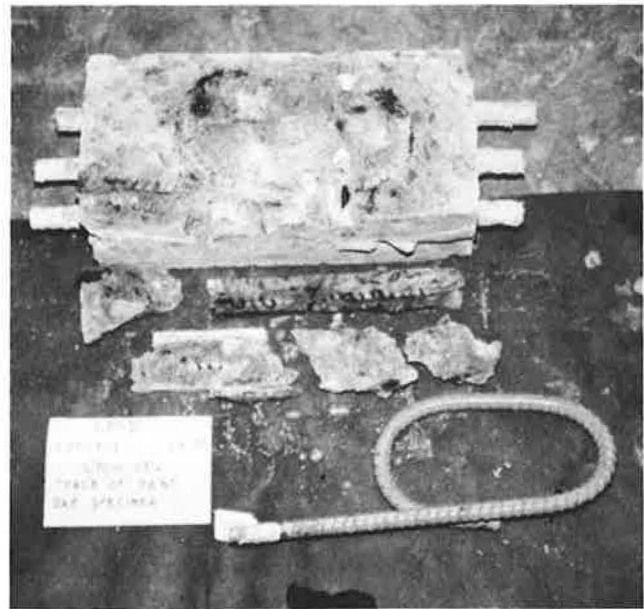
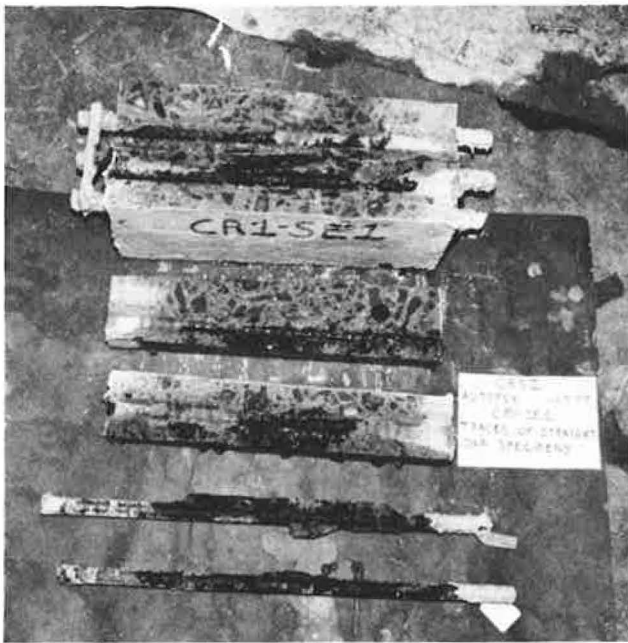
**FIGURE 11** Rebars after completion of autopsy of a slab representing black bar controls.

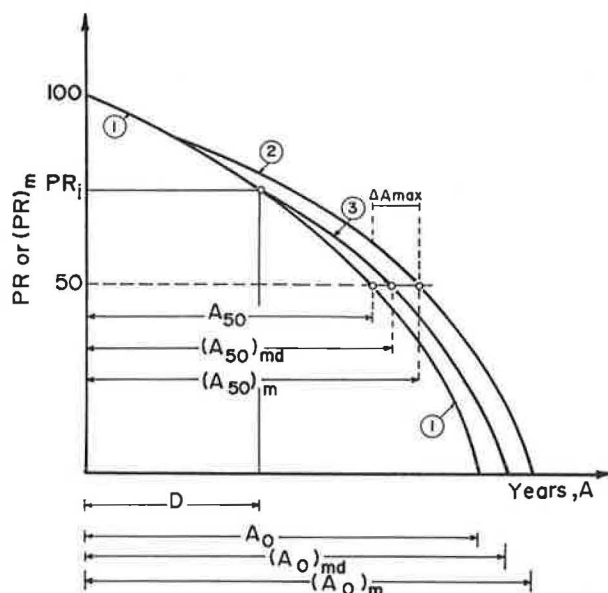
FIGURE 1 Deterioration curves as a result of immediate implementation of routine maintenance or as a result of deferment of routine maintenance work (2).

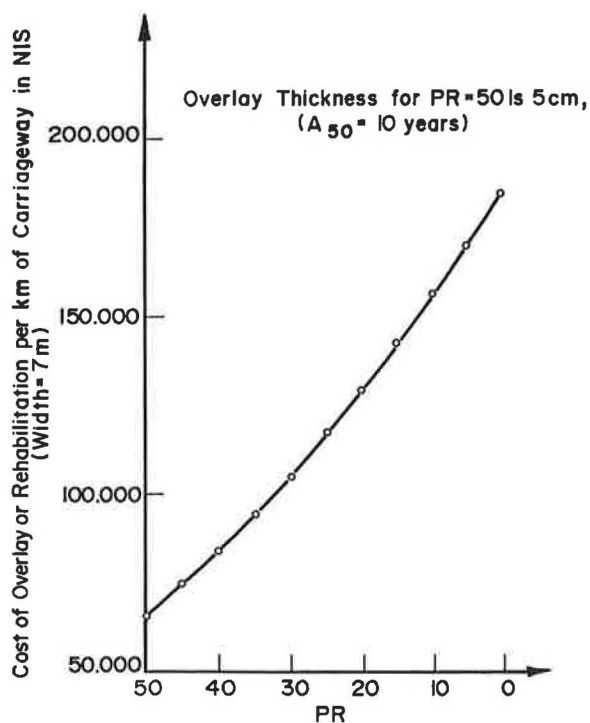
FIGURE 2 Relationship between pavement condition and the cost of overlay or rehabilitation  $C_a$  (2).
