Monitoring Asphalt Concrete Performance at High Altitudes in the Peruvian Andes

JACOB GREENSTEIN, Y. HERRERA, AND ALBERTO GARCIA

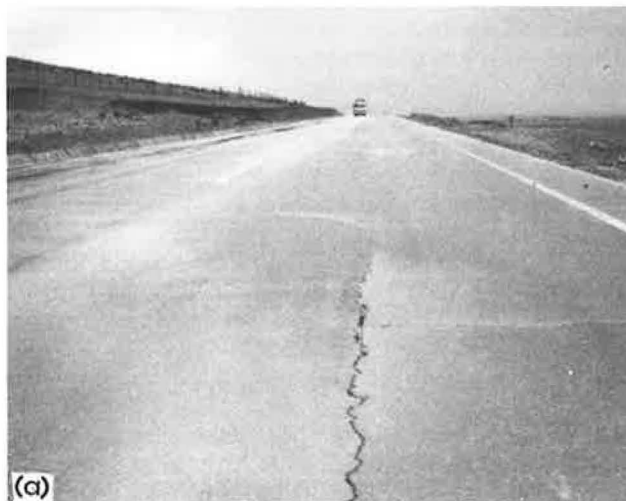
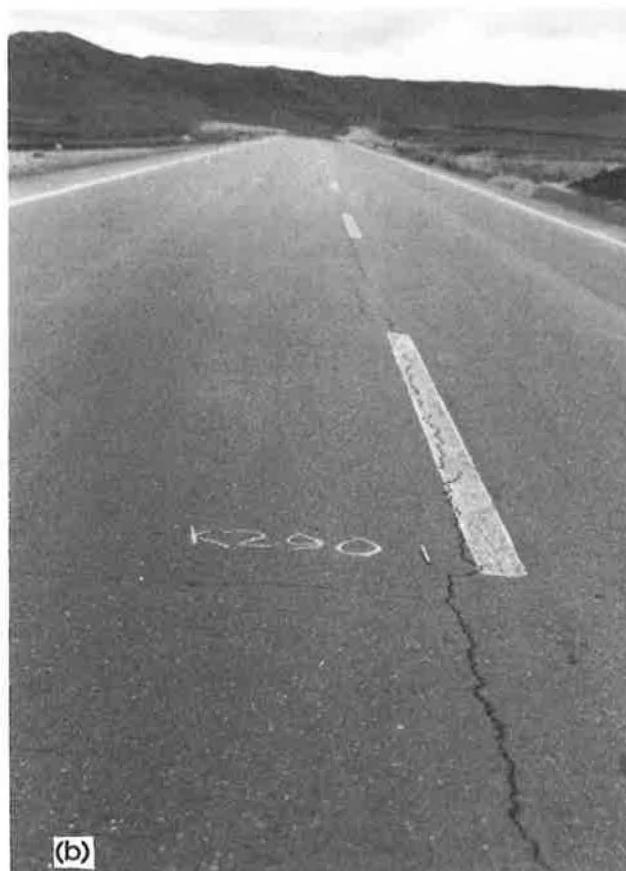
FIGURE 3 a, Typical longitudinal cracking; b, typical longitudinal joint cracking.

procedures and specifications (1–3), severe cracking appeared 5 to 8 months after construction. This cracking usually occurs in the form of longitudinal cracks, combined with some transverse cracking. Longitudinal cracks usually appeared after 5 to 6 months, and usually in the lane or road center as shown in Figure 3. This thermal cracking was not associated with traffic stresses. After 3 to 5 months, transverse cracking appeared on the road surface, as shown in Figure 4. Two years after construction, the road surface was severely cracked, as shown in Figure 5. With no modification of the specifications or construction procedures, pavement that was designed for 15 to 20 years was completely cracked after approximately 3 years, as shown in Figure 6. In order to reduce this thermal cracking, the following material characteristics and construction procedures were analyzed:

Standard construction procedures such as sawing, tack coating, or heating, failed to prevent joint cracking along the La Oroya-Cerro de Pasco Road, as shown in Figure 3b. This type of distress can be reduced when the full asphalt road width is constructed simultaneously.

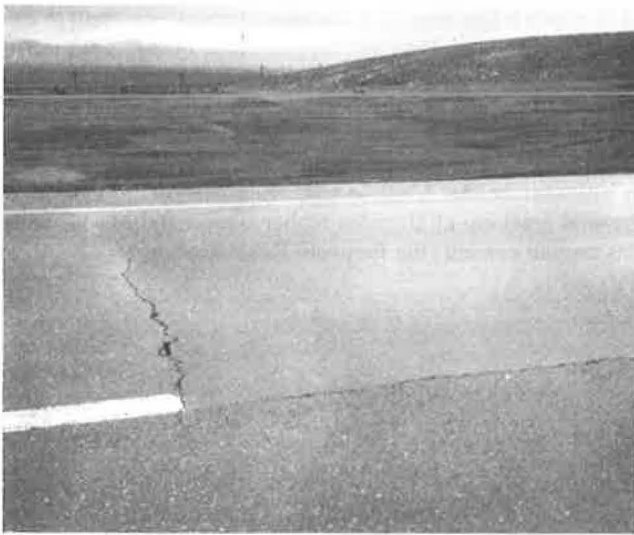
FIGURE 4 Typical transverse cracking.

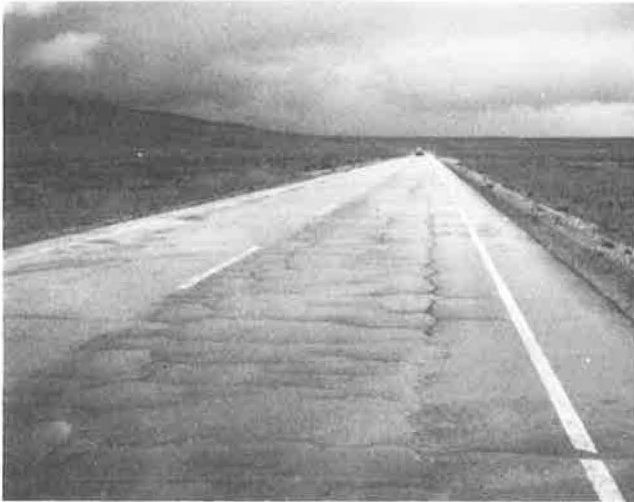
FIGURE 5 Typical pavement cracking, 2 years after completion of construction.

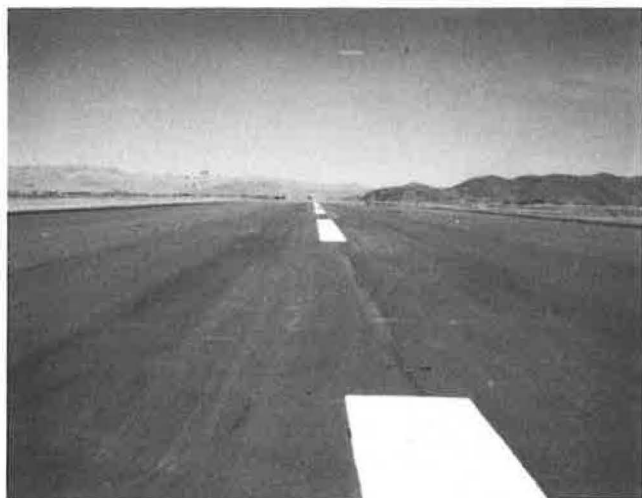
FIGURE 7 AC surface condition—Juliaca Airport at 3,890 MASL.

In the Juliaca Airport asphalt pavement project constructed at an elevation of 3,890 MASL, thermal cracking had not developed 2 years after construction. In this project (see Figure 7), the conclusions obtained from the La Oroya-Cerro de Pasco highway were implemented.

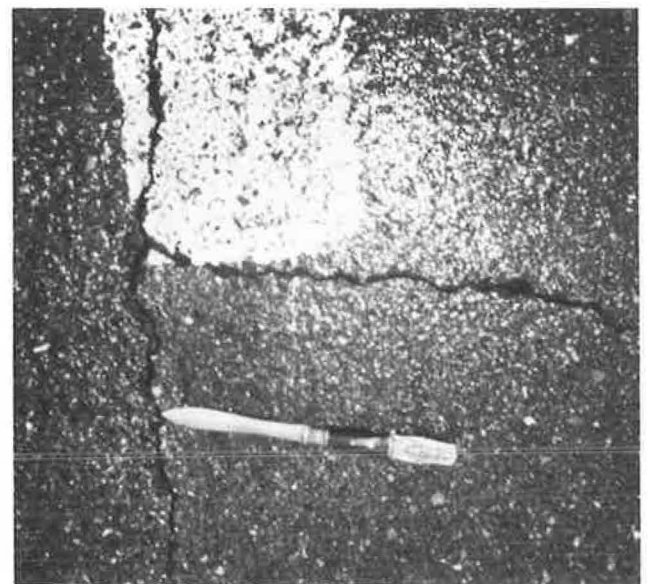
FIGURE 9 Typical 2-mm thermal crack, 5 years after completion of construction (with 2 percent hydrated lime).

The first road section between La Oroya and Cerro de Pasco was constructed without any lime in the AC mix because the local filler was nonplastic with 60 percent of CaCO_3 and both the aggregate and the AC mixture fulfill the AASHTO and ASTM standard specifications (2,3). When surface thermal cracking developed only 5 to 8 months after construction, authorities studied the use of hydrated lime in the asphalt mix. They decided to use hydrated lime as 2 percent of the total weight of the filler, even though the materials met the specifications. Use of lime in the AC mixture and the other implementations mentioned significantly improved the performance of asphalt pavement at 4,160 MASL. Figure 8 shows a typical improved pavement section 2 years after construction. After this performance period, the width of a typical thermal crack was 1 mm (Figure 8b). A typical road condition 5 years after construction is shown in Figure 9. After this period, the typical crack width is about 2 mm.

A visual survey of the road in the spring of 1986 showed that after 5 years of service the thermal cracking reached stable conditions. In the last year or so, no significant deterioration or new thermal cracking has occurred and the typical crack width is still 2 mm, as shown in Figure 9. Riding quality is good and in the first approximation the existing 1 to 2 mm of thermal cracking does not affect the pavement riding quality along the La Oroya-Cerro de Pasco Road at altitudes of 4,100 to 4,300 MASL.
