TRANSPORTATION RESEARCH
RECORD

No. 1275

**Bridge Research
1990**

A peer-reviewed publication of the Transportation Research Board

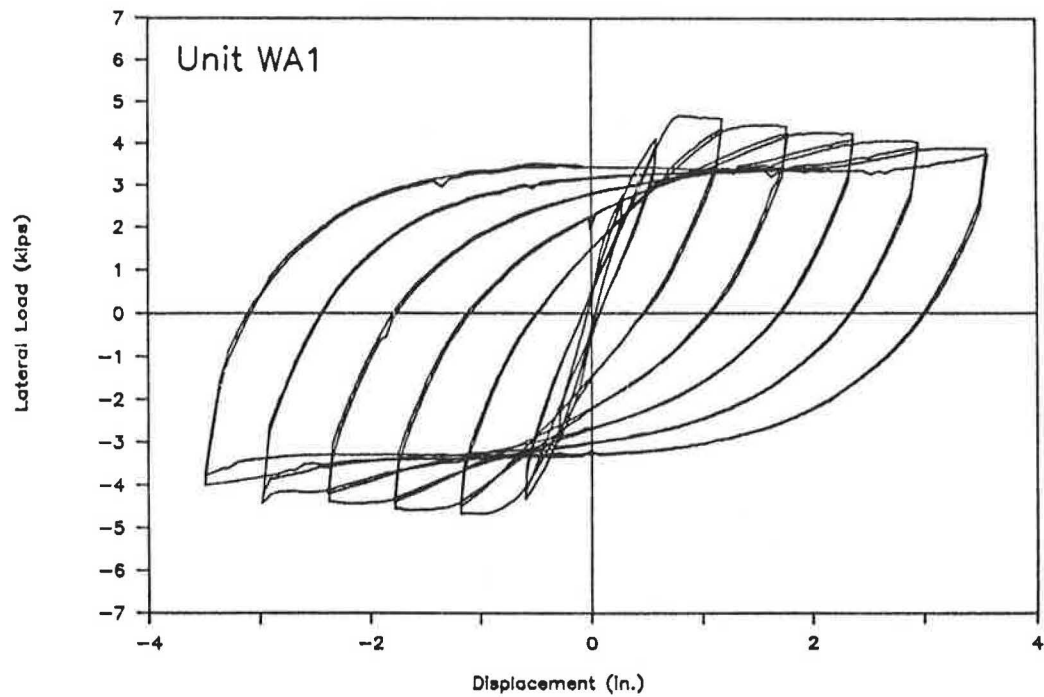
FIGURE 11 Lateral load-displacement hysteresis curves for Unit WA1.

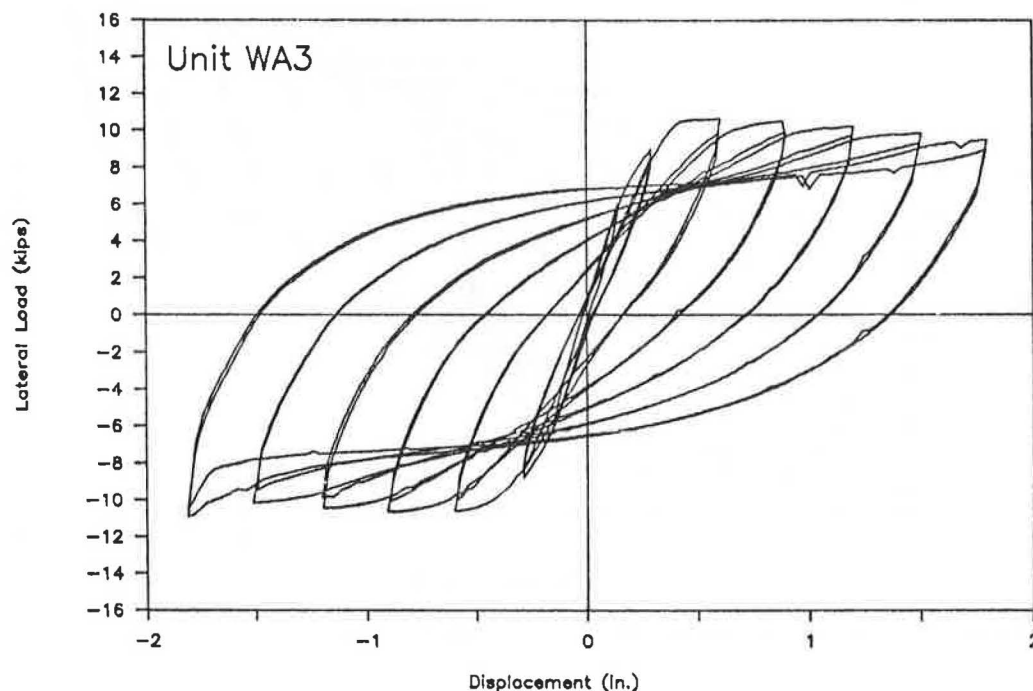
FIGURE 15 Lateral load-displacement hysteresis curves for Unit WA3.

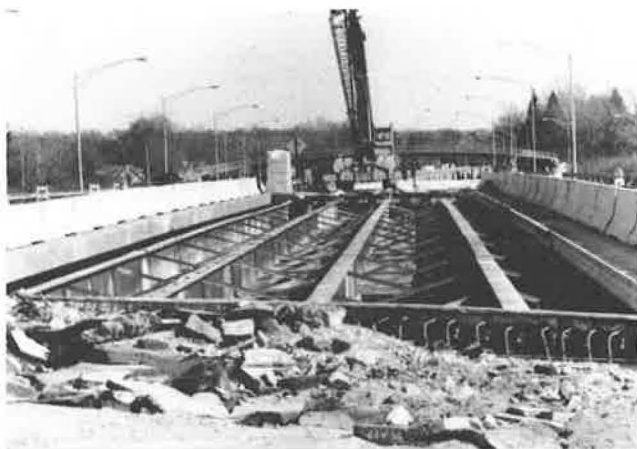
FIGURE 8 Beam lines with deck removed.

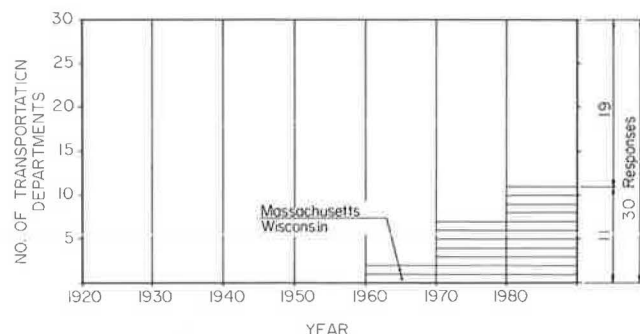
FIGURE 1 Design trends for continuous bridges: early conversion of simple spans to continuous spans.

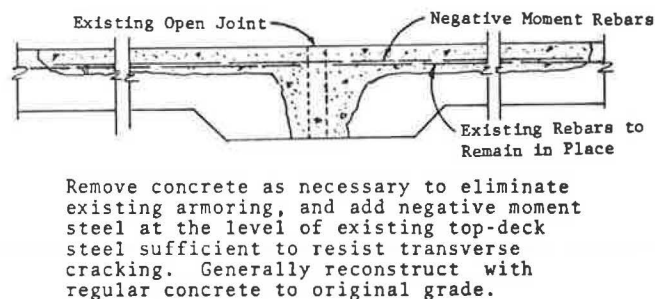
FIGURE 11 Integral conversions at piers: Texas.

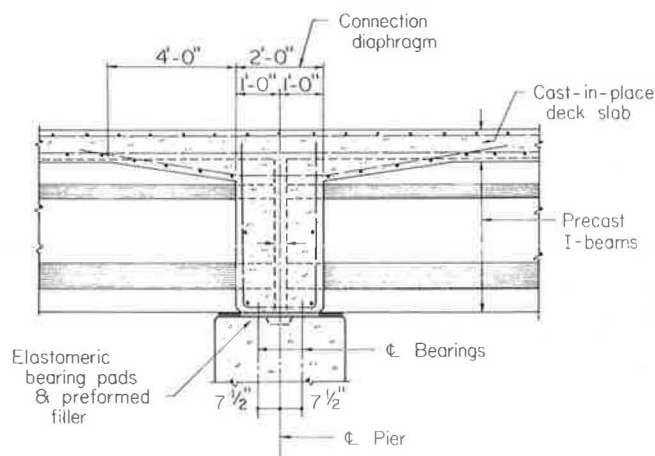
FIGURE 13 Integral conversions at piers: Wisconsin.

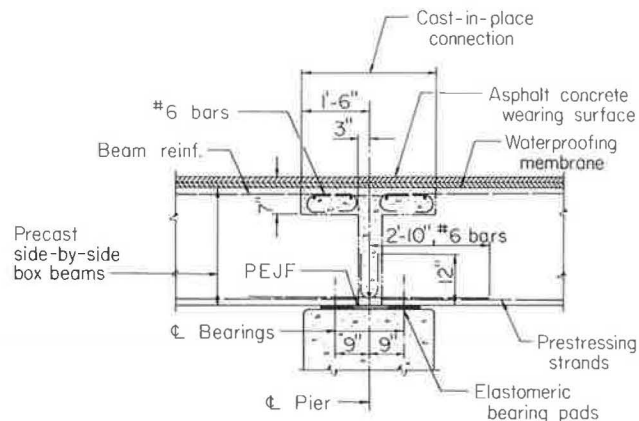
FIGURE 14 Integral conversions at piers: Ohio.
