TRANSPORTATION RESEARCH
RECORD

No. 1279

**Hydrology and
Environmental
Design
1990**

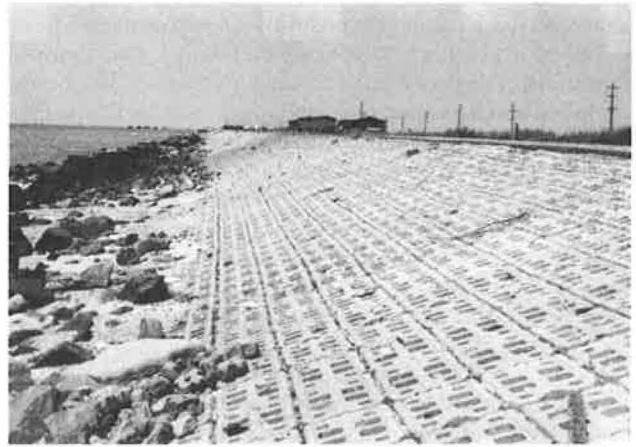
FIGURE 1 *Left:* A section of LA-82 after tropical storm Chris in 1982, and *Right:* one of the several revetment projects along LA-82.

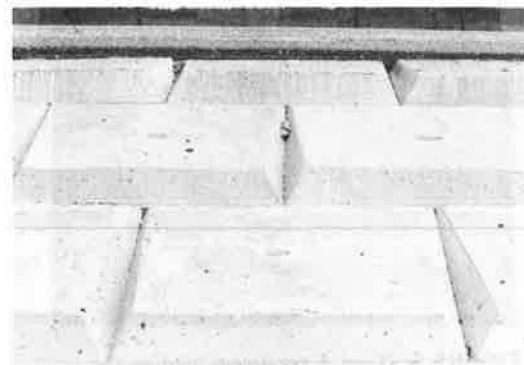
FIGURE 6 Type B revetment.

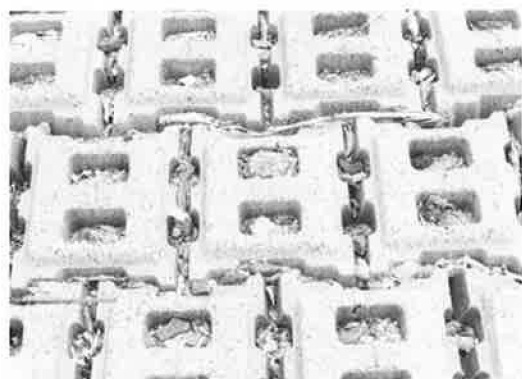
FIGURE 7 Type C revetment.

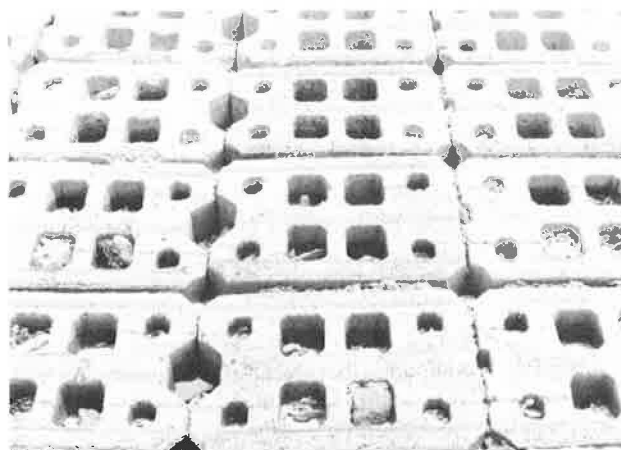
FIGURE 8 Type D revetment.

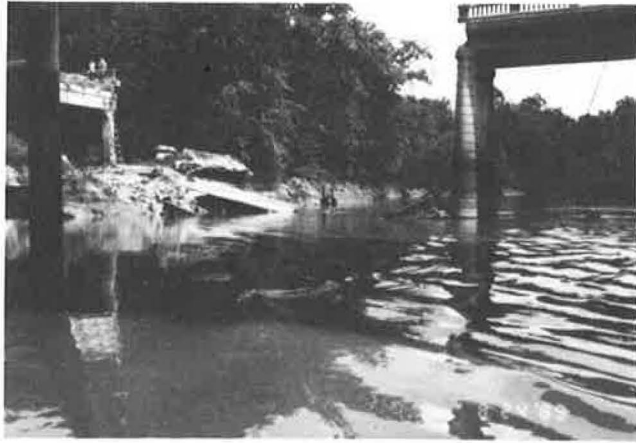
FIGURE 6 Span 79 debris removed.

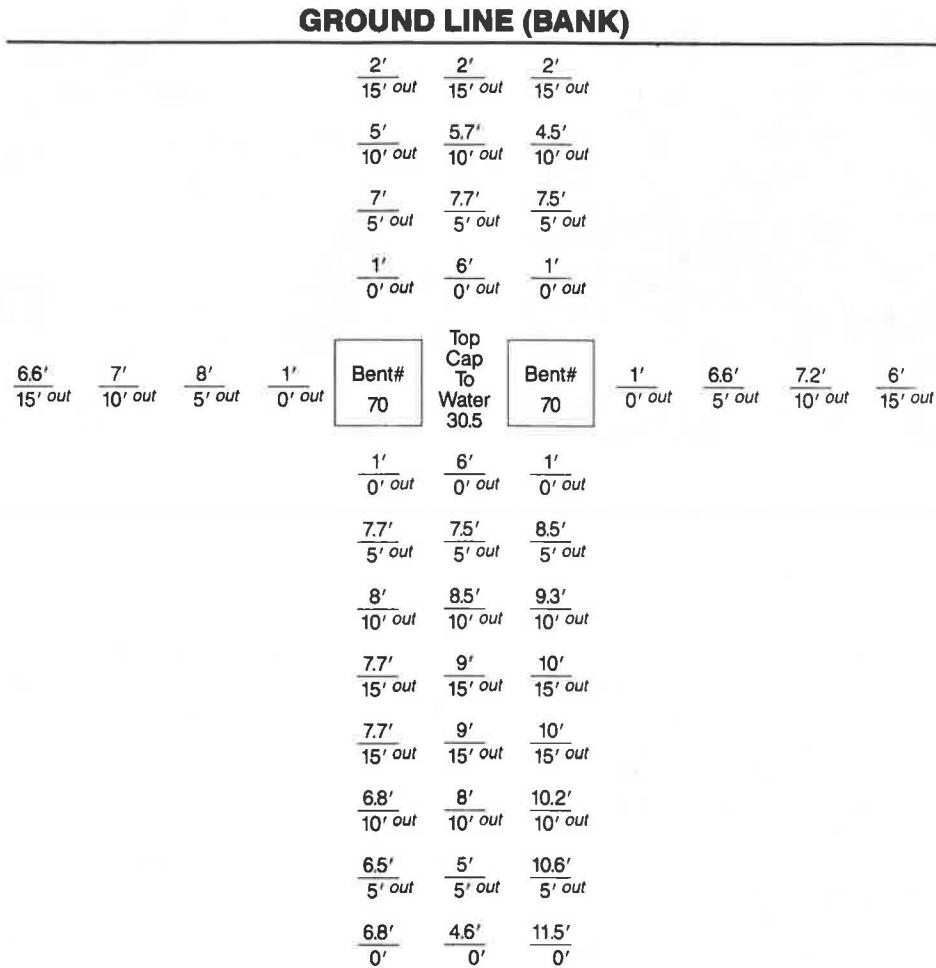
FIGURE 8 Soundings at Bent 70 (NTSB 1990).

The inspectors confirmed that drift had accumulated on Bents 70 and 71. The reproductions of the photographs in the
