Unique Methods Used in Constructing the Robert E. Lee Bridge

THOMAS P. MCCARTHY, RALPH SALAMIE, AND W. R. NASH

The Robert E. Lee Bridge in Richmond, Virginia, consists of twin trapezoidal concrete box structures 3,400 ft long and consisting of constant-width and varying-width cross sections placed with form travelers. This bridge represents two firsts in North America: (a) the largest number of form travelers (eight) ever used concurrently, and (b) the first use of a strand stability system in segmental concrete balanced cantilever construction. The use of portable fabric cofferdams was a unique method for constructing the bridge piers in the James River. These fabric cofferdams provided a safe, environmentally sound structure within which to drill and blast for rock excavation and to place concrete for the pier footing and the first lift of the pier columns in the river.

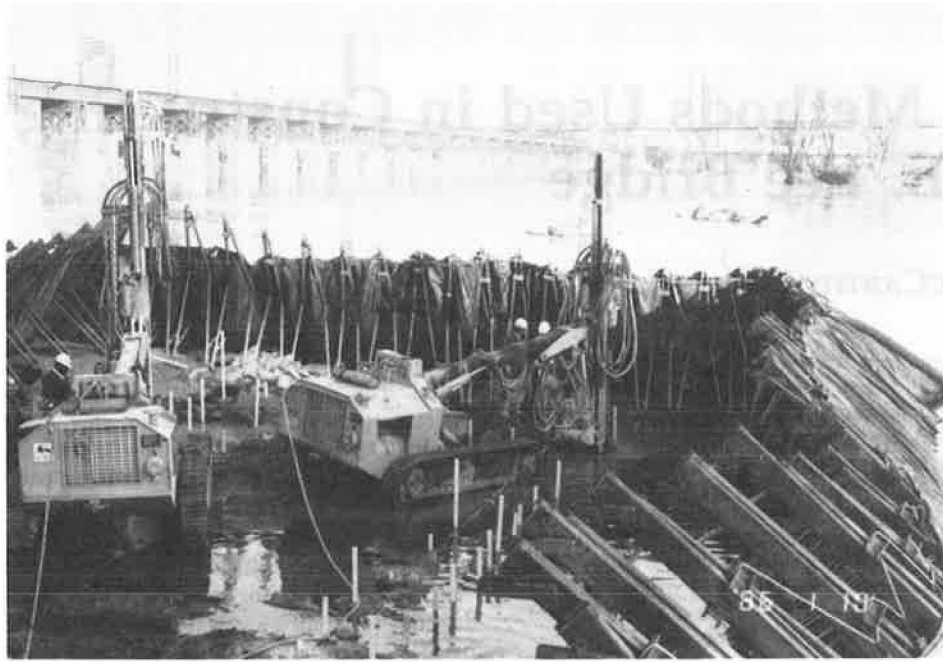
FIGURE 1 Fabric cofferdam drilling of rock excavation.

A common British concept for cofferdams, not yet applied in the United States, was used for the main channel river footings (Figure 1). A fabric cofferdam was installed in the river to provide a work area around each pair of footings, one northbound lane (NBL) and one southbound lane (SBL). The cofferdam consisted of steel frames and a rugged polyvinyl material draped from the frame to the river bottom. After the survey location was determined, divers installed the cofferdam in the following sequence of operations:

1. Cleaned the river bottom of cobbles along the frame lines.
2. Installed the steel frames, which interlocked and rigidly held the fabric. A hydraulic crane on the causeway helped rig the frames to the water. Typical spacing for the frames was 2 ft.
3. Installed the fabric. The fabric, in sheets 30 × 50 ft, was attached to the outside of the frame and rolled down the sloped outward leg to the river bottom and then along the river bottom. The divers weighted this fabric to the river bottom with a chain fixed to the end of the fabric. The fabric was overlapped and connected along the vertical fabric joints with velcro-type fasteners.

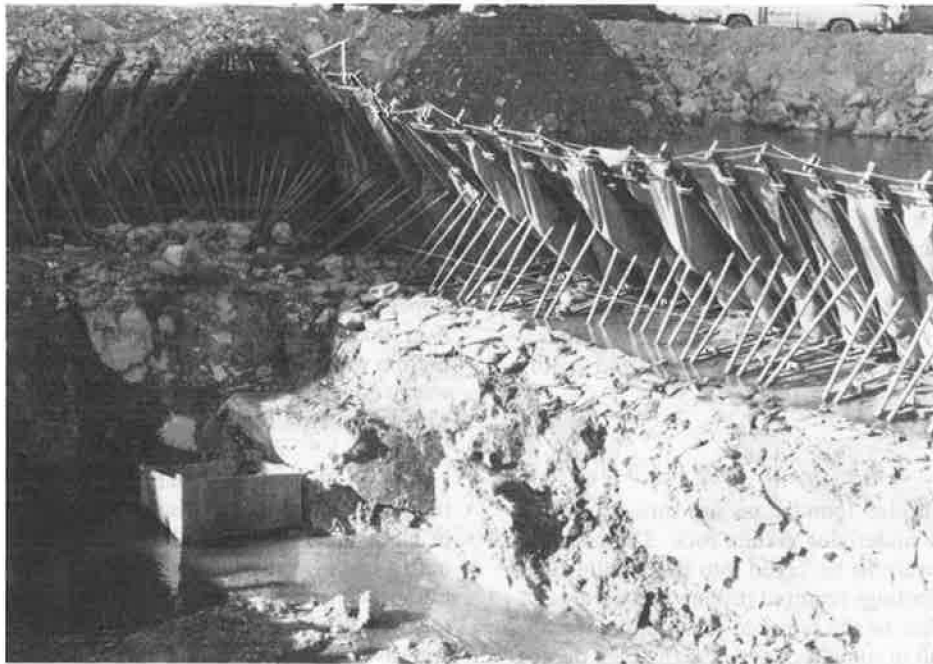
FIGURE 2 Fabric cofferdam on steel frames after rock blasting.

The rock excavation required drilling and blasting operations. Water gel explosives and nonelectric blasting caps were used. The portadam was partially flooded before shooting the footing to help absorb the concussion from the blast (Figure 2).

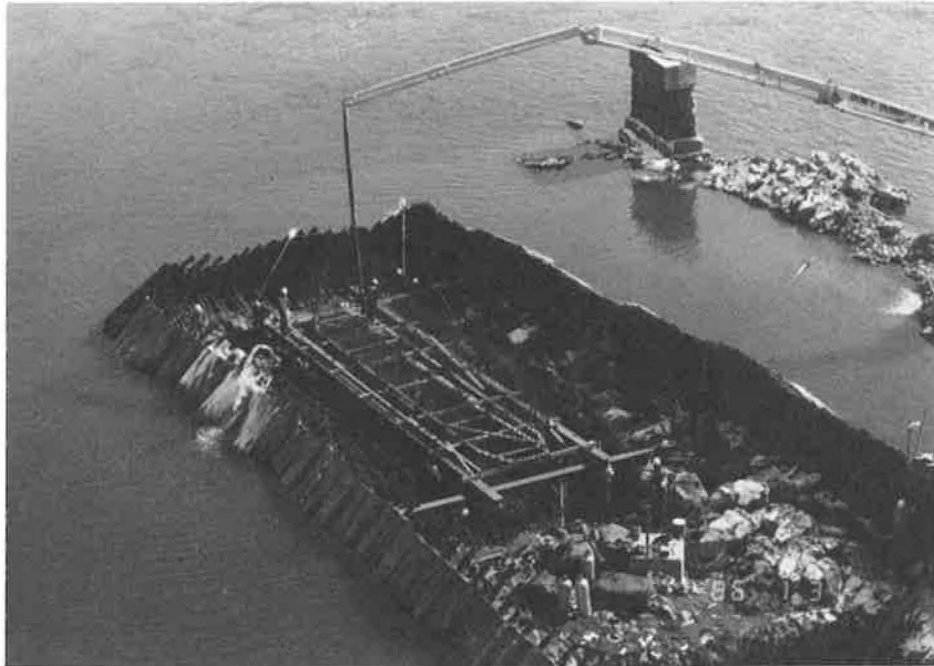
FIGURE 3 Placing of pier concrete in footing with protection of cofferdam.

On completion of one pair of footings, the cofferdam was quickly and easily removed and reinstalled. Typical installation time was 4 weeks—3 weeks of single shift work and 1 week for dismantling. The fabric cofferdam was environmentally advantageous in that it eliminated the use of steel boxes

with tremie concrete, timber cribs, impervious fill, and other such materials (Figure 3).

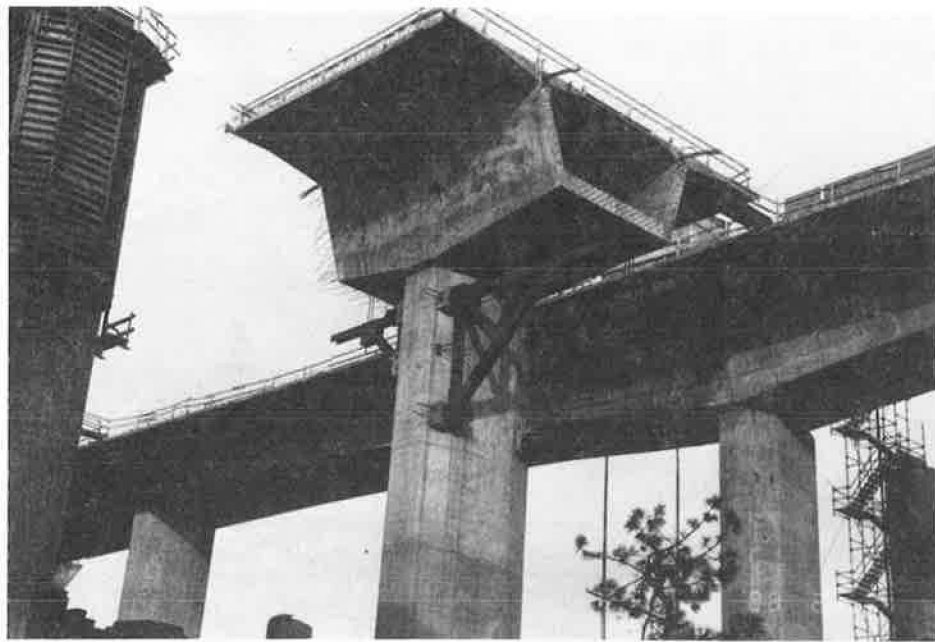
FIGURE 4 Pier table (two-web) with brackets awaiting traveler erection.

The pier tables (the superstructure section cast at each pier to permit erection of the form travelers) were constructed by using falsework supported by steel brackets posttensioned to the piers with threadbars (Figure 4). Wood forms were used to build the pier tables. Concrete was placed in three stages—the bottom slab, the walls, and then the top slab. A typical two-web pier table required 243 yd³ of concrete; a three-web pier table required 436 yd³. Superstructure concrete strength was specified to be 5,000 psi.

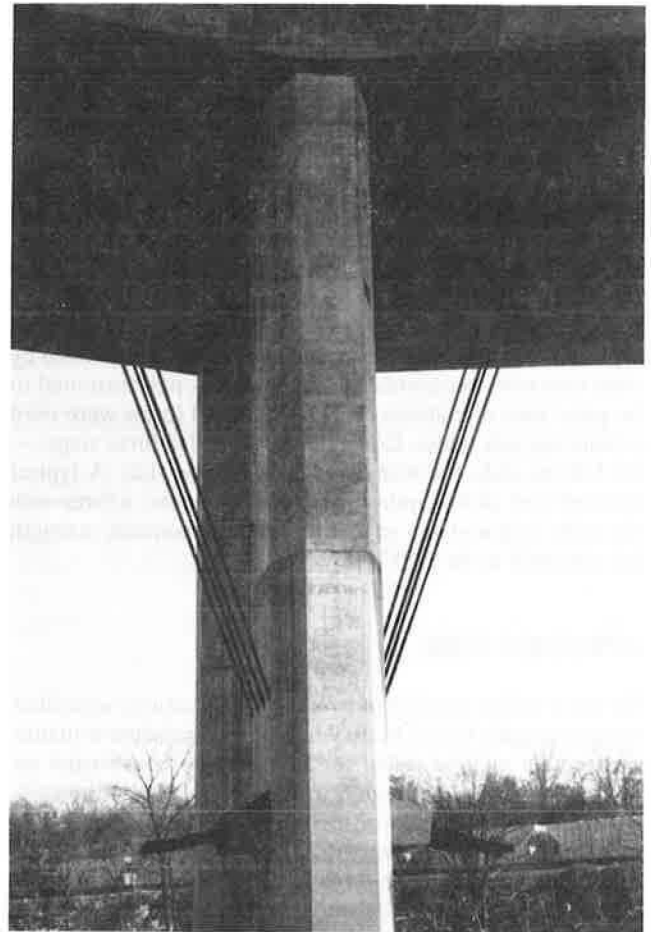
FIGURE 5 Stability strand ties restraining a three-web cantilever.

The selected stability system incorporated brackets designed to act as pier-table falsework and yet resist the out-of-balance moment resulting from the first segment placement. The pier-table moments were much smaller than the maximum moments produced by the full cantilever. Before the second segment was cast, brackets were replaced by routing the piers through a duct to its anchor plate (Figure 5). The upper anchorage was made in a concrete wall blister that was added and post-tensioned to the web, inside the box at a distance of 28 ft from the centerline of the pier. With completion of the last cantilever, using multistrand stays, the system worked without failure, despite some obstacles.

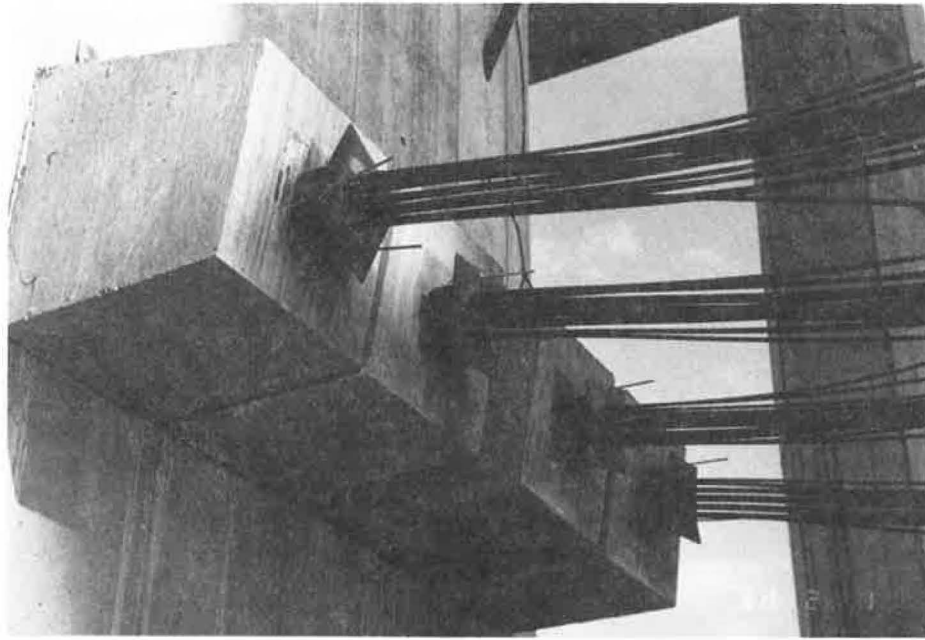
FIGURE 6 Lower anchorage of strand stability system.

The stability tie system was costly in time and money. Similar to a prop setup, two separate systems were fabricated and erected. Special tapered concrete shoes were fixed to the faces of the pier-table stability brackets, which mount on a tapered face of the pier. Concrete anchor blocks were required at both the live and dead ends of the ties. The strands and wedge plates could not be reused. Casting the anchor blocks and replacing the brackets with ties took 5 days on a two-web cantilever section and 9 days on a three-web section (Figure 6).

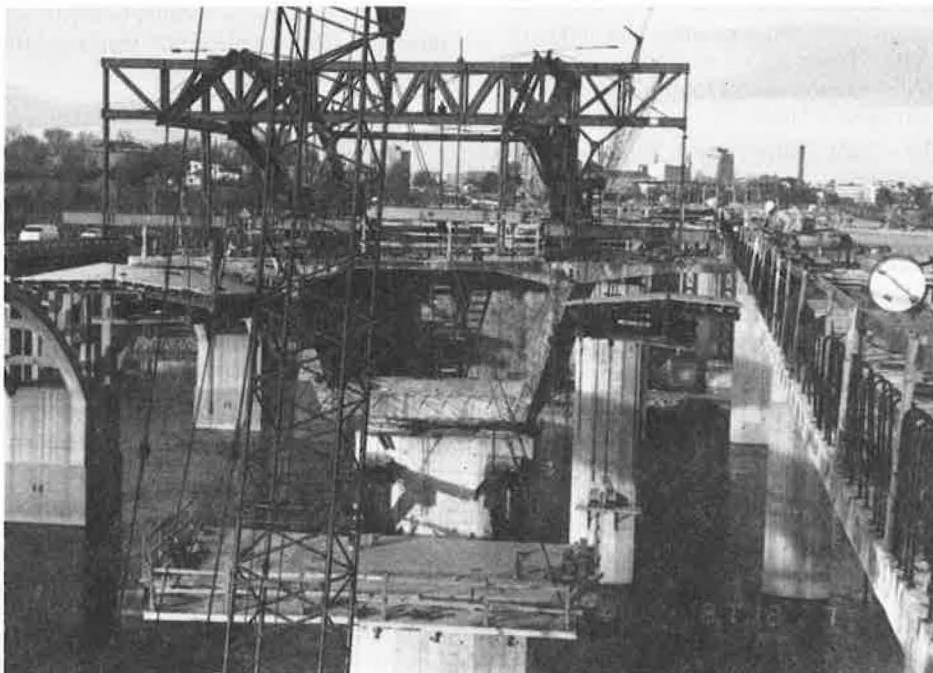
FIGURE 7 Single-cell (two-web) box—bottom drive deck erection of A side.

The maximum out-of-balance moment was 44,861 ft-kips at Pier 10 NBL and the maximum rotation under this moment was 0.428° at Pier 2 NBL. Two pairs of constant-width form travelers and two pairs of variable-width form travelers were used to construct the balanced-cantilever portions of the bridge (Figures 7 and 8). The weight characteristics of these are as follows:
