Long-Term Outdoor Exposure Evaluation of Concrete Slabs Containing Epoxy-Coated Reinforcing Steel

WILLIAM T. SCANNELL AND KENNETH C. CLEAR

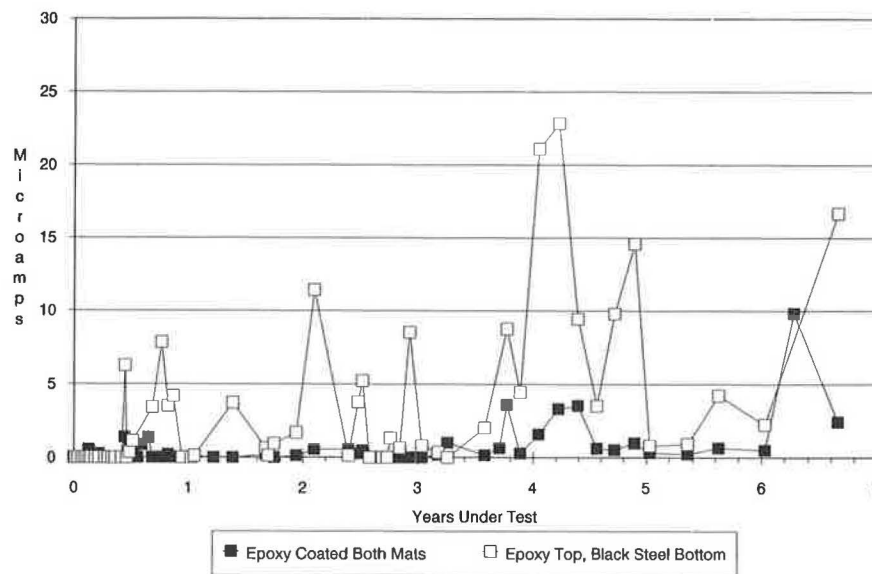
FIGURE 3 Average macrocell corrosion current (70°F) versus time.

Figures 3 and 4 present the average adjusted (i.e., 70°F) macrocell corrosion current versus time for the three variables studied. For epoxy-coated bars in both mats (Figure 3), the average corrosion current was zero or negligible (less than 10 μA) for the test duration (overall average was 0.61 μA). Slabs with epoxy-coated bars in the top mat only (Figure 3) started with zero corrosion current and after about 0.4 year of salting, variable but very low corrosion currents were measured (overall average was 3.23 μA). Slabs with black steel in both mats (Figure 4) began to show measurable corrosion currents 0.2 year into the study. After 1.2 years of salting, corrosion currents increased drastically, averaging 886.87 μA through 3.7 years. Values were frequently more than 40 times the maximum current measured in the slabs with epoxy-coated bars in the top mat only and more than 100 times that for the slabs with epoxy-coated bars in both mats. Macrocell currents remained at high levels through the remaining test period,

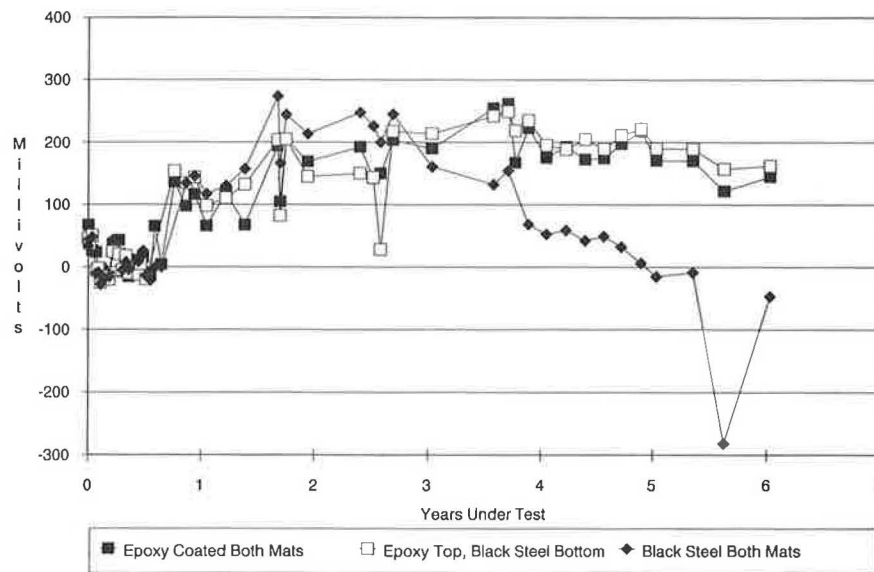
FIGURE 7 Average potential difference versus time.

for years 1 through 6 was 171 mV). However, as discussed previously, the macrocell corrosion currents have remained near zero. Thus, these data tend to support previous findings that, although corrosion will occur at small breaks in the coating once critical quantities of chloride penetrate, its magnitude is so low that significant iron consumption and tensile stresses high enough to crack the concrete will not occur for very long periods of time (5). Performance of the epoxy top mat only slabs has been similar to that of epoxy both mat slabs except that average top-mat rebar potentials are generally more positive in epoxy top mat only slabs. In the case when the bars in both mats were coated, more negative potentials were undoubtedly exhibited because of oxygen starvation (cathodic polarization), whereas such was not the case when the bottom mat was uncoated. Potential differences were similar throughout the test period (overall average for epoxy top

mat only slabs for years 1 through 6 was 176 mV). Macrocell corrosion currents remained at low values throughout the test period, although at times they were about 5 to 10 times higher than the epoxy both mat slabs. Thus, these data indicate that specification epoxy-coated bars perform best when all bars are coated, although both variables (i.e., epoxy-coated bars in both mats and epoxy-coated bars in the top mat only) provide significantly enhanced resistance to corrosion-induced concrete damage as compared with uncoated steel (average top-mat potential and potential difference for years 1 through 3.7 was -486 and 191 mV, respectively). The decreasing trend in potential difference (average bottom-mat potential minus average top-mat potential difference) (Figure 7) for this variable was the result of corrosion activity on the bottom steel caused by chloride migration through large surface cracks. The formation of liquid corrosion product that does not lead to spalling is possible, particularly in a crevice or coating undercutting situation, although this was not seen on the full-depth cores as discussed in the following.

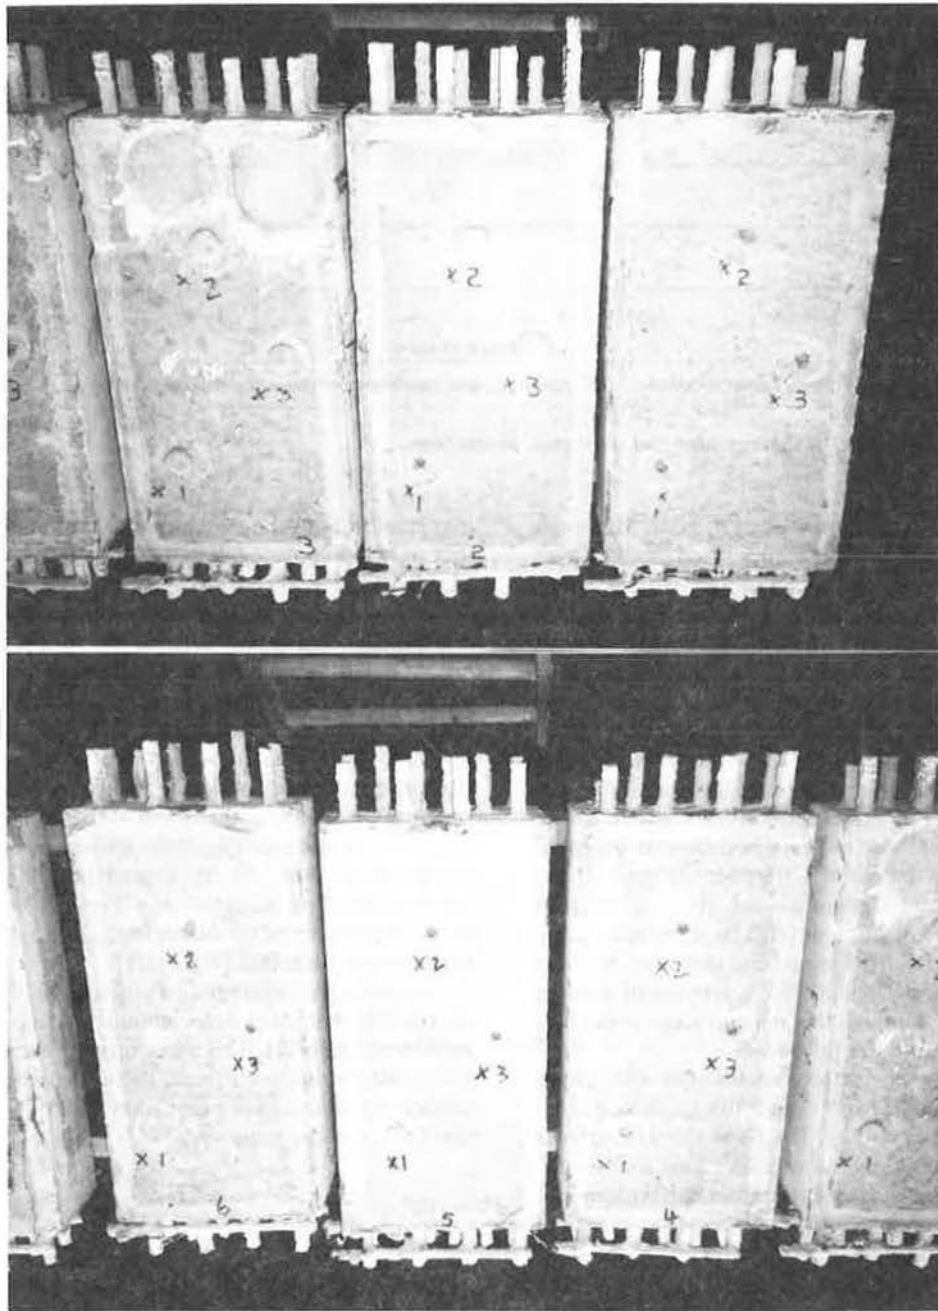
FIGURE 8 Surface condition after exposure. (Top: both mats coated; bottom: top mat only.)

Figures 8 and 9 show the surface condition of each group of slabs after more than 6.5 years of outdoor exposure, including about 3.1 years of salt ponding. The x's on the slab surfaces designate top-mat potential monitoring locations and the circular mounds on the slab surfaces represent the bottom-mat potential wells discussed previously. No surface cracking, staining, or other deterioration was found on any of the slabs containing epoxy-coated bars in both mats or epoxy-coated bars in the top mat only. However, extensive surface cracking and staining can be seen on the slabs containing black steel bars in both mats. Fine corrosion-induced cracking and minor staining were first observed on these slabs after only 0.9 year into the study.

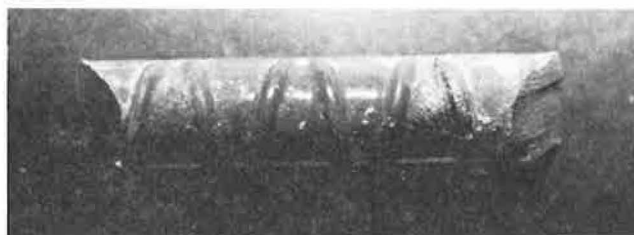
FIGURE 10 Autopsy photographs. (*Top*: top bar, epoxy-coated bars in both mats. *Middle*: bottom bar, epoxy-coated bars in both mats. *Bottom*: epoxy-coated rebar trace).

Upon completion of the exposure period, full-depth cores representing each variable were obtained from one slab. These cores were then autopsied to determine the relative extent of corrosion-induced damage, if any, and the overall physical condition of the epoxy-coated bars. Figures 10 through 12 are photographs typical of those taken during autopsies. The top-

mat steel in both the epoxy-coated both mats and epoxy top mat only situations exhibited similar results (Figures 10 and 11). There was no visible corrosion product at the rebar-concrete interface or beneath the coating (steel was bright and clean) when it was scraped off with a utility knife. No visible deterioration was observed on the coating itself; however, the coating was more easily removed from these specimens as compared with bar with a retained original coating that had never been embedded in concrete. Hence, the coating softened somewhat during exposure, but no obvious detrimental effects were discerned and there was no observed tendency for undercutting of the coating by corrosion. Similar results were found on the coated bottom-mat bar for the epoxy-coated both mats variable (Figure 10). Very minor corrosion was observed on the uncoated bottom bar in the epoxy top mat only situation (Figure 11).

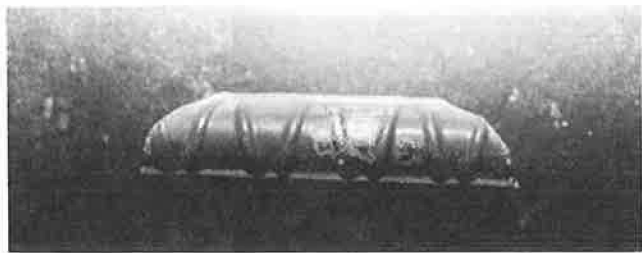
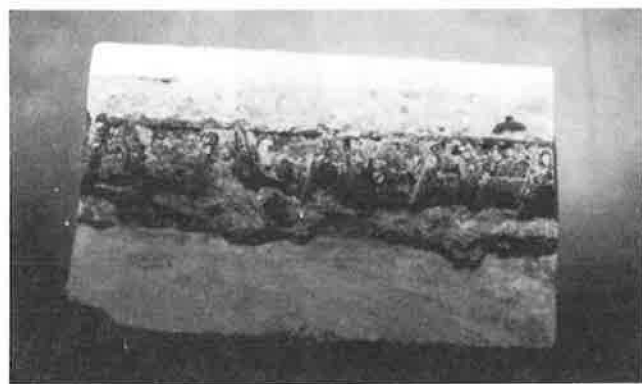
FIGURE 11 Autopsy photographs of slabs with epoxy-coated bars in top mat only. (Top: top bar. Bottom: bottom bar.)

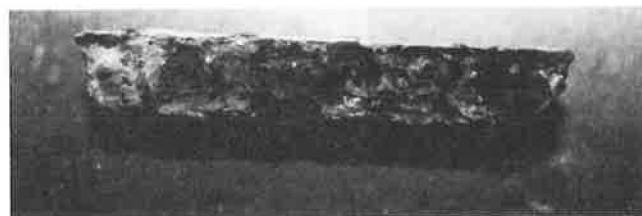
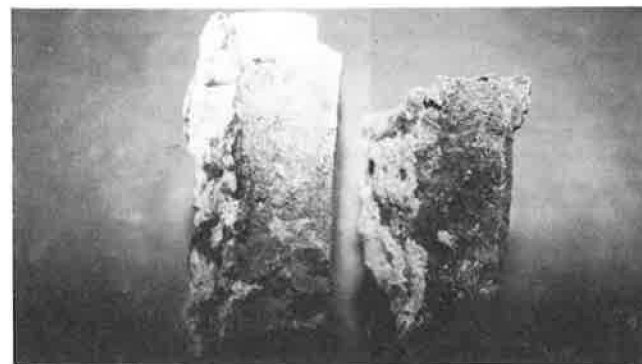
FIGURE 12 Autopsy photographs of slabs with black steel (uncoated) bars in both mats. (Top: top bar. Middle: top rebar trace. Bottom: bottom bar.)

Extensive corrosion product and section loss were observed on the top-mat steel representing the uncoated both mats variable (Figure 12). This was expected because of measured macrocell corrosion currents, half-cell potentials, and visual surface condition. Minor corrosion was found on the bottom-mat bar from the same variable.
