Field Investigation of Punchout Distress in Continuously Reinforced Concrete Pavement in Illinois

DAN G. ZOLLINGER AND ERNEST J. BARENBERG

Most maintenance activities on continuously reinforced concrete (CRC) pavements are related in one way or another to punchout distress. Over several years of observation of CRC pavement, several symptoms related to the structural aspects of punchout distress have been noted. These symptoms include, but are not limited to, close crack spacing, surface widening and spalling of transverse cracks, development of longitudinal cracking, loss of load transfer, and subbase and subgrade pumping. Literature reviews have elaborated on punchout-related factors with respect to pavement performance. However, the punchout mechanism relating the various factors is not completely defined. Some questions exist concerning the sequence of events leading to the loss of load transfer across transverse cracks as a prerequisite to the development of a punchout. This sequence of events relates to the role reinforcement plays in the punchout process and whether the loss of aggregate interlock requires rupturing of the steel. If rupturing of the steel occurs, the questi

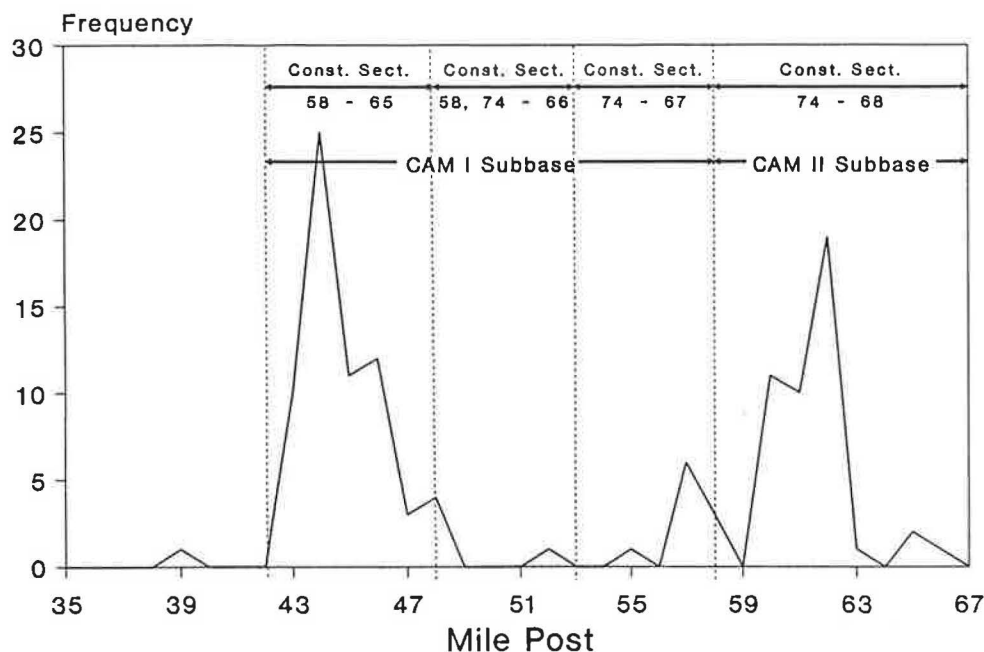
FIGURE 2 I-72WB CRC pavement survey of punchouts and patches in driving lane.

Although no significant distinctions could be made in the crack spacing distributions between the adjacent good- and the bad-performing sections of I-72WB (shown in Figure 2), the apparent differences lie in whether the coarse aggregate was D-cracking susceptible. The pavement thicknesses are equivalent and the average crack spacing is similar. The construction section containing the low percentage non-D-cracking susceptible aggregate source (Thornton Pit) is the one with the highest rate of distress.

The subbase types used on I-72WB are CAM I and CAM II. CAM I subbase is roller compacted and usually contains an 8 percent cement content, an aggregate blend of 75 percent coarse aggregate, and 25 percent natural sand (9). CAM II subbase type is equivalent to a lean concrete subbase. Two of the construction sections with high rates of distress had different subbase types, so the source of the distress may not be strictly attributable to the type of subbase. A standard procedure was followed on each construction section, making little difference in construction procedure between the sections. Especially with regard to the construction of the CAM I subbase, the standard procedure called for the trimming of the CAM I material with an autograder. This meant that the stabilized subbase was trimmed before placement of the 8-in. CRC pavement. The subbase material was not roller compacted again after the trimming operation was completed.

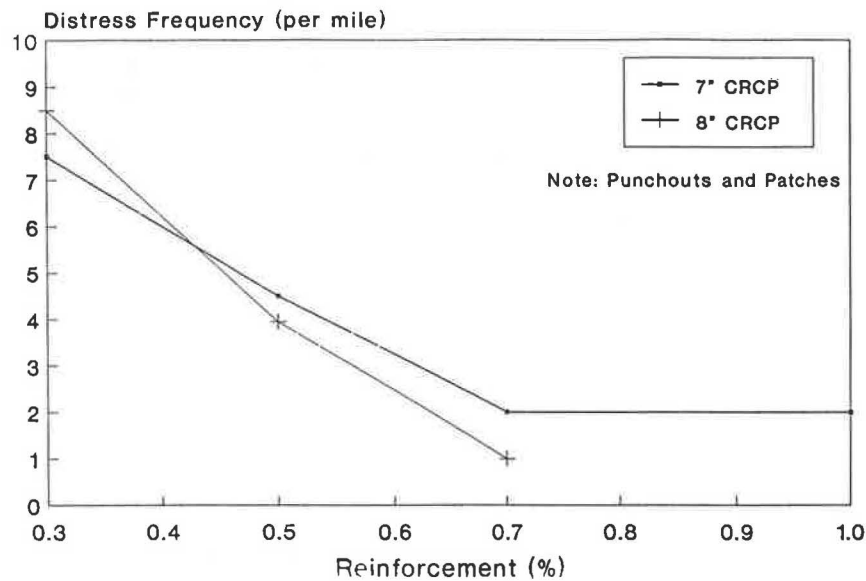
FIGURE 3 Effect of reinforcement on performance of Vandalia CRC pavement (US-40).

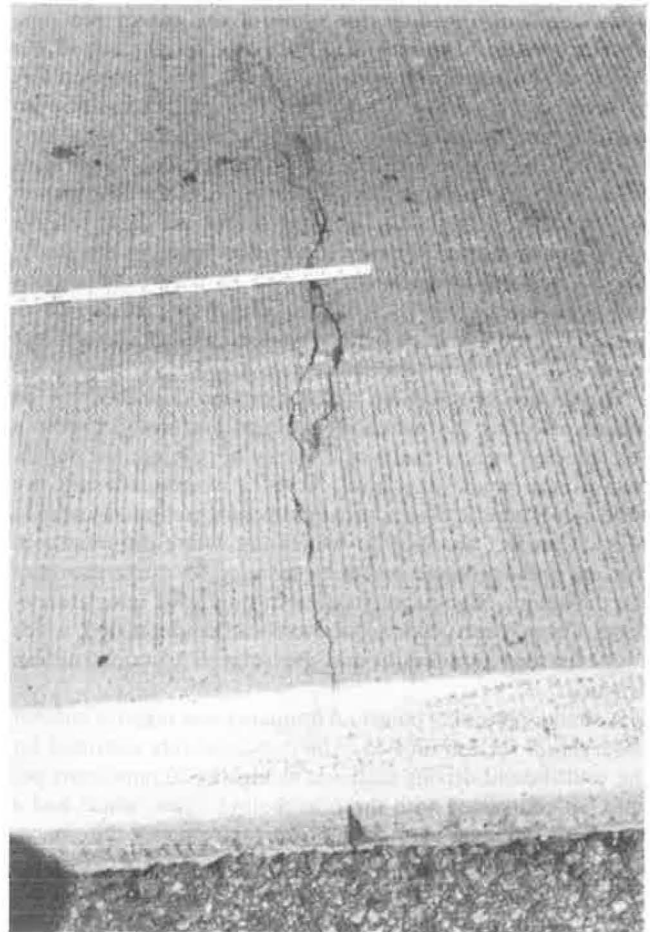
FIGURE 4 Type 1 spalling, I-39SB.

Spall development was investigated on the I-57 sites, in which two types of spalls were noted. Spalling developing as a result of a spall mechanism suggested by McCullough et al. (10) is classified as a Type 1 spall (Figure 4). A Type 1 spall develops into an advanced stage when the pavement is broken out within the boundaries of the cracking. Although not in all cases, it was noted that Type 1 spalls tend to coincide with the longitudinal reinforcement in the pavement and can extend to a considerable depth into the pavement. Spalling of this nature that extends to the depth of the reinforcement severely reduces the aggregate interlock and may lead directly to punchout distress. It may also contribute to the Type 2 form of spalling shown in Figure 5 and can be classified as either minor or severe spalling as noted previously. These spalls tend to develop abruptly into a severe condition of spalling in a period of a few months. McCullough et al. (11) indicated that Type 2 spalling increases with crack spacing because of an increase in crack width. A low-severity form of Type 1 spall or concrete wearing also leads to widening of the crack width. The formation of longitudinal cracking is associated with spall development and concomitant loss of load transfer.

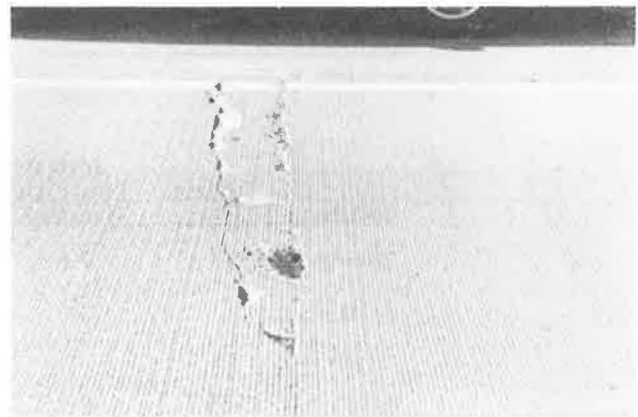
FIGURE 5 Type 2 spalling, I-39.

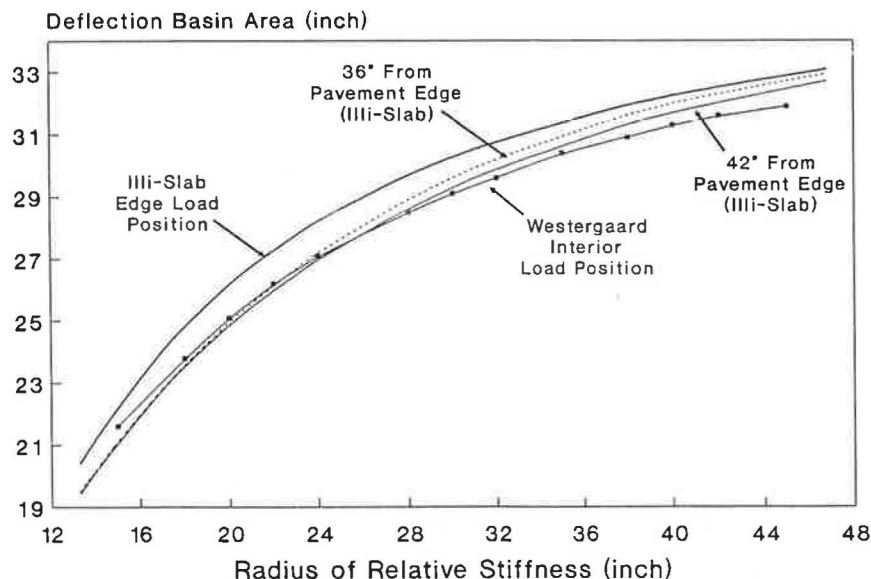
This backcalculation procedure can be accomplished for a range of thicknesses and load positions. The calculations for l_k using ILLI-SLAB analysis at the wheel path locations were found to be similar to those of the closed form curve obtained from the theoretical solution (19) of a case of a circular load and a dense liquid foundation for an interior loading condition. Consequently, the theoretical curve could possibly be used in place of the ILLI-SLAB generated curves. As stated earlier, the FWD wheel path testing position varied anywhere from 36 to 42 in. from the pavement edge. Given the deflection basin area from the FWD test results, the radius of relative stiffness can be obtained from Figure 10 for either the edge load or wheel path load positions for any pavement thickness.

The determination of unique E and K values is discussed elsewhere (19) from l_k values obtained from Figure 10 and Westergaard solutions (20) for slab-on-grade deflections at the edge and interior load positions. The theoretical interior loading solution is applied to the wheel path load position in the actual pavement since the load behavior between the two positions was shown to be similar.

FIGURE 10 Variation of deflection basin area with l_k .

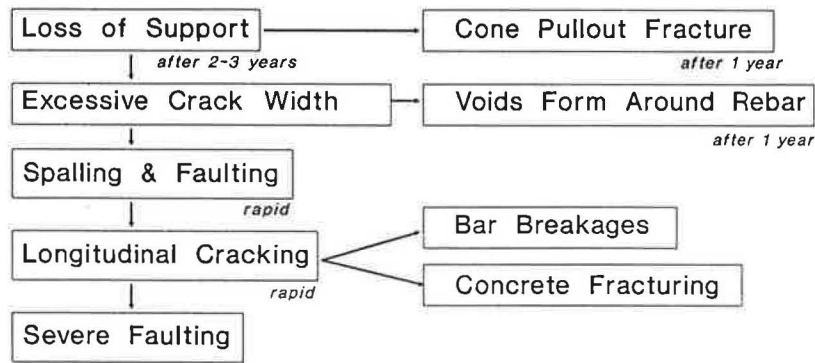
FIGURE 12 Morphology of punchout distress.

Based on an appraisal of the previously noted factors, a punchout mechanism is postulated. A schematic diagram of the formation of punchout distress is shown in Figure 12. This

diagram may apply to premature punchouts and those that occur at the end of the pavement life, depending on the cause of loss of load transfer. A noted prerequisite to punchout formation is the loss of subbase support. (This is particularly true in the case of premature punchout distress.) Support loss can develop in a number of ways. Support loss normally will develop if the subbase is susceptible to erosion when the necessary moisture conditions or discontinuities of load transfer or faulting in the subbase exist, all of which cause a non-uniform support condition in the pavement system. Stabilized subbases may also erode if they become or are weakened in the upper surface. Weakening may occur from poor compaction or poor strength gain. Wet subgrade conditions can also contribute to nonuniform support. Loss of support, depending on its nature, can develop as early as 2 to 3 years. The time for punchout development may be more dependent on the length of time associated with the development of unsupported conditions rather than the given pavement thickness (within the range of thicknesses, subbases and levels of traffic

A reduction in bending stiffness at the transverse cracks can cause spalling and faulting, leading to a loss of load transfer. After load transfer is lost, longitudinal cracking can form quickly—possibly simultaneously. The formation of a longitudinal crack should not be considered as the cause of the punchout but only a consequence of it. Type 2 spalling leads to a significant reduction in load transfer across the transverse cracks, which, as pointed out above, dramatically increases the stresses that lead to longitudinal cracking. Rebar breakages and pavement delamination are consequences of the above processes and are the result of loss of load transfer. Rebar breakages can occur either at the crack face or displaced from it. The breaks at the crack face are usually a consequence of corrosion, which reduces the cross-sectional area of the bar. This corrosion weakens the bar and makes it susceptible to an abrupt tensile failure caused by temperature contraction or wheel load-induced shear stress. This process may begin on the pavement edge, leading to a widened crack there, and proceeding to the next bar until the entire lane is encompassed. Consequently, a wide and faulted crack develops. The

bar breakages displaced from the crack face are load induced and fatigue related. Stresses forming this break are not great enough until most of the load transfer from aggregate interlock is lost. Once the bar has failed, the faulting can progress rapidly to a severe level since the reinforcement was transferring most of the load before failure. If the crack spacing is short, as in the case of a Y-crack, the rebar may not fail, which may lead to delamination and deep spalling of the concrete pavement above the reinforcement.
