Bridge Superstructure Rehabilitation and Strengthening

FRIEDER SEIBLE, M. J. NIGEL PRIESTLEY, AND KOSALRAM KRISHNAN

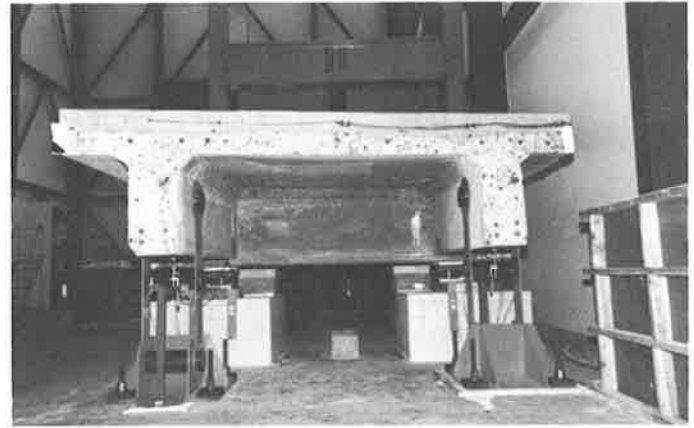
FIGURE 2 Gepford overhead bridge section laboratory setup

Point loads were applied at midspan with a MTS servo controlled actuator reacted against a four column load frame depicted in Fig. 2. The load was applied in increments of the AASHTO-83 [5] HS-20 basic maximum wheel load of $P_{20} = 16,000$ lbs. without impact allowance. The 8 inch by 20 inch loading area was based on AASHTO-83, Section 3.3 tire contact area of $A = 0.01 P_{20}$ [in²] or 160 in² with a 1:2.5 aspect ratio. At full multiples of the P_{20} load, three cycles of unloading and reloading were performed to simulate three traffic cycles at that particular load. The point load tests were primarily used to establish comparative load deformation or stiffness characteristics between adjacent girders.

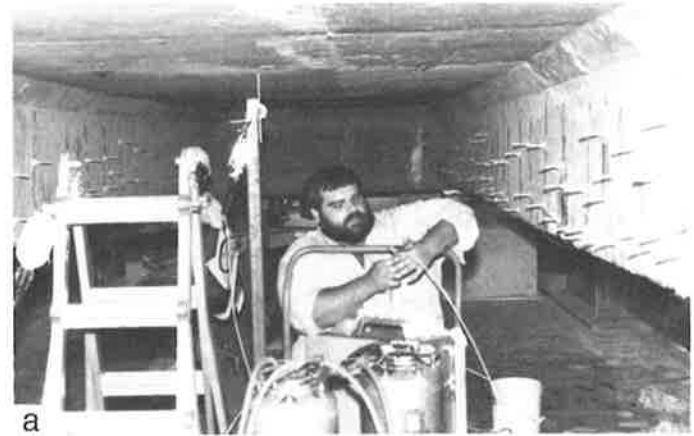
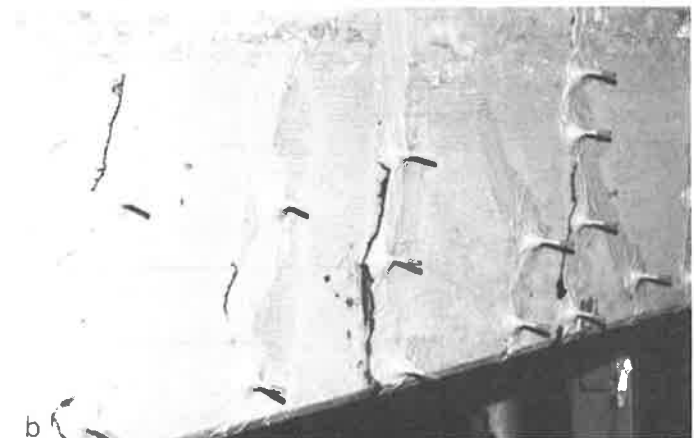
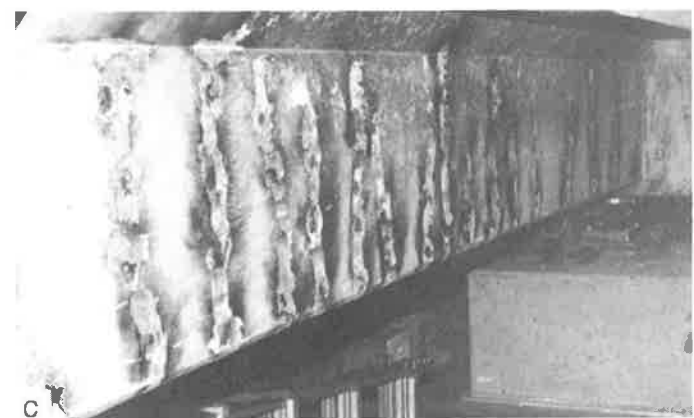
placed every 10 to 12 inches along the length of the crack, as shown in Fig. 3(a). The port spacing corresponds approximately to the web thickness to ensure adequate epoxy penetration through the cracks. A two component, rapid curing, smooth paste epoxy gel was used to seal the cracks and secure the injection ports to the cracks prior to pressure grouting. Upon curing of the epoxy seal (approximately two hours), a two component, low viscosity, high strength epoxy adhesive was used for pressure injection of the flexural cracks. Injection started at the lowermost injection port on each crack and progressed from port to port, as soon as epoxy emerged from the next higher port along the crack or a pressure of 100-150 psi was sustained at one port for 30 seconds without the flow of epoxy. Injection was not essential at all ports; if the resin flow was good, the interim ports were only used to monitor penetration. Upon curing of the epoxy adhesive (approximately 1-2 days), the epoxy seal around the cracks was burnt off with a gas torch and the residues scraped off leaving a smooth but discolored surface as indicated in Figs. 3(b) and 3(c).

FIGURE 3 Epoxy injection of flexural cracks

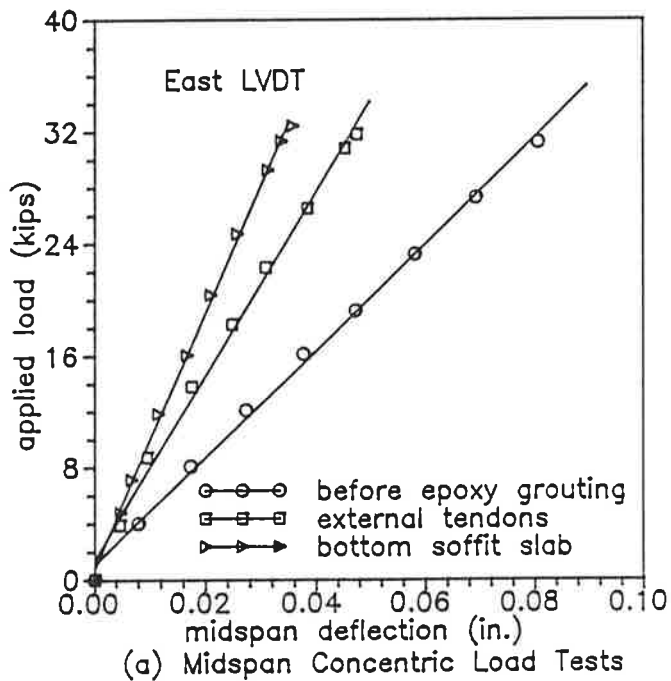
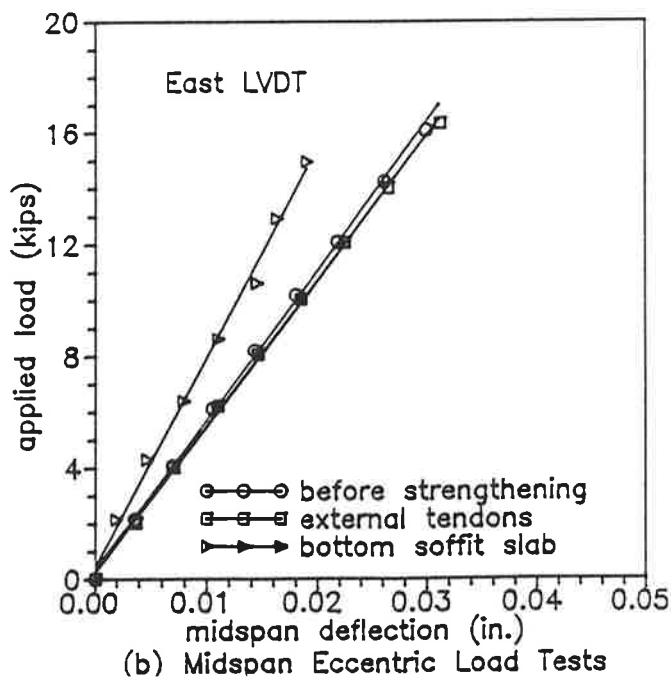
FIGURE 5 Stiffness characteristics of the test section

The longitudinal stiffness increases due to the overlay application and continuous support conditions were expected but the most striking result was obtained from the epoxy injection of the flexural cracks, where a substantial stiffness increase was noticed, see Fig. 5(a). This stiffness increase can be completely attributed to the epoxy injection since no additional stiffness increase resulted from the external post-tensioning as is evident from Fig. 5(b).

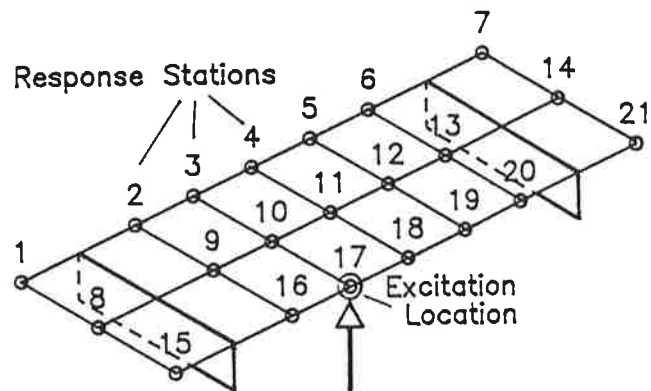
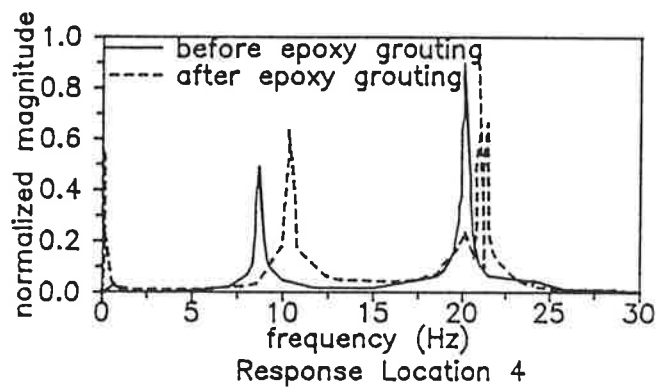
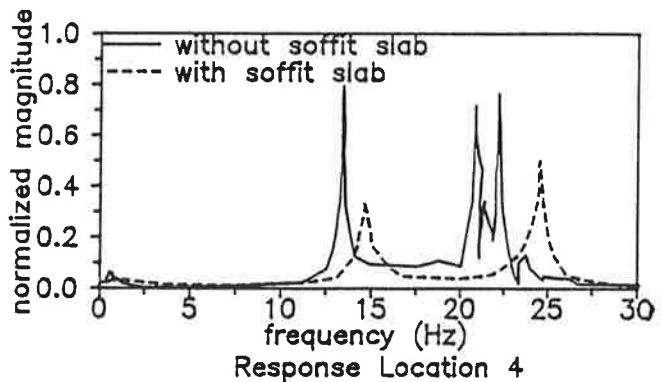
FIGURE 6 Change in dynamic response characteristics

A numerical evaluation of the first two natural frequencies obtained from the forced vibration tests conducted and the various support conditions are presented in Table 1. The most striking result can be found in a 15% frequency increase in the first mode of the simply supported bridge structure due to epoxy grouting of the flexural cracks, from 8.80 Hz to 10.42 Hz, whereas virtually no additional stiffness increase was observed due to external prestressing. Gluing a thin precast slab panel to the bottom of the double-Tee bridge section increased the fundamental frequency from 13.23 Hz to 14.5 Hz, thereby indicating an increased longitudinal stiffness. A significant increase in the transverse load distribution characteristic was also noted by the change in the second mode frequency from 20.9 Hz to 24.4 Hz on the addition of the precast bottom soffit panel, since the transverse flexible T-girder deck was transformed into a stiff box girder with highly improved torsional characteristics. However, no transverse stiffness increase was noticed due to the epoxy injection of the flexural girder cracks or external prestressing. The shift in the natural frequency is graphically depicted for a midspan response station in Fig. 6. These low level dynamic systems identification results are currently correlated to service and overload test results as well as comprehensive analytical modeling to quantify the effectiveness of rehabilitation measures based on nondestructive systems evaluation.

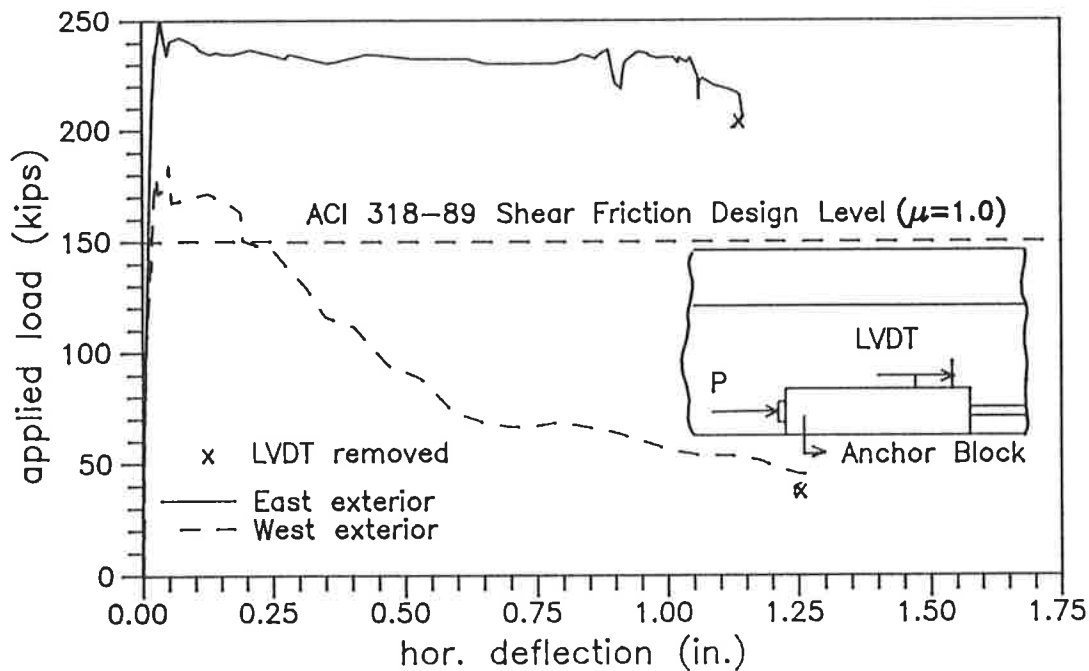
FIGURE 9 Anchor block-ultimate load test response

Finally, ultimate load tests were conducted on the west and east exterior anchor blocks added for the external post-tensioning strengthening measure, see Fig. 4(a), to investigate ultimate limit state characteristics for different anchoring procedures. The west exterior anchor block had 16 # 4 dowels anchored in 6 in. deep inclined holes and grouted with Type II modified Portland cement grout. The east exterior anchor block had 16 # 4 through dowels anchored in horizontally drilled holes, grouted by epoxy injection. The anchor blocks were sheared off with calibrated hollow core jacks and the horizontal anchor block movement as well as the dowel strains were monitored. Fig. 9 depicts the load versus horizontal displacement relationship obtained for the two different anchoring procedures together with the ACI shear friction design level. It is evident that the anchor blocks performed adequate with respect to the shear friction design value. However, the through dowels exhibited a ductile behavior while the set dowels resulted in anchor block slip with significant capacity loss, see Fig. 9, due to slip in the dowel anchorage.
