TRANSPORTATION RESEARCH
RECORD

No. 1290

**Third
Bridge Engineering
Conference**

*Papers presented at the
Third Bridge Engineering
Conference
March 10-13, 1991
Denver, Colorado*

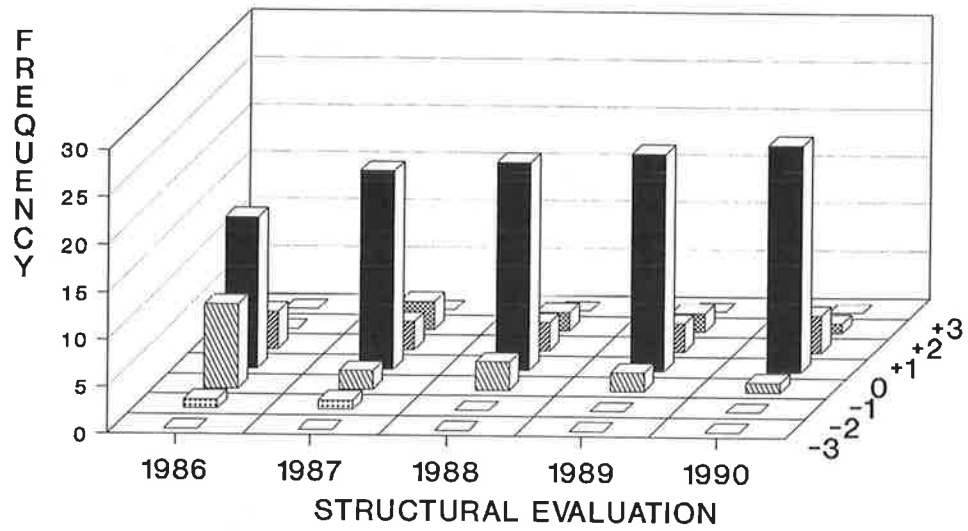
EXHIBIT 3 DIFFERENCE BETWEEN QUALITY ASSURANCE REVIEW AND DISTRICT RATINGS

NOTE: + Indicates District rating greater than review

Exhibit 1 illustrates the correlation in all the numerical condition and appraisal ratings for a single district QA review. Exhibit 2 illustrates the correlation with the QA team for all the districts in the state for the same inspection item. Exhibit 3 illustrates the average statewide correlation on one inspection item with the QA team per year for a five-year span.

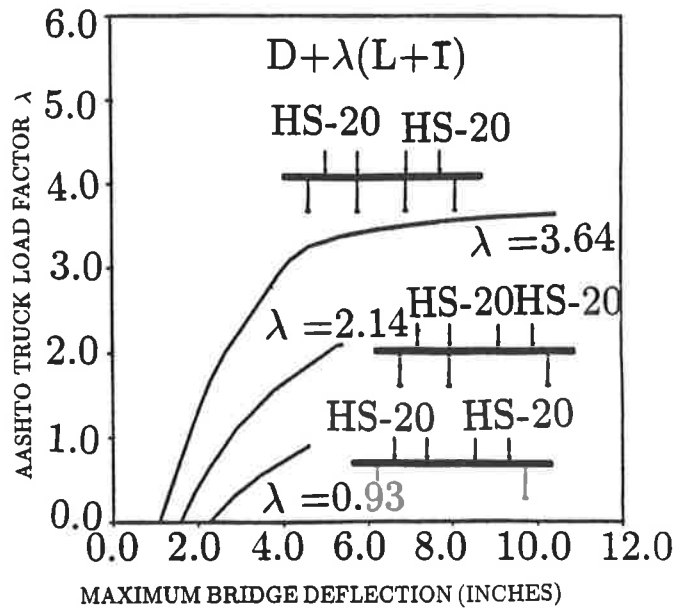
FIGURE 2 Load-deflection response for accidental damage scenarios.

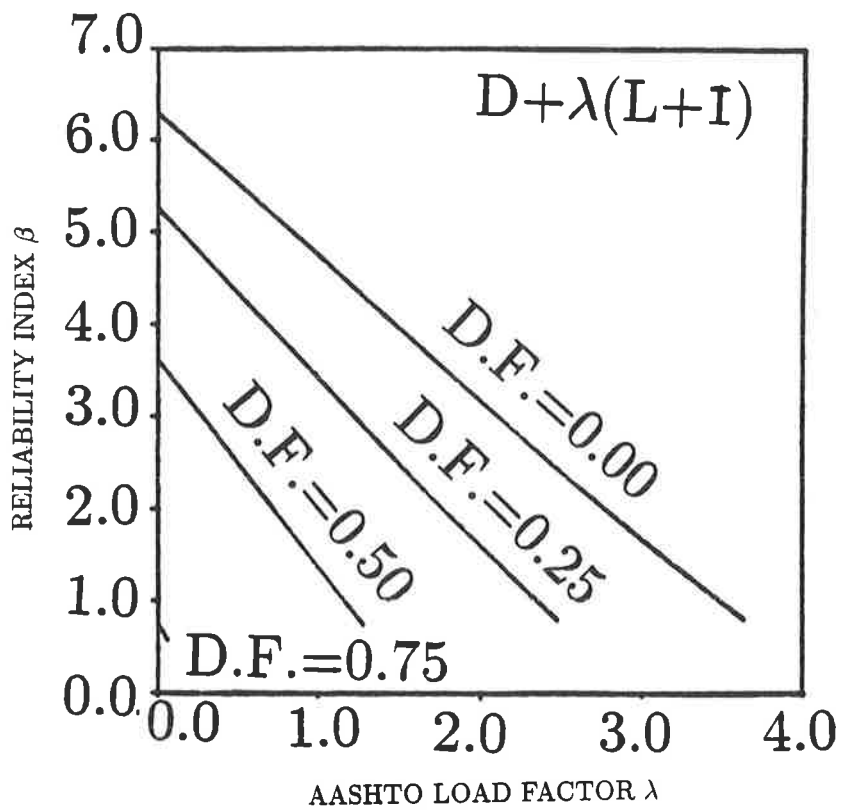
FIGURE 3 Bridge reliability index under incremental loading and corrosion damage states.

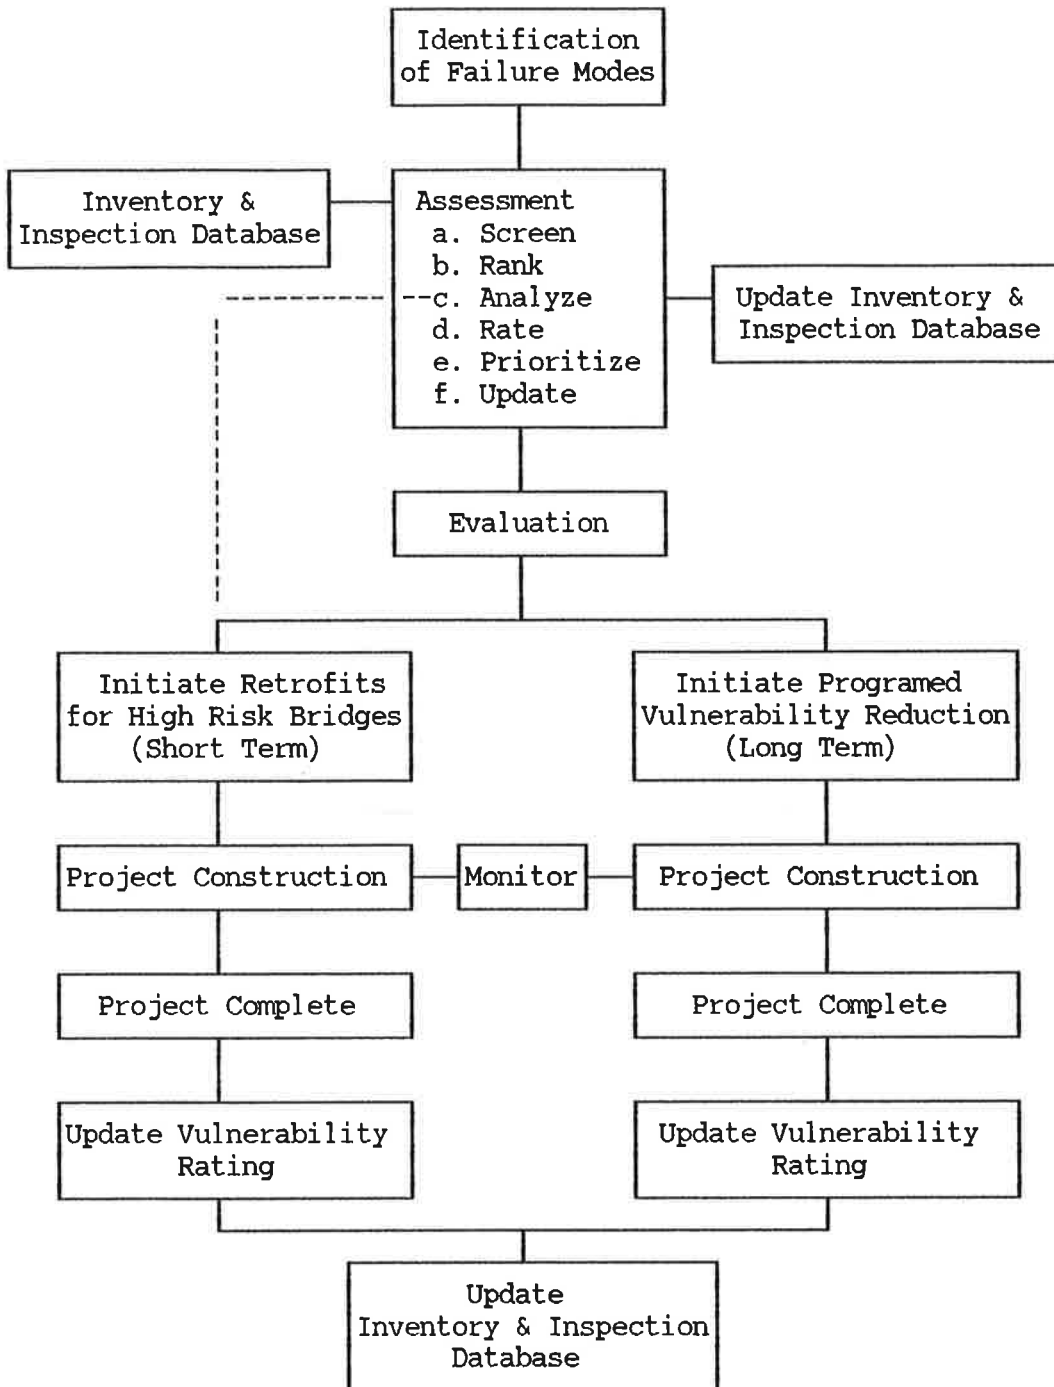
FIGURE 4. BRIDGE SAFETY ASSURANCE IMPLEMENTATION FLOWCHART.

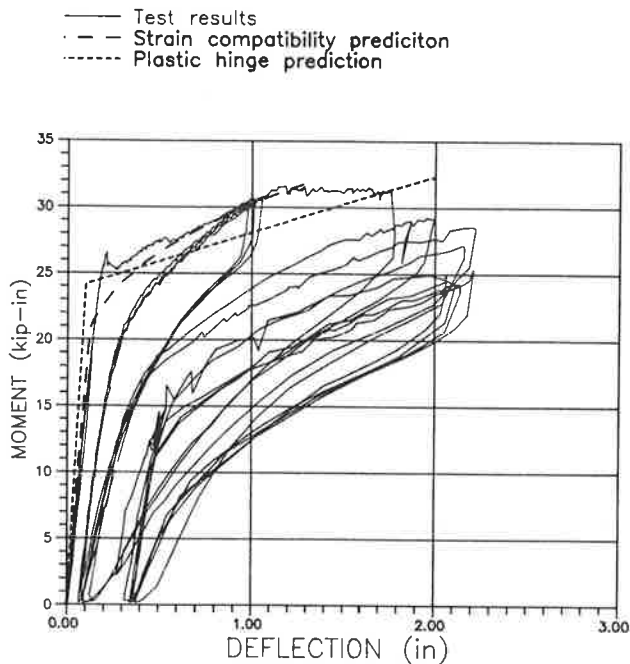
FIGURE 6 Moment Deflection Curve for a Beam with Unbonded Tendons

The unbonded tendons specimens failed when the concrete exceeded its ultimate strain capacity. After initial crushing of the concrete, the sections continued to carry load, although the initial moment capacities were never regained. The test frame limited the total beam deflection, therefore it was not possible to strain the tendons to failure. Figure 6 shows a typical moment deflection curve for a six rod unbonded tendon system. The section was cycled several times after the initial failure. Deterioration of the section is evident by the gradual loss of deflection and strength capacity.

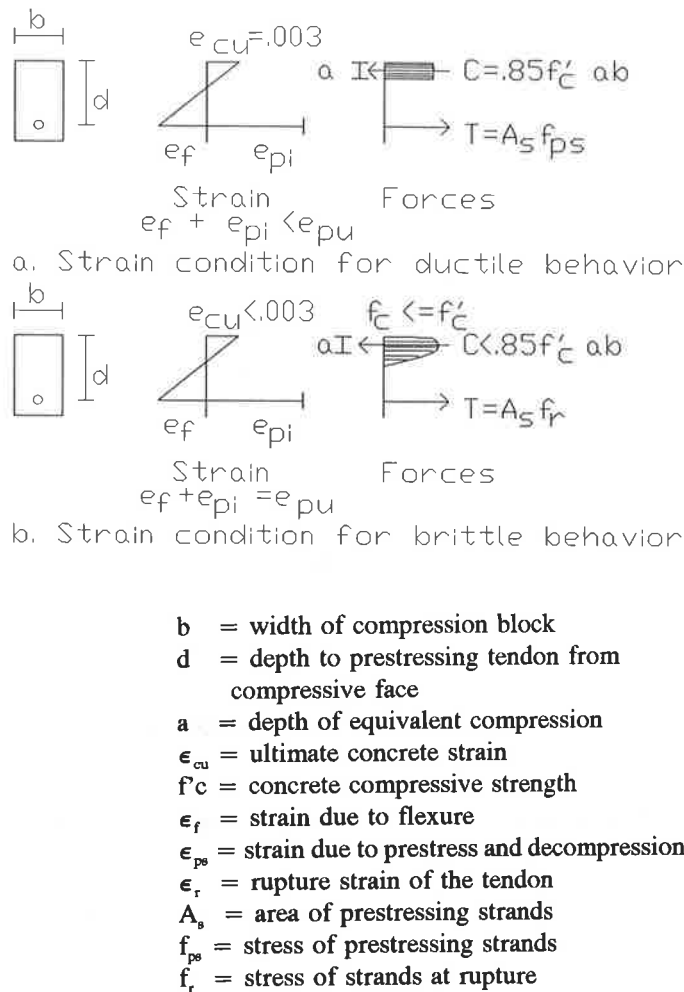
FIGURE 9 Schematic representation of the strain compatibility of composite tendons in prestressed flexural member design.

The concept of strain compatibility has been prevalent in concrete design for decades. The brittle nature of composite tendons suggests that strain compatibility must be extended to the design of the tension reinforcement in addition to the limitations imposed on the concrete compressive strain. This is a direct result of the lack of an extended yield zone to provide a large tensile strain capacity. The highly uniform strain to failure behavior of composites suggests that a strain approach to strength prediction is desirable. Depending upon the location of the neutral axis, the depth of the structure and the structural configuration, the tendon may remain elastic, or it may exceed its ultimate strain capacity. Figure 9 indicates the possible stress and strain conditions which may occur in a concrete section reinforced with a composite tendon.

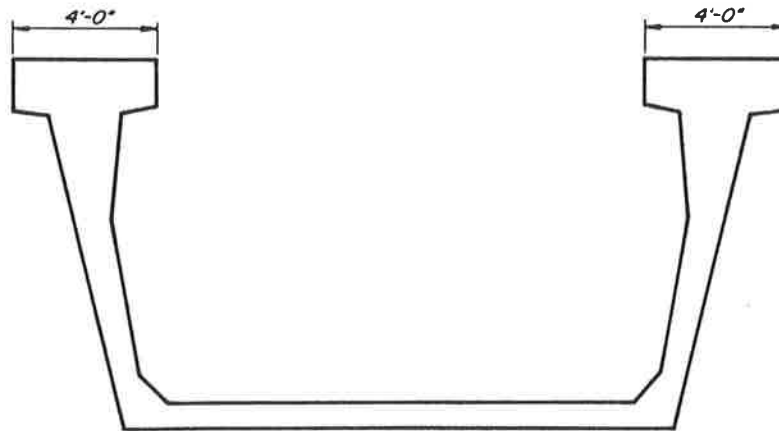
CROSS SECTION DURING DECK REPLACEMENT OPERATIONS

Typical cross-sections during replacement.

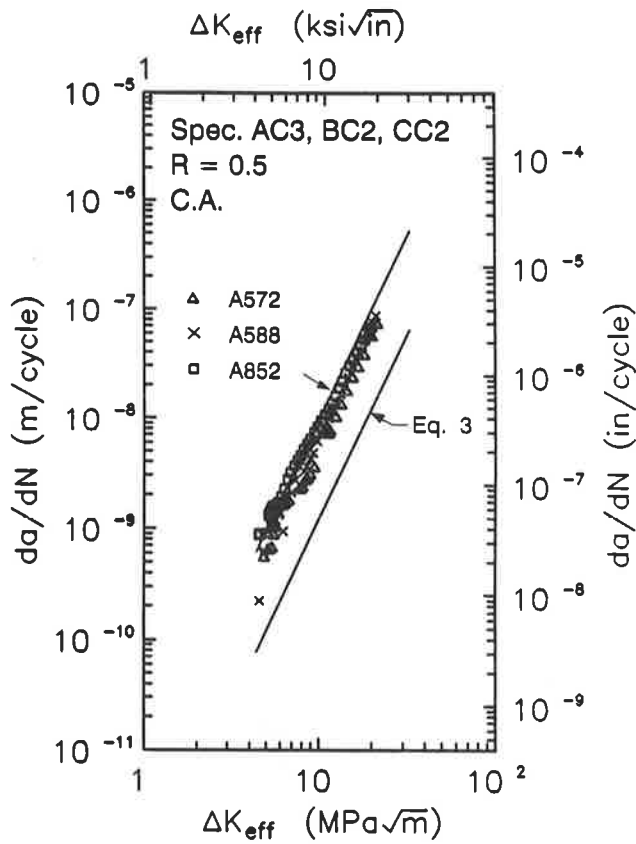
FIGURE 10 Comparison of crack growth rate for all steels at R = 0.5.

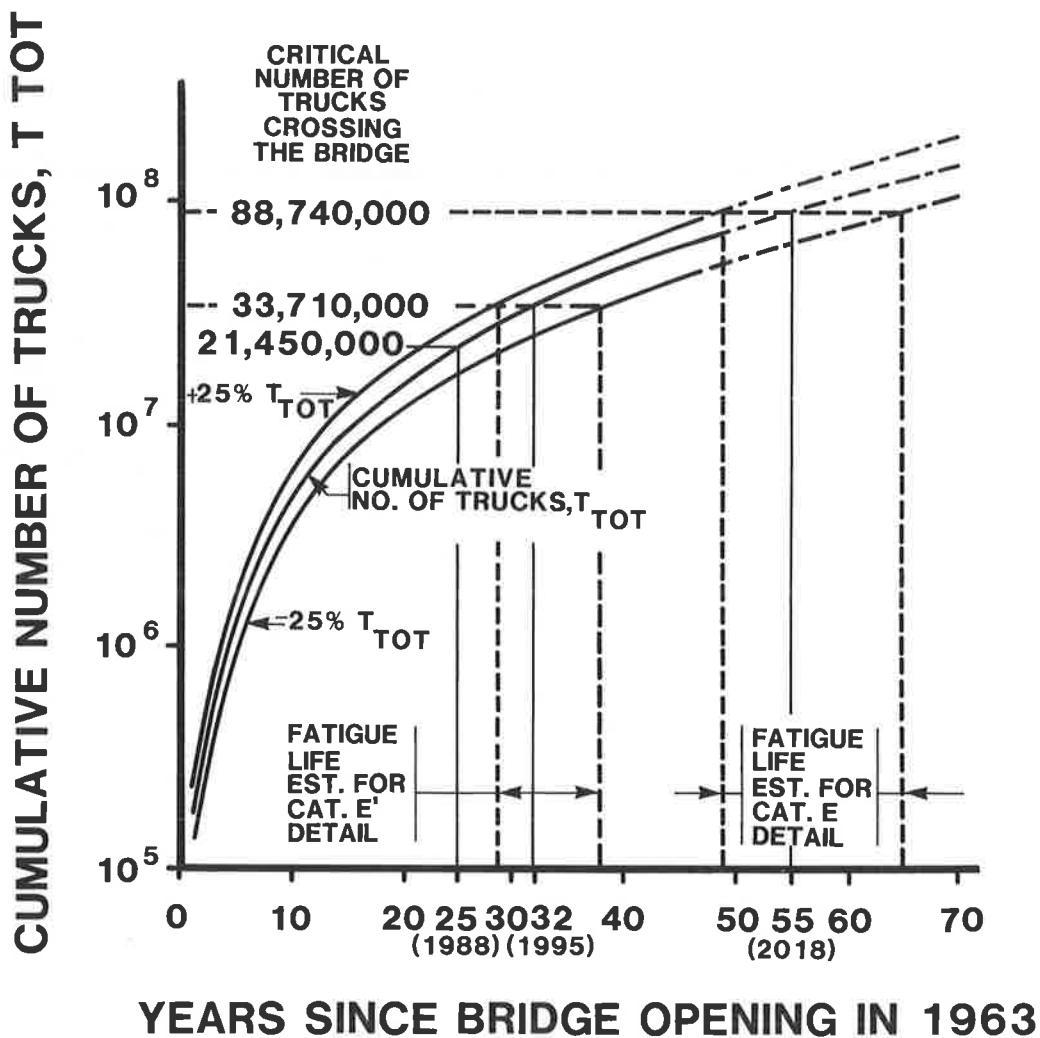
FIGURE 10 Fatigue life estimates.
