# Cross Sections and Pavement Subdrainage of Low-Volume Roads in Madagascar

JOSÉ CARLOS DE O. S. HORTA

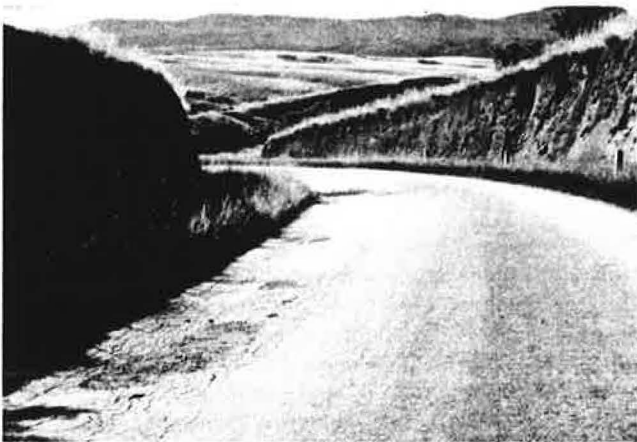
**FIGURE 2** Longitudinal cracks and settlements along the shoulder, typical of poorly drained pavement.

In the absence of appropriate pavement subdrainage, water may seep into the pavement system and flow along the transverse grade to the pavement edges as well as along the longitudinal gradient to low sections. Where impervious shoulders oppose flow, seepage of water into the subbase and the subgrade results in a loss of bearing capacity and traffic loads produce longitudinal settlement and cracks along the shoulders (Figure 2). This combination of distress types is characteristic of poorly drained pavements. In straight alignments, water-related distress develops along both pavement edges but in curves it only develops along the lower shoulder.

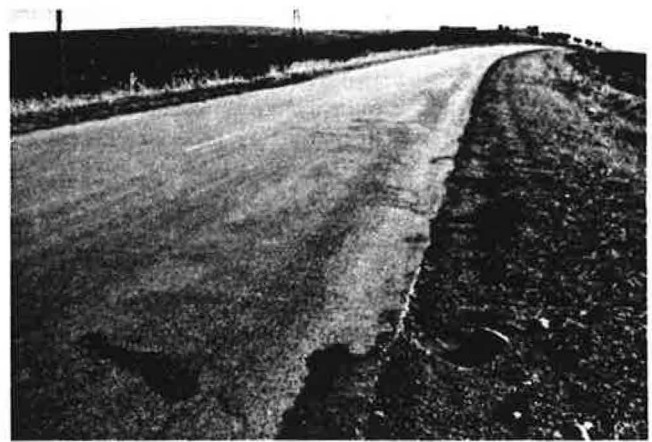
**FIGURE 3** Edge settlement and water outflow through longitudinal cracks.
