# Reduced Tire Inflation Pressure—A Solution for Marginal-Quality Road Construction Rock in Southeast Alaska

BILL POWELL AND BRUCE BRUNETTE

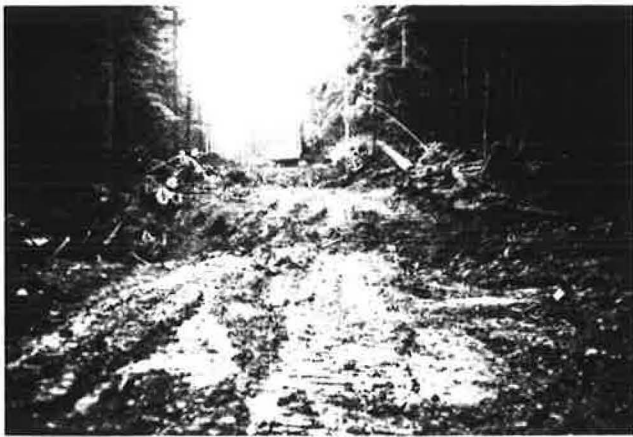
FIGURE 1 Road subgrade preparation.

levels the saturated subgrade material to the pioneer-grade elevations. Because the saturated excavated material is usually too weak to be incorporated into the road embankment, and rain frequency makes drying impractical, most of the roadway excavation is wasted. During pioneer operations, the hydraulic backhoe incorporates the clearing debris, such as limbs, tree tops, cull logs and stumps, into the prepared subgrade as a debris-reinforced mat. Once the subgrade is prepared, pit-run quarry rock is end-dumped on the debris-reinforced mat and spread with a bulldozer. The depth of rock on the finished road typically ranges between 30 and 48 in., except occasional weak muskeg may require more rock, sometimes exceeding 10 ft. Road surface failures can be caused either by inadequate subgrade support or the degradation of rock borrow materials. Photographs of the construction of the Toncan timber sale road, which is typical in Southeast Alaska, are shown on Figures 1–3.

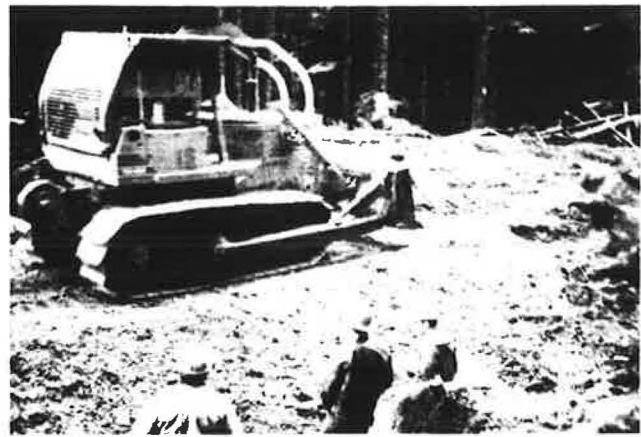
FIGURE 3 Bulldozer used to shape desired road prism.

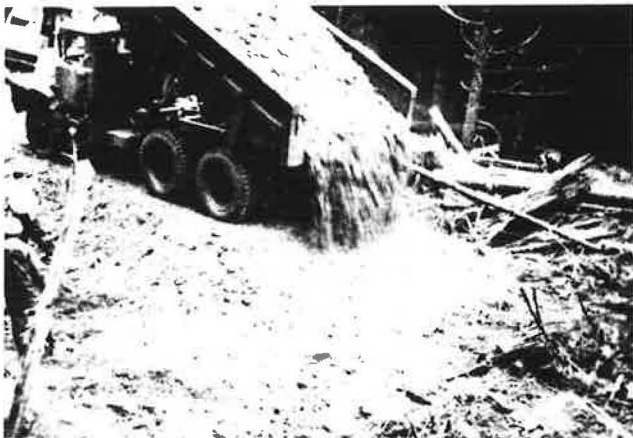
FIGURE 2 End-dumping rock used for road construction.

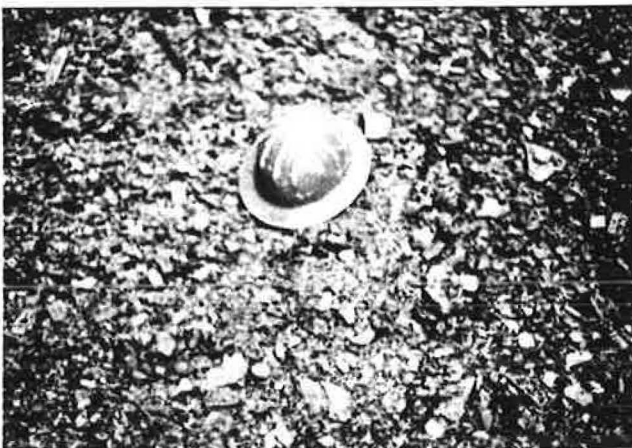
FIGURE 6 Rock borrow after initial placement.

formance of the material. Figure 6 shows the conditions of the rock after the initial placement, and Figure 7 shows the conditions during rock haul.

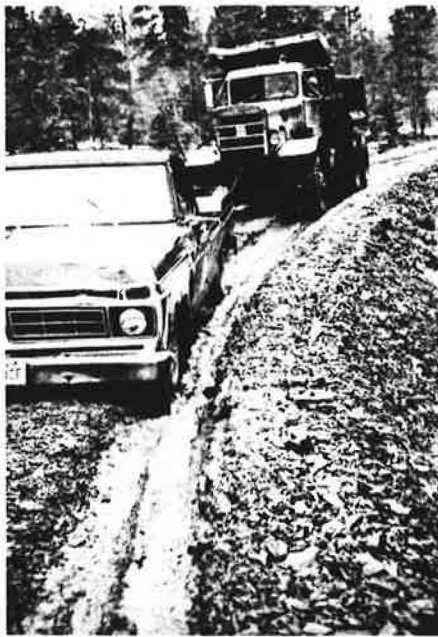
**FIGURE 7** Deep ruts resulting from construction haul.

Severe rock degradation was experienced during rock haul. This process, concurrent with heavy rainfall, resulted in 12- to 18-in.-deep ruts, excessive sedimentation, and daily blading was required to continue operations. During some periods of heavy rainfall, haul operations could not continue for an entire day without performing maintenance because of the poor per-

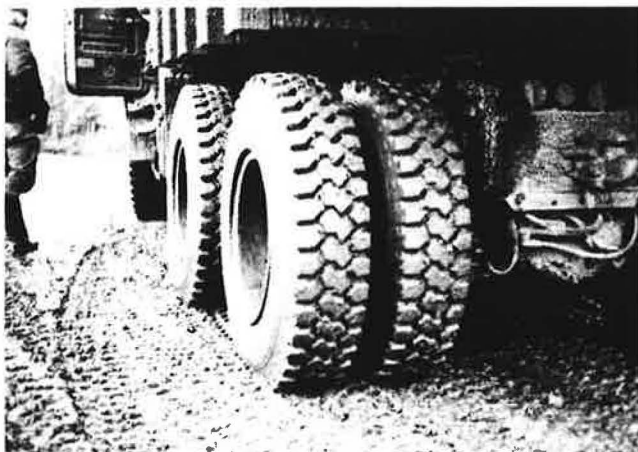
**FIGURE 8** Mounted 12.00R24 radial tires.

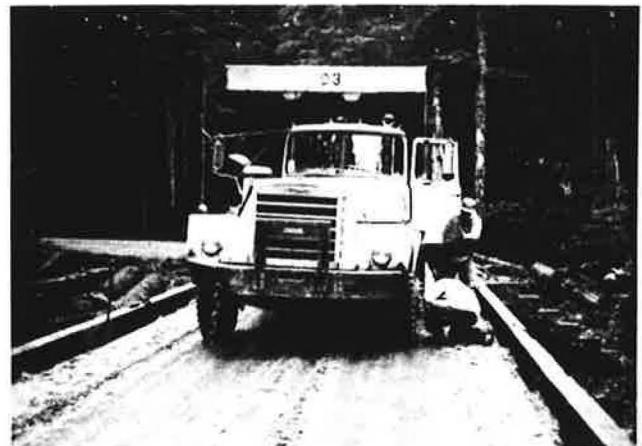
**FIGURE 9** Bridge deck used for setting pressures and deflections.

using a large caliper to measure tire section heights as shown in Figure 9. The final tire pressures varied because of the different load capacity of the trucks used on the project as well as the difference between front- and rear-axle loading. Final pressures selected ranged from 42 to 62 pounds per square inch (psi). Normal tire inflation pressures of 100 to 110 psi are used for the same tire and load.

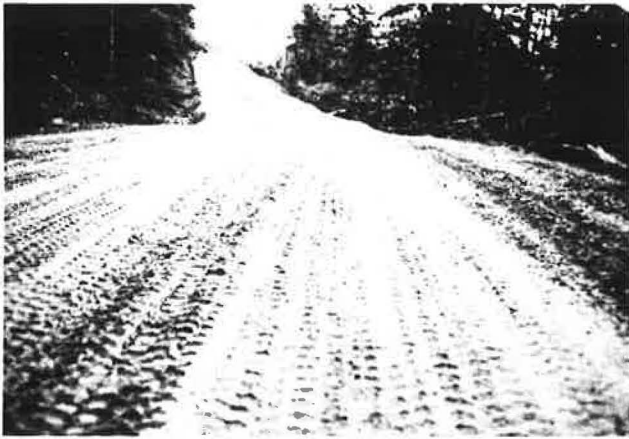
FIGURE 10 Resulting road surface, full-width travel.

similarly to pneumatic rollers and compacted the road surface, rather than producing deep agitation of the road base. Where road widths allowed, the drivers varied the wheel path of the construction vehicles that served to compact and seal the entire roadway, effectively preventing further moisture infiltration, as shown in Figure 10. In narrower road segments, typically on steep 10 to 15 percent grades, traffic was concentrated to a confined wheel path and some rutting did develop (see Figure 11). However, measured rut depth rarely exceeded 4 in. The road contractor was extremely pleased with the results and elected to equip his entire log haul fleet with radial tires to take advantage of the reduced road damage and maintenance.

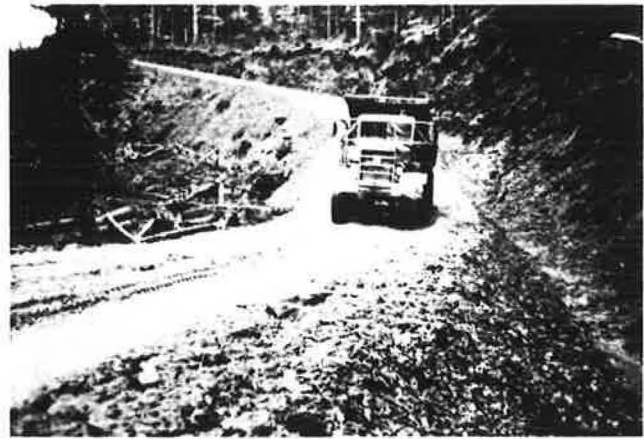
FIGURE 11 Maximum rutting where trucks could not vary wheel path.
