TRANSPORTATION RESEARCH BOARD
RECORD

No. 1291
Volume 2

**Fifth International
Conference on
Low-Volume Roads
1991**

*Papers presented at the
Fifth International
Conference on Low-Volume Roads
May 19-23, 1991
Raleigh, North Carolina*

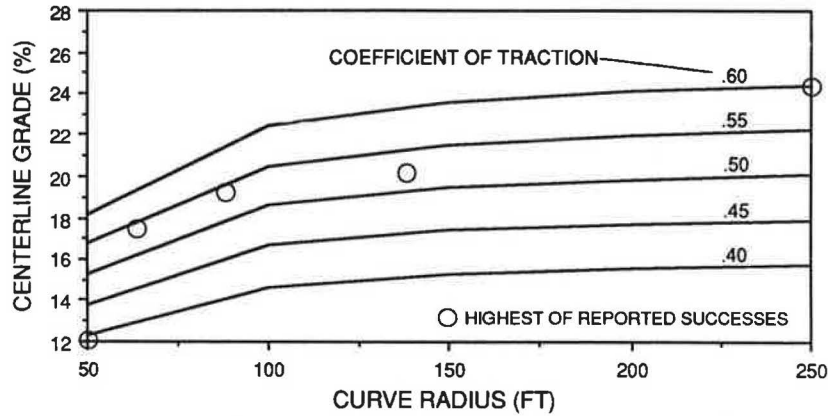
FIGURE 5 Gradeability as a function of traction coefficient, curve radius, and zero superelevation. Points of highest reported successful operations are identified.

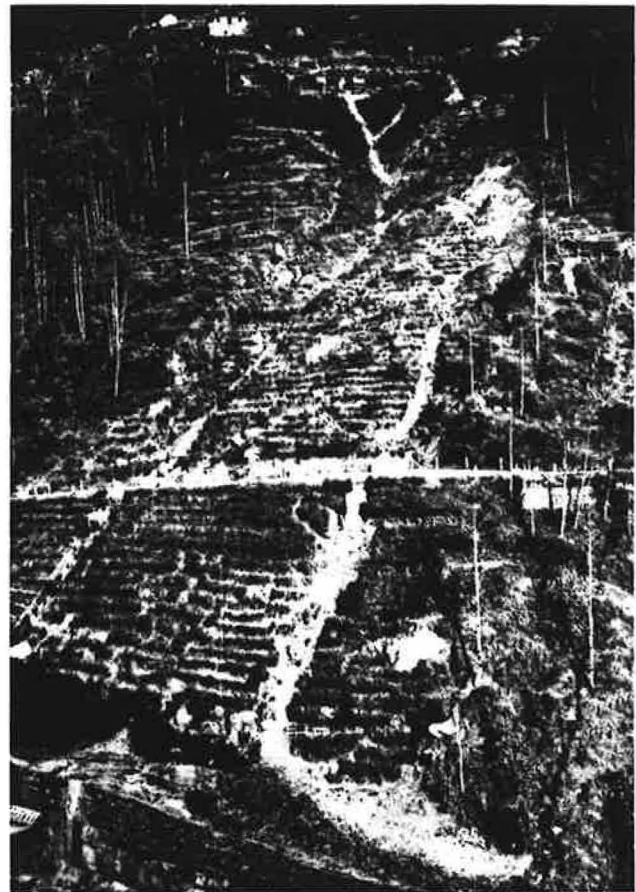
FIGURE 7 Stabilized slide at Charnawati left bank, Km 45.1. Two main drains crossing the road are supported by the gabion guidewall at the river.

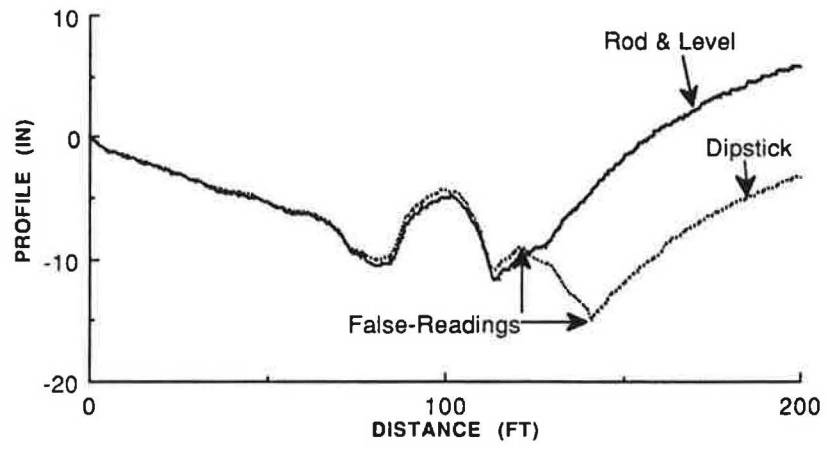
FIGURE 2 Dipstick data with false readings versus rod-and-level survey.

False readings represent the most serious problem in the auto-read version of the dipstick. False readings can cause the reported direction of the pavement's design slope to change several times during a single survey run. Figures 2–4 show

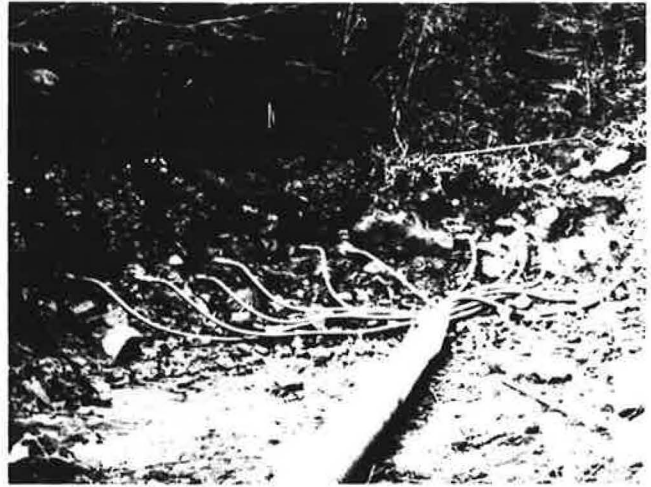
FIGURE 1 Collector system intake point.

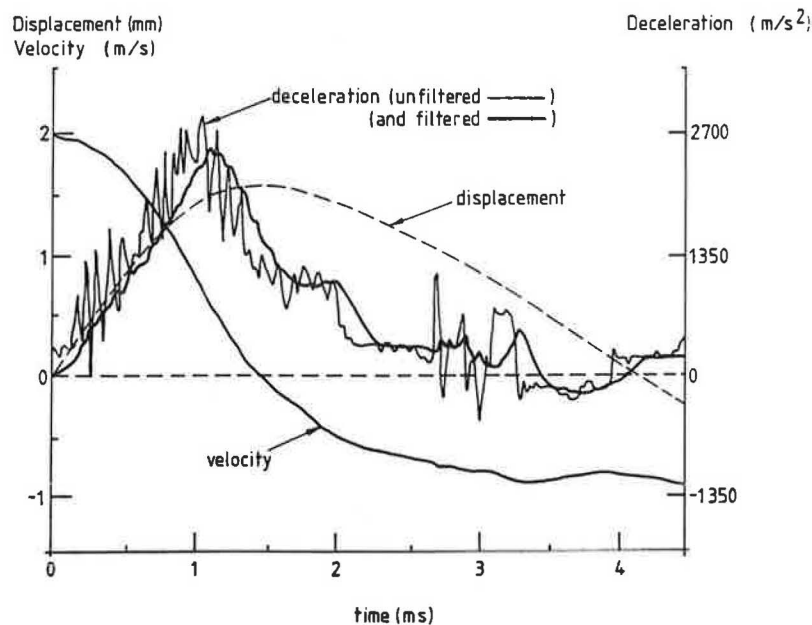
FIGURE 3 Typical unfiltered, filtered, and integrated accelerometer signal on impact.

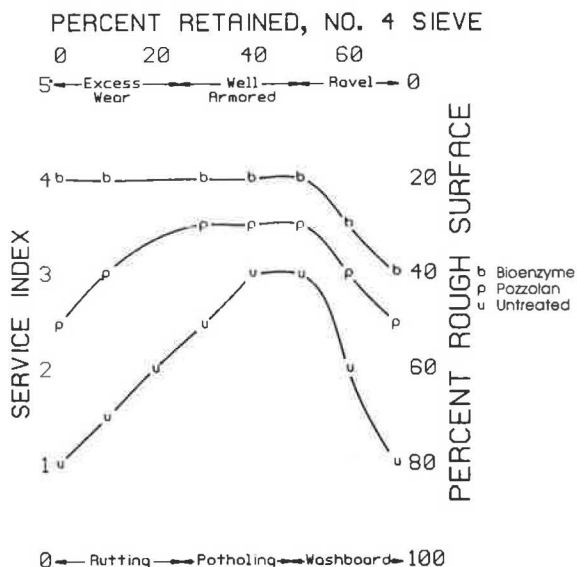
FIGURE 1 Performance of treated surfaces as related to percentage of coarse material in aggregate.

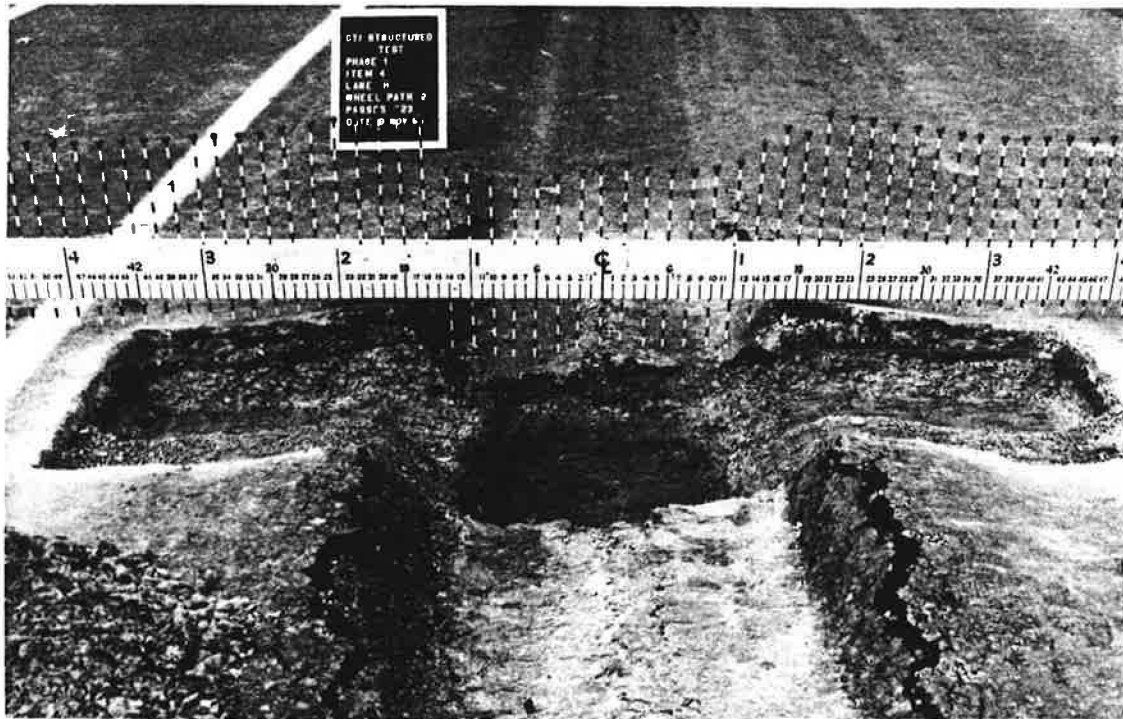
FIGURE 6 High-pressure lane, Section 4, test trench after 323 passes.

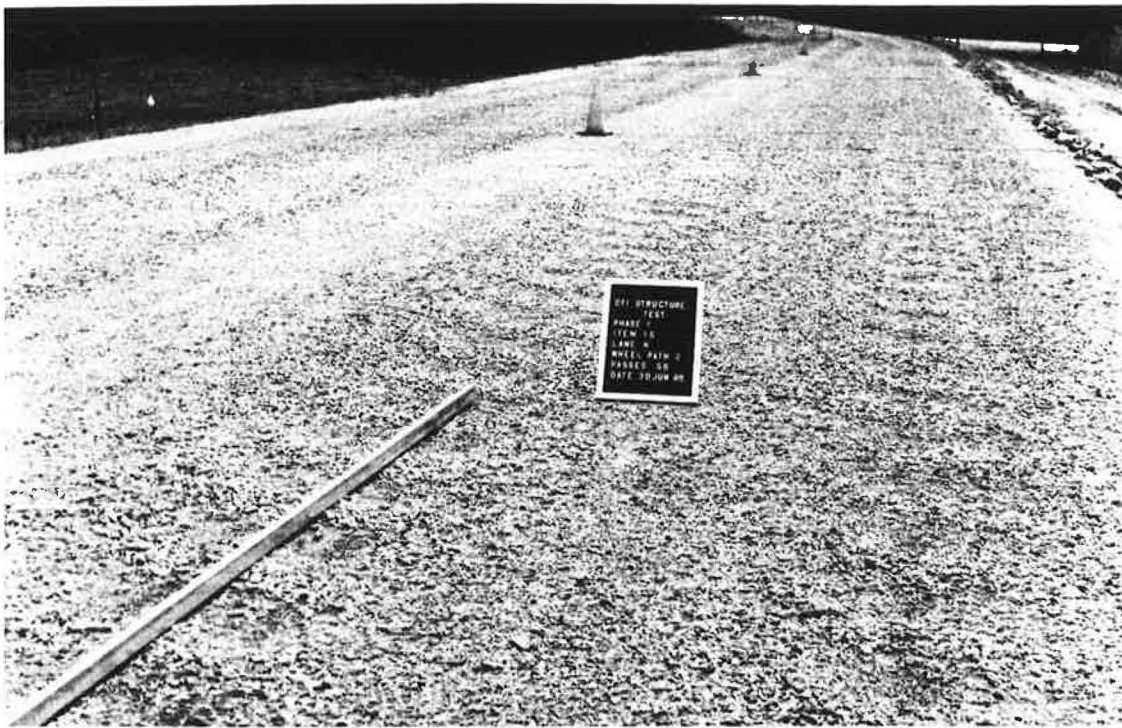
FIGURE 11 High-pressure lane, Section 15, low-severity washboarding, after 58 passes.
