TRANSPORTATION RESEARCH
RECORD

No. 1300

**Asphalt Pavement and
Surface Treatments:
Construction and
Performance
1991**

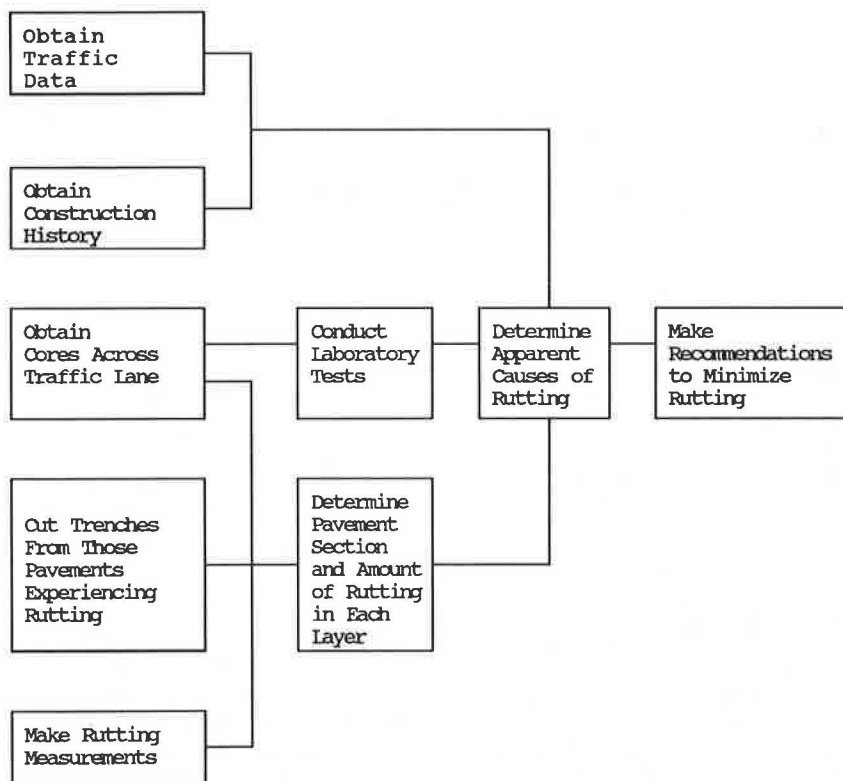
FIGURE 1 Test plan.

The test plan for the rutting study is shown in Figure 1. A complete listing of the overall test plan can be found elsewhere (5). The field testing consisted of obtaining 4- and 6-in.-diameter cores, measuring rut depths, and, in a majority of the rutted pavements, viewing the pavement layers in a trench cut across the traffic lane. In general, 11 to 12 cores were obtained on 1-ft intervals across the traffic lane at each site. The 4-in. cores were saved for further testing. The 6-in. cores were tested, and the relevant results are reported herein.

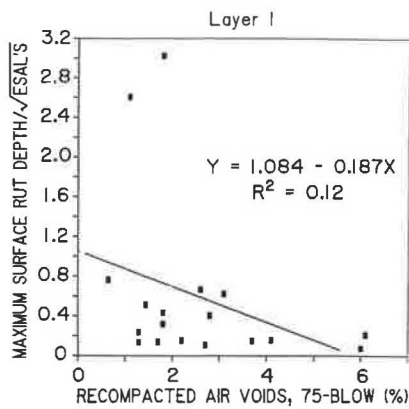
FIGURE 2 75-blow recompact air-void content versus maximum surface rut depth divided by the square root of traffic in million ESALs.

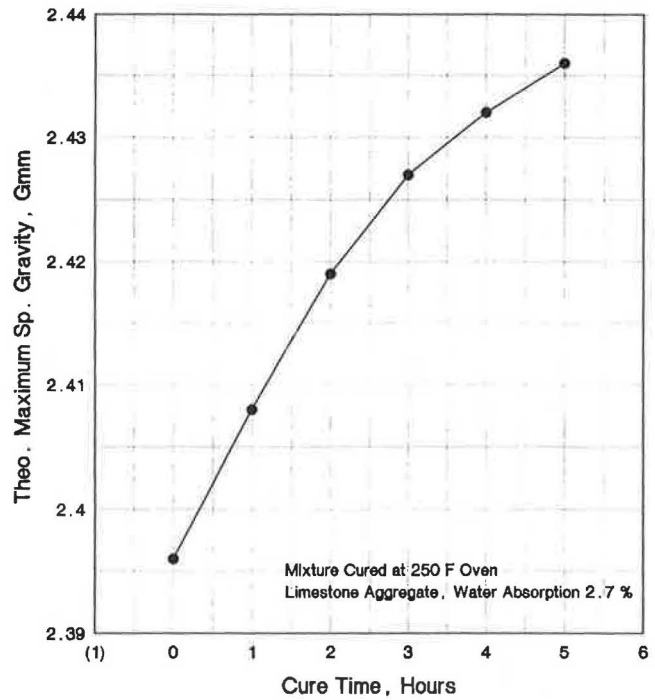
FIGURE 5 Influence of curing time on *Gmm* determination (Rice method).

This hypothesis was tested for a mixture in the *Mmm* category. Figure 5 shows the result. Loose samples were mixed and placed in an oven according to the Martin procedure. Using the Rice procedure, *Gmm* was determined for the samples at 1, 2, 3, 4, and 5 hr. An additional sample was tested immediately after mixing and cooling. Use of *Gmm* within the range shown would result in as much as 2 percent difference in the calculated air-void content. Based on this experience, all loose mixes used to determine Rice's *Gmm* were oven-cured for 2 hr at 250°F.

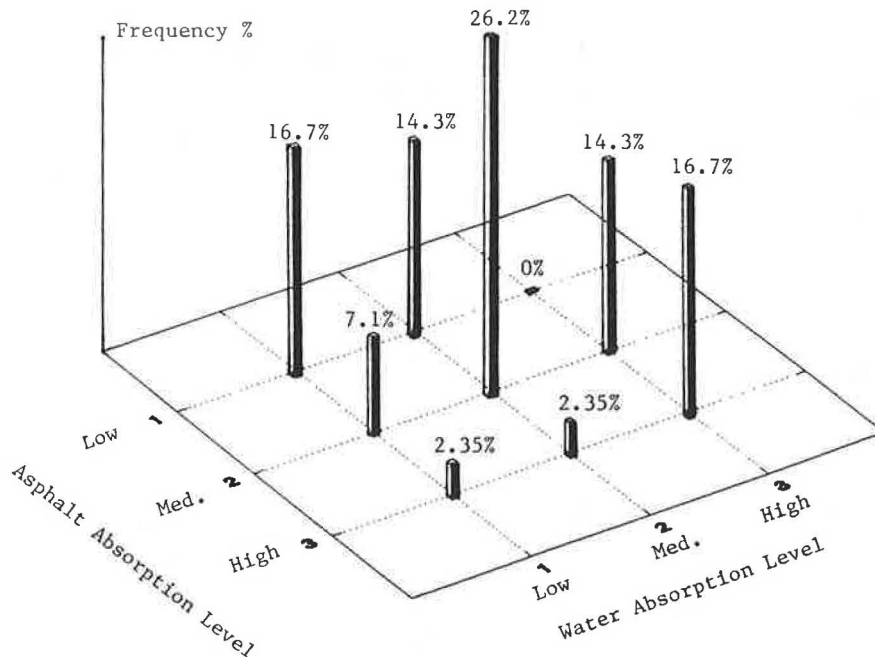
FIGURE 4 Frequency of occurrence of specific mix groups.

This grouping indicates that mix group *Mmm* (medium water and medium asphalt absorption) was the most likely to occur. As expected, no mix fell within the group *Mhl*, and only one mix was found in each of the groups *Mlh* and *Mmh*.

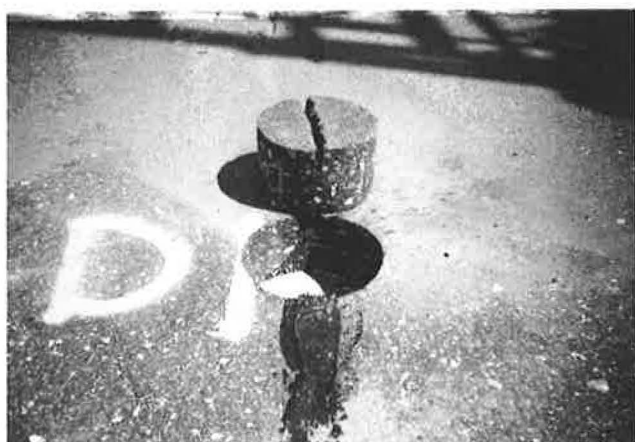
FIGURE 7 Core of transverse crack taken from low side of superelevated curve in Section 2.

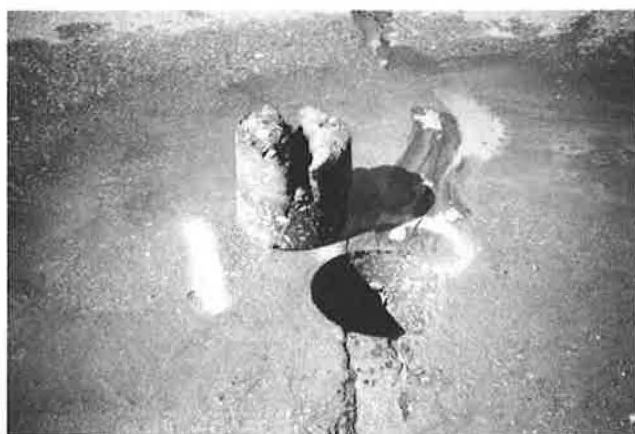
FIGURE 8 Core of transverse cracks in Section 1.

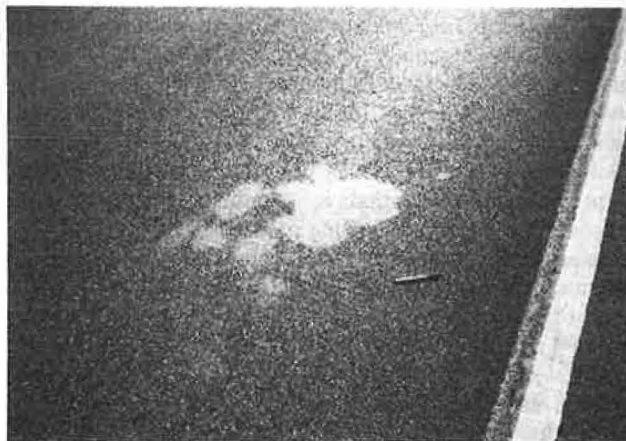
FIGURE 3 Typical localized bleeding area, northbound lanes of I-55 near Collinsville, Ill.

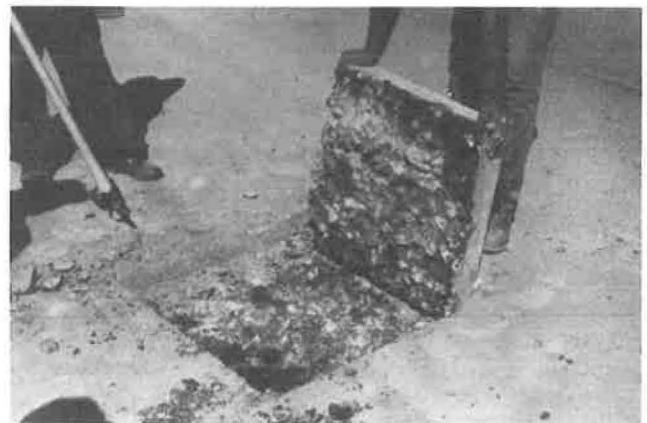
FIGURE 4 Typical pavement sample.

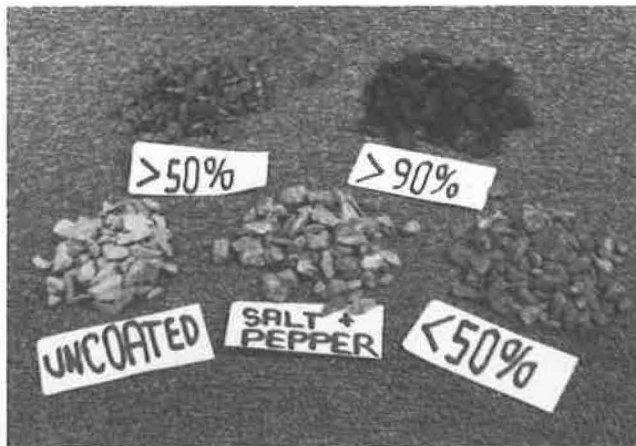
FIGURE 1 Typical five precoating conditions.

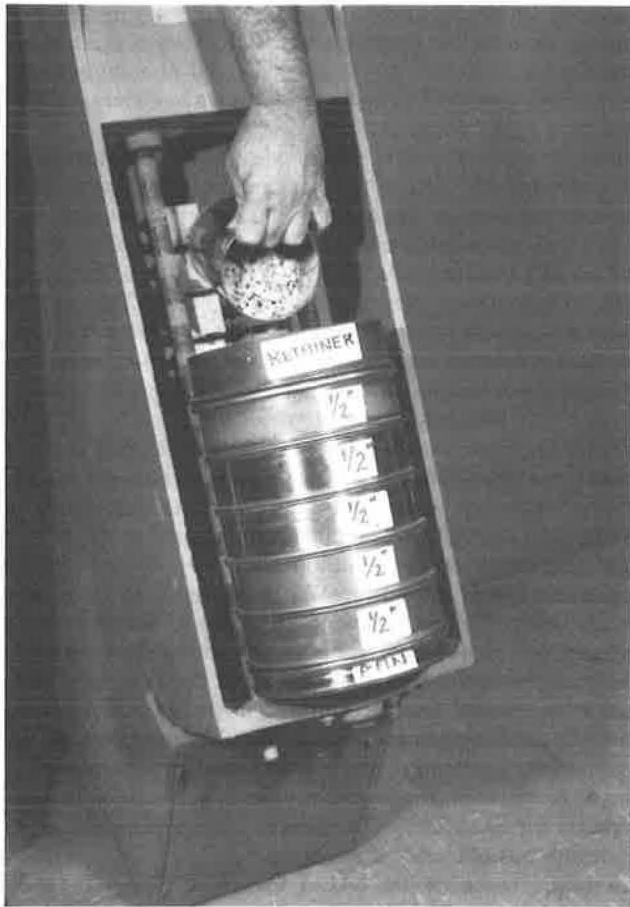
FIGURE 2 Complete assembly for applying aggregate.

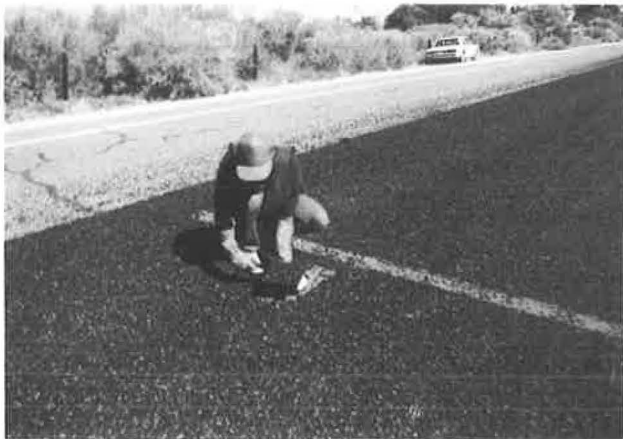
FIGURE 2 Removal of Vialit plates for testing.

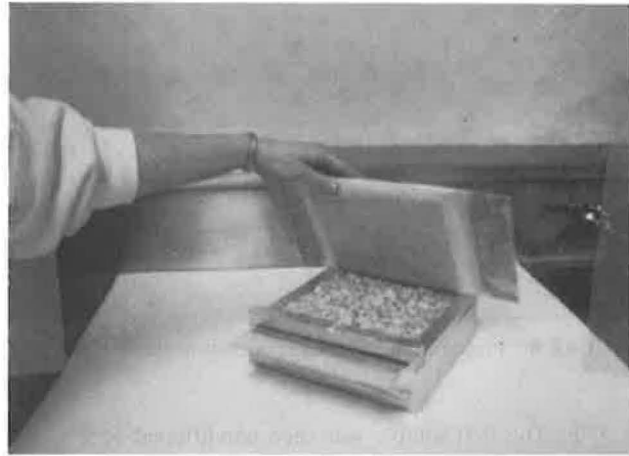
FIGURE 6 Preparing to drop aggregate on binder.

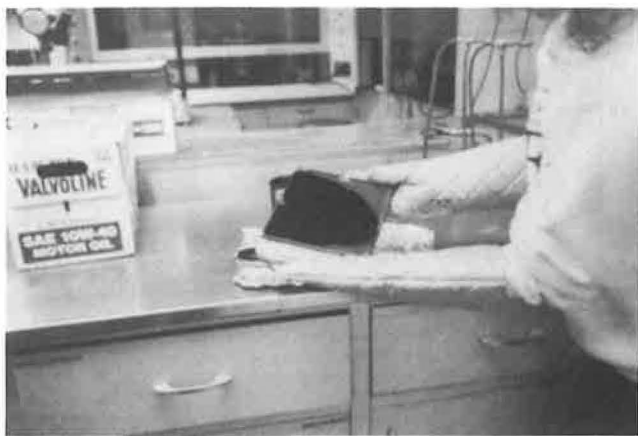
FIGURE 4 Preparation of sample plate (application of binder).

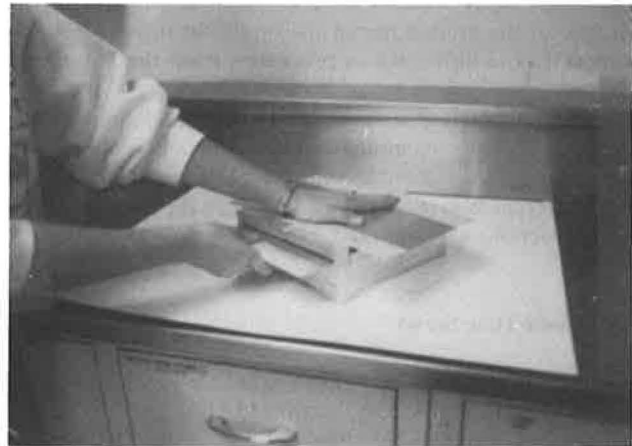
FIGURE 7 Metal plate being pulled out so that chips fall evenly onto binder surface.

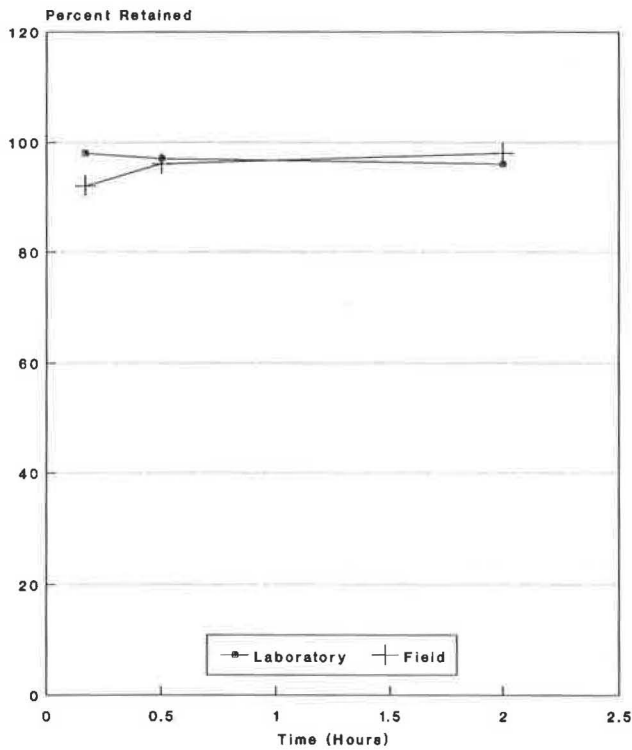
FIGURE 10 Percent retention of laboratory and field testing (styrene-based modified AR 4000, Section 8C).
