TRANSPORTATION RESEARCH
RECORD

No. 1302

**Roadside Safety
Features
1991**

Two crash tests each were performed on a Thrie beam bridge rail and on the adjoining transition section to the approach guardrail. The bridge rail was designed (a) as a retrofit to replace the rail portion of an inadequate bridge rail supported on W6X15.5 steel posts at 6 ft 3-in. spacing, or (b) as a completely new barrier installed using resin capsule anchors to attach the posts to the edge of an existing bridge deck. The transition uses the same rail element, a 10-gauge Thrie beam, supported on standard wood posts. The tests performed approximated those required for a PL-1 bridge rail outlined in the 1989 American Association of State Highway and Transportation Officials *Guide Specifications for Bridge Railings*. The bridge rail was struck by a 5,400-lb pickup truck at 44.9 mph at an angle of 21 degrees and a 1,830-lb car at 48.7 mph at an angle of 18¼ degrees. The transition was hit by a 5,400-lb pickup truck at a speed of 44.7 mph at an angle of 18 degrees and a 1,930-lb car at 49.1 mph at an angle of 20¼ degrees. The crash tests satisfied the requirements for structural adequacy, occupant risk, and

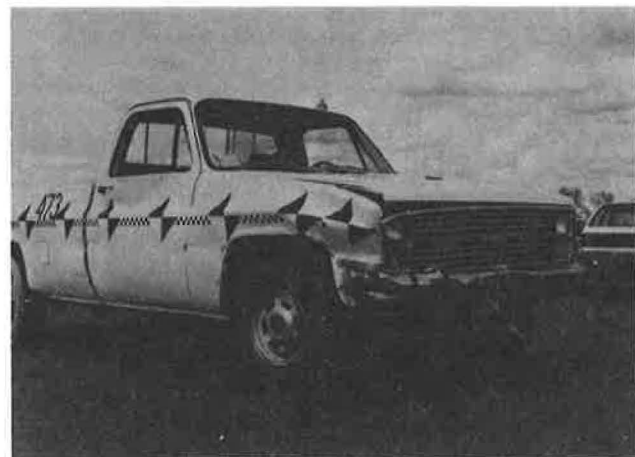
FIGURE 6 Vehicle after Test 473.

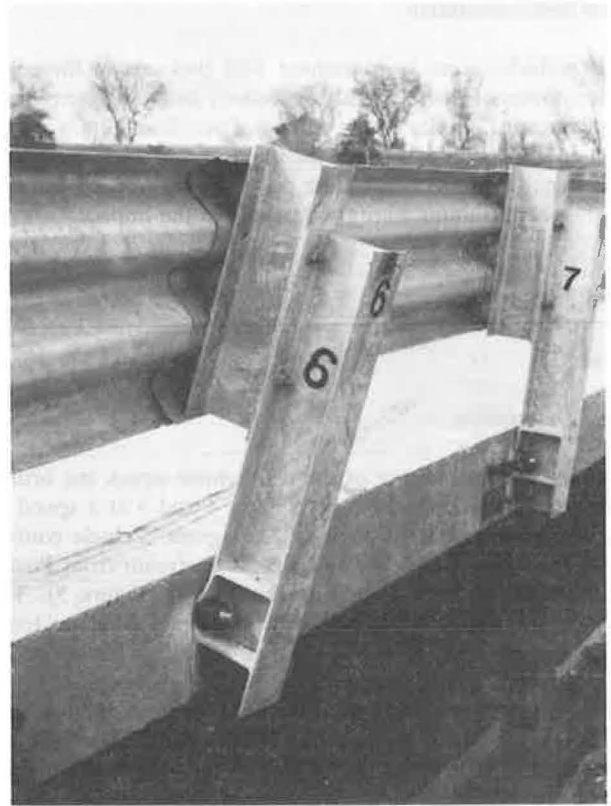
On Posts 4, 5, 6, and 7, the washers at the top mounting studs that attached the posts to the deck were pulled into the holes in the posts as the post flange was pushed around the nuts. The web was buckled at the bottom of Posts 4, 5, 6, and 7 (Figure 8). At Posts 5 and 6, the flange fractured at the upper mounting stud holes.

FIGURE 8 Post 6 was severely bent after Test 473.

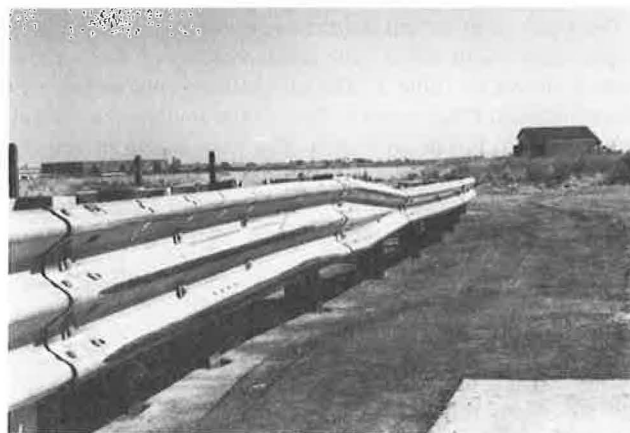
FIGURE 12 Vehicle contact marks, Test 475.

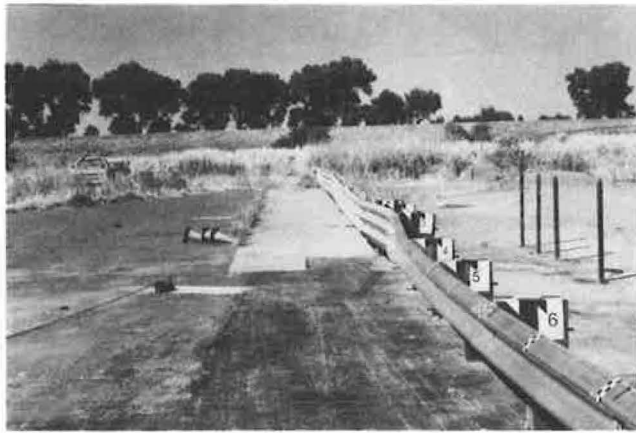
FIGURE 13 Rail damage: displaced posts, bent rail, broken post, Test 475.

The right front bumper of the test vehicle struck the bridge approach transition near the midpoint between Posts 2 and 3 of the transition at a speed of 44.1 mph at an impact angle of 18 degrees. Vehicle contact with the transition began 3.1 ft downstream from Post 3 and continued for a distance of about 10 ft (Figure 12). The vehicle was smoothly redirected without exhibiting any tendency to snag or pocket and lost contact with the barrier at an exit angle of $4\frac{1}{4}$ degrees. The maximum roll was $-2\frac{3}{4}$ degrees. The final location of the pickup truck was 140 ft downstream from impact and 37 ft in front of the bridge rail face (Figure 13). The vehicle was lightly damaged (Figure 14).

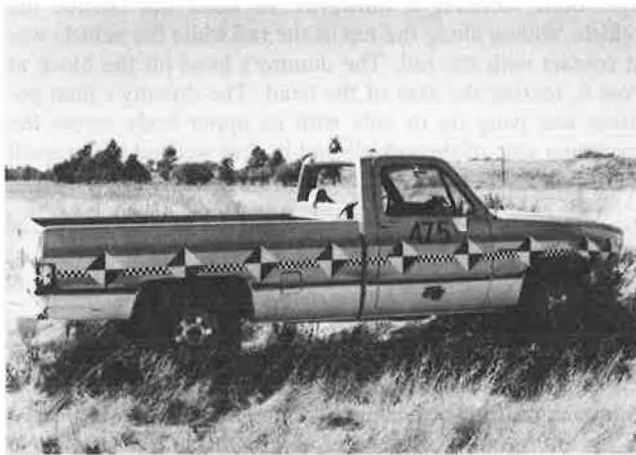
FIGURE 14 Vehicle after Test 475.

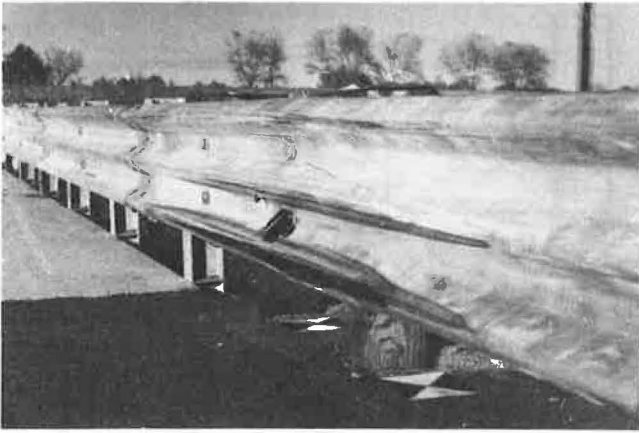
FIGURE 16 Vehicle contact marks, Test 476.

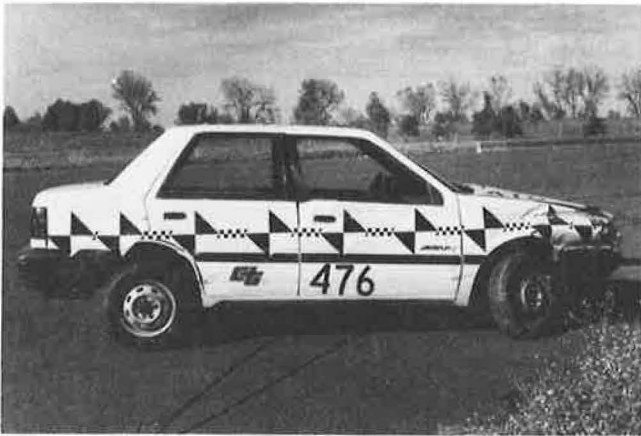
FIGURE 17 Vehicle after Test 476.

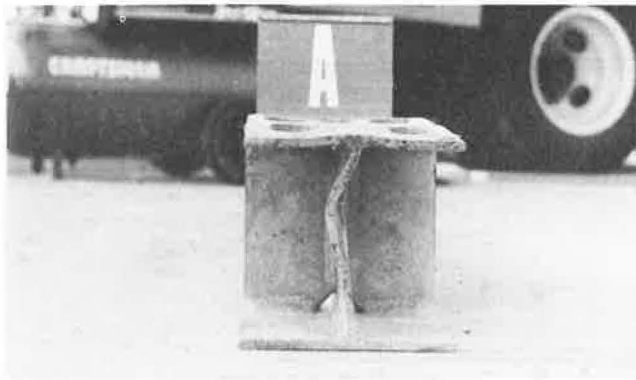
The test results are summarized in Table 4. Typically the web at the base of the post would buckle upon failure (Figure 20*a*, *b*, and *c*). In Tests *A* and *B* the web stiffeners and sandwich plates added sufficient strength so that the top anchor bolts pulled out. Total deformation of test Post *A* was less than two of the posts in Crash Test 473 (Figure 21).

FIGURE 20 Bottom end of three posts after static tests.

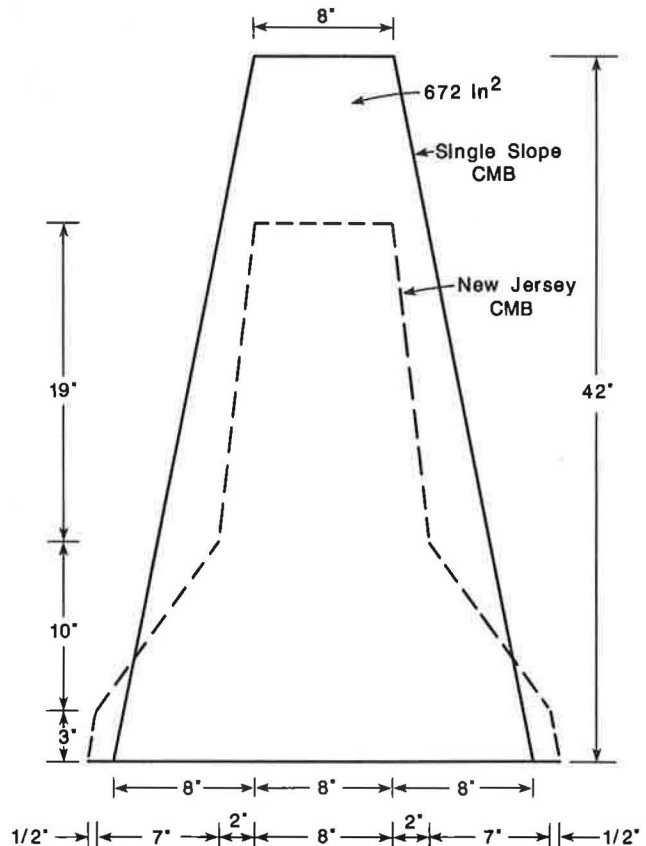
FIGURE 2 Comparison of single-slope CMB and New Jersey CMB.

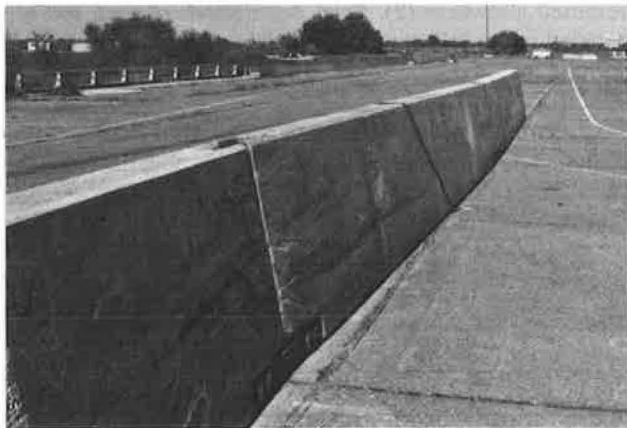
FIGURE 5 Single-slope barrier after Test 1.

A 1980 Cadillac Sedan DeVille was directed into the single-slope CMB. The test inertia mass of the vehicle was 4,500 lb (2,043 kg). The speed of the vehicle at impact was 60.3 mph (97.0 km/hr) and the angle of impact was 15.2 degrees. These impact conditions are recommended in *National Cooperative Highway Research Program Report 230 (I)* for temporary barriers. The vehicle struck approximately 55 ft (16.8 m) from the upstream end of the barrier. The maximum roll angle of the vehicle was about 12 degrees. The barrier received minimal cosmetic damage, as shown in Figure 5. The maximum lateral movement of the barrier was 7 in. (17.8 cm). The vehicle sustained moderate damage to the left side, as shown in Figure 6.

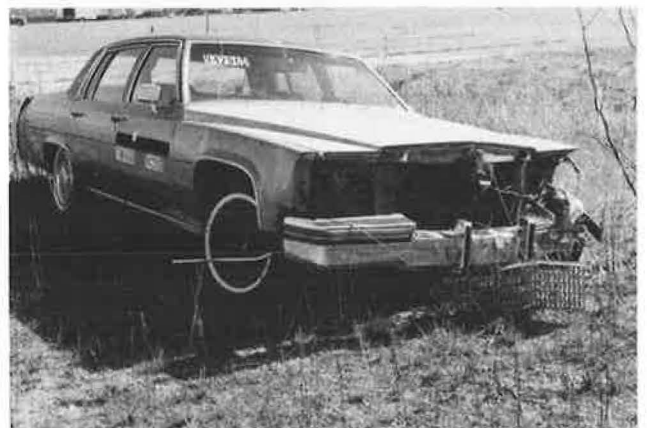
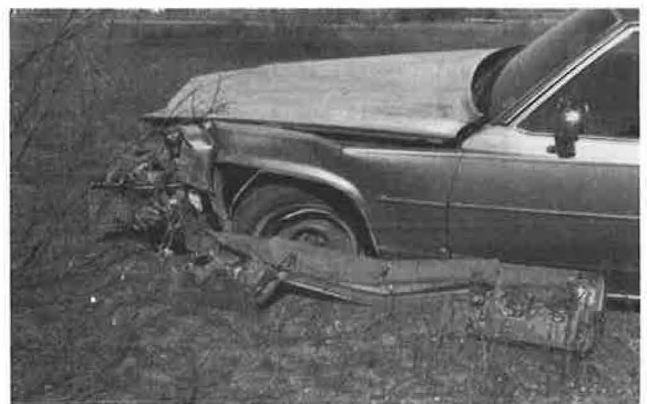
FIGURE 6 Vehicle after Test 1.

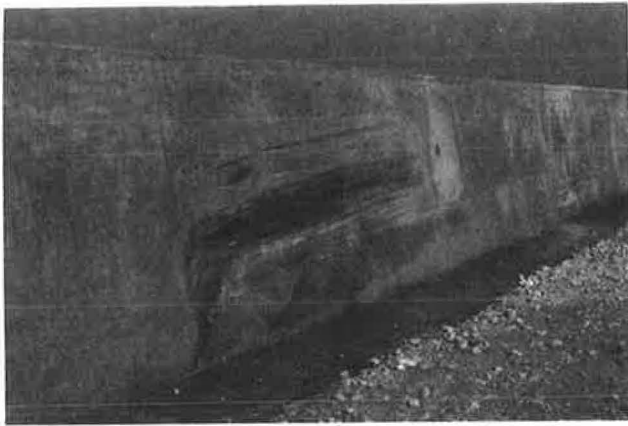
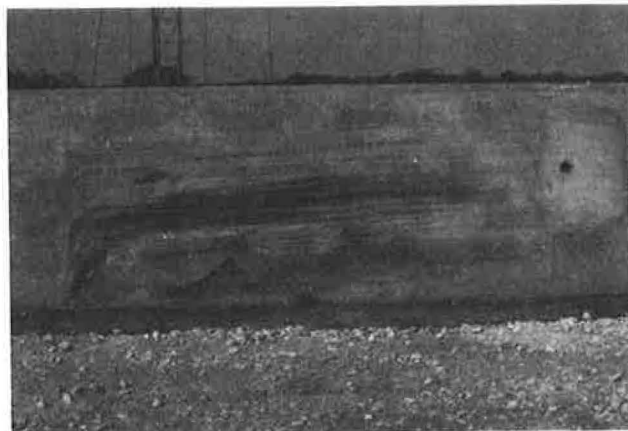
FIGURE 8 Single-slope barrier after Test 2.

about 6.3 degrees. The barrier received minimal cosmetic damage, as shown in Figure 8. There was no discernible movement of the barrier. The vehicle sustained moderate damage to the left side, as shown in Figure 9.

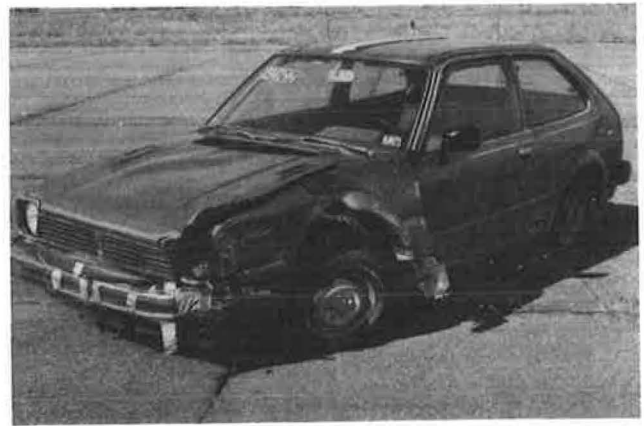
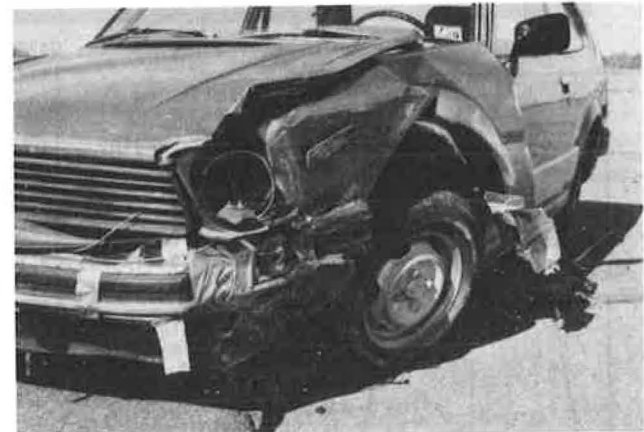
FIGURE 9 Vehicle after Test 2.

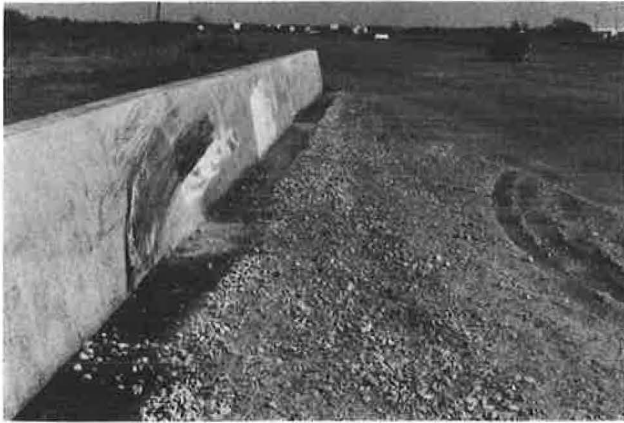
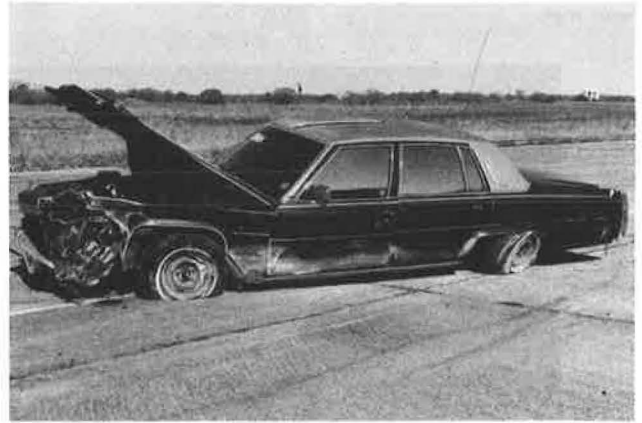
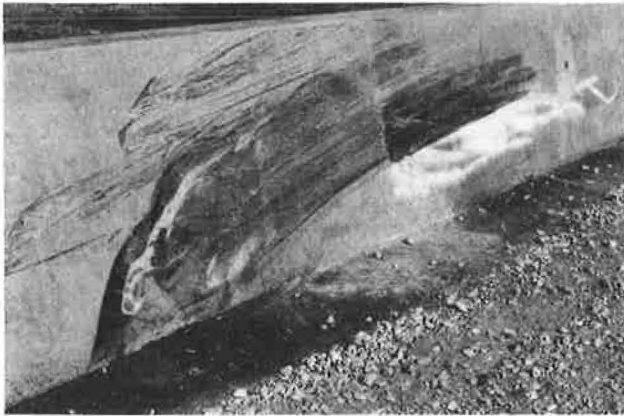
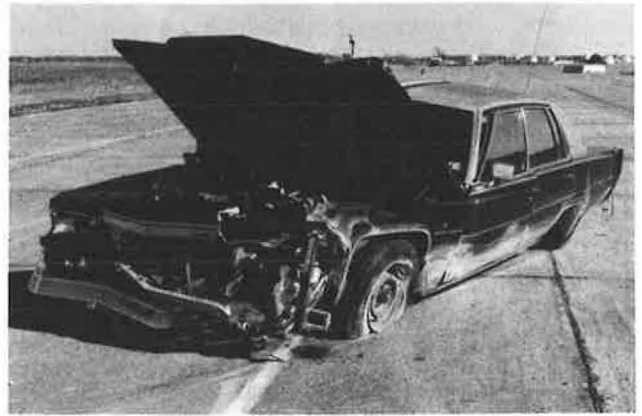
FIGURE 11 Single-slope barrier after Test 3.

FIGURE 12 Vehicle after Test 3.

Test 3 involved the impact of a 1979 Cadillac Sedan DeVille. The vehicle struck approximately 54 ft (16.5 m) from the upstream end of the barrier. The speed of the vehicle at impact was 63.1 mph (101.5 km/hr) and the angle of impact was 26.5 degrees. There was no discernible movement of the barrier and it received only minimal cosmetic damage, as shown in Figure 11. Examination of the high-speed movies and direct measurements of the markings on the barrier showed that the center of the wheel hub rose to a height of 26 to 30 in. (66 to 76 cm) before losing contact with the barrier. This was the highest vehicle elevation achieved in the set of four crash tests. The maximum vehicle roll angle was about 32 degrees. The vehicle sustained severe damage to the left side, as shown in Figure 12.

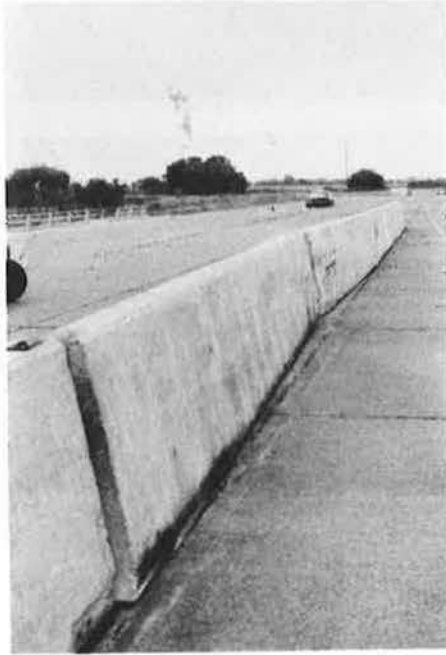
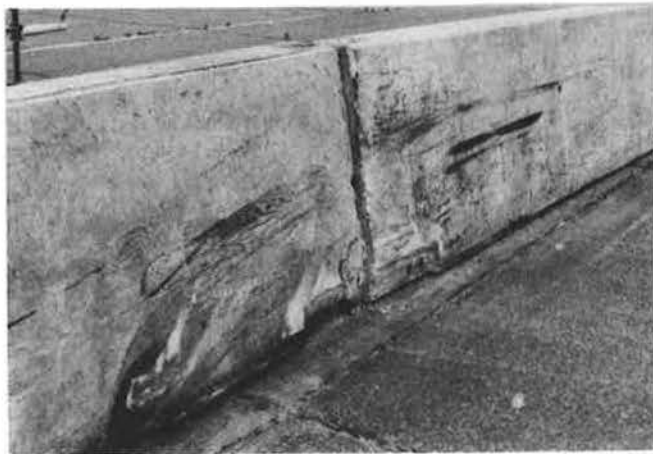
FIGURE 14 Single-slope barrier after Test 4.

A 1981 Pontiac Bonneville was directed into the single-slope CMB. The test inertia mass of the vehicle was 4,500 lb (2,043 kg). The speed of the vehicle at impact was 62.0 mph (99.8 km/hr) and the angle of impact was 15.1 degrees. The vehicle struck approximately 85 ft (26.0 m) from the upstream end of the barrier. The maximum vehicle roll angle was about 17 degrees. The barrier received only minimal cosmetic damage, as shown in Figure 14. The maximum lateral displace-

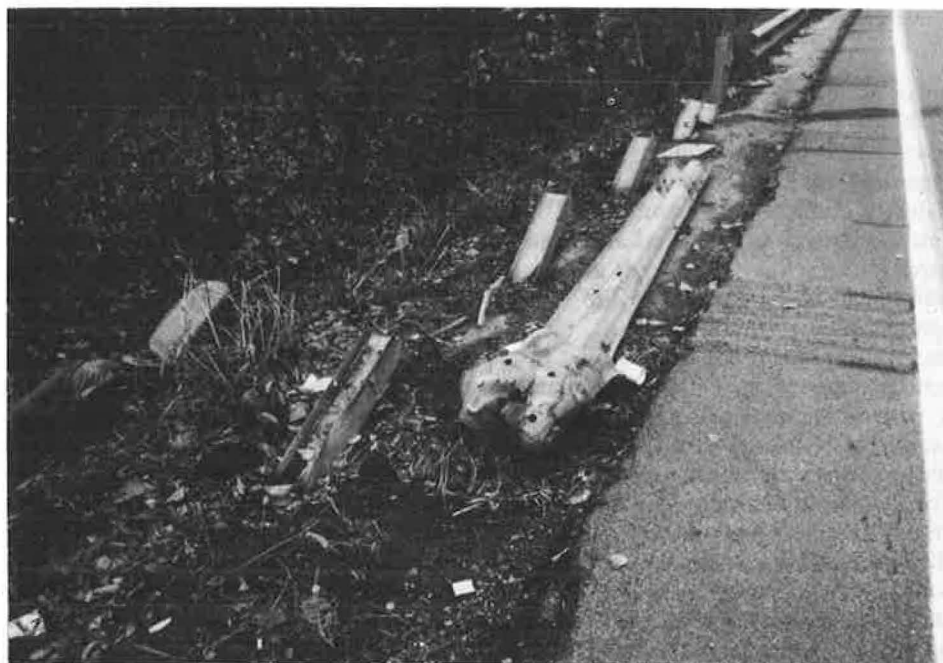
FIGURE 1 Vehicle path and guardrail end in collision: NASS-LBSS Case 83-08-512T.

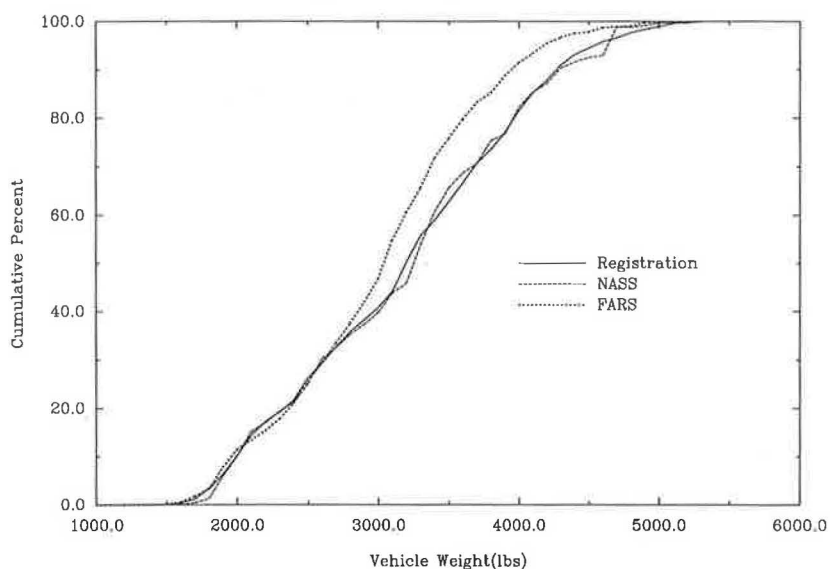
FIGURE 3 Cumulative distribution function for 1983 FARS, NASS, and registration data.

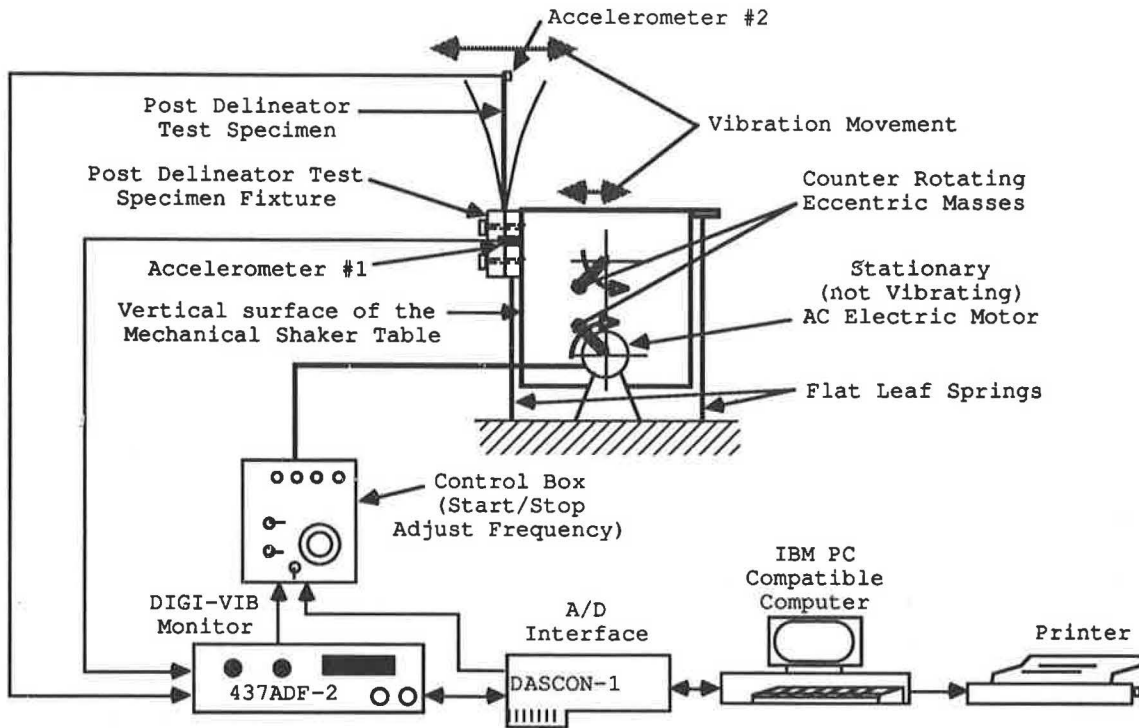
FIGURE 1 Schematic representation of mechanical shaker, post delineator test specimen, and monitoring-control system.
