Electrochemical Removal of Chloride Ions from Reinforced Concrete: Initial Evaluation of the Pier S19 Field Trial

D. G. MANNING AND F. PIANCA

The initial evaluation of a commercial process for the electrochemical removal of chloride ions from concrete is reported. A trial was conducted over an 8-week period in 1989 on a section of Pier S19 of the Burlington Skyway. The evaluation included visual examination, corrosion potential, and rate-of-corrosion measurements on the structure, and petrographic examination and measurement of chloride ion profiles on samples removed from the structure. Data up to 13 months after treatment of the concrete are reported. The treatment was successful in moving chloride ions away from the reinforcing steel and in removing a substantial proportion from the concrete without apparent damage to the concrete. The long-term effectiveness of the treatment is the major unknown factor.

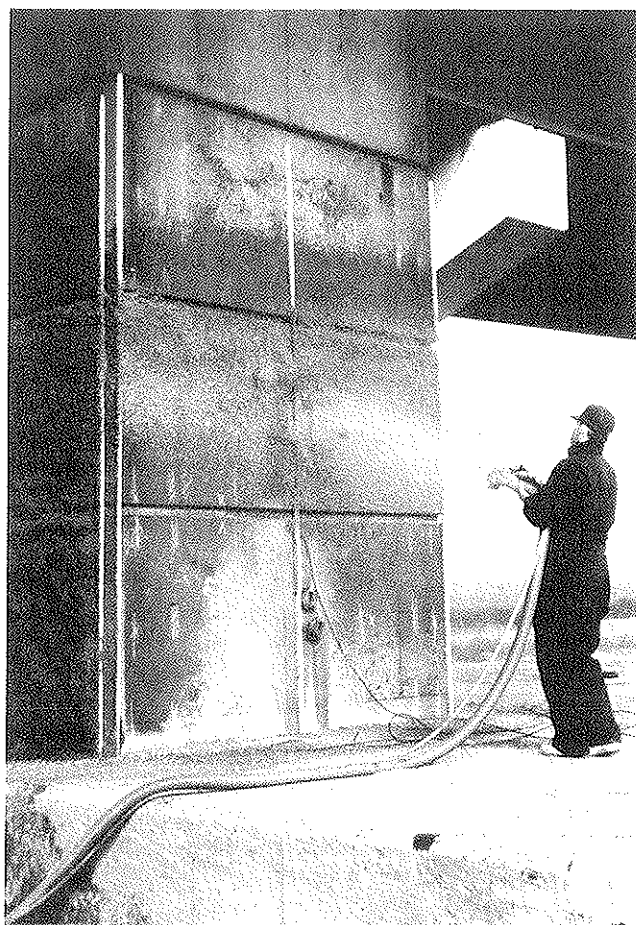
FIGURE 1 Spraying of cellulose fiber on concrete.

A connection was made to the reinforcement and insulated to prevent corrosion. Wooden strips, approximately 40 mm wide by 20 mm thick, were fastened vertically to the concrete using insulated anchor screws. Cellulose fiber, moistened with lime water to act as an electrolyte, was sprayed on the concrete to the same thickness as the battens, as shown in Figure 1. A 100- × 100-mm steel mesh of 5-mm wire diameter was

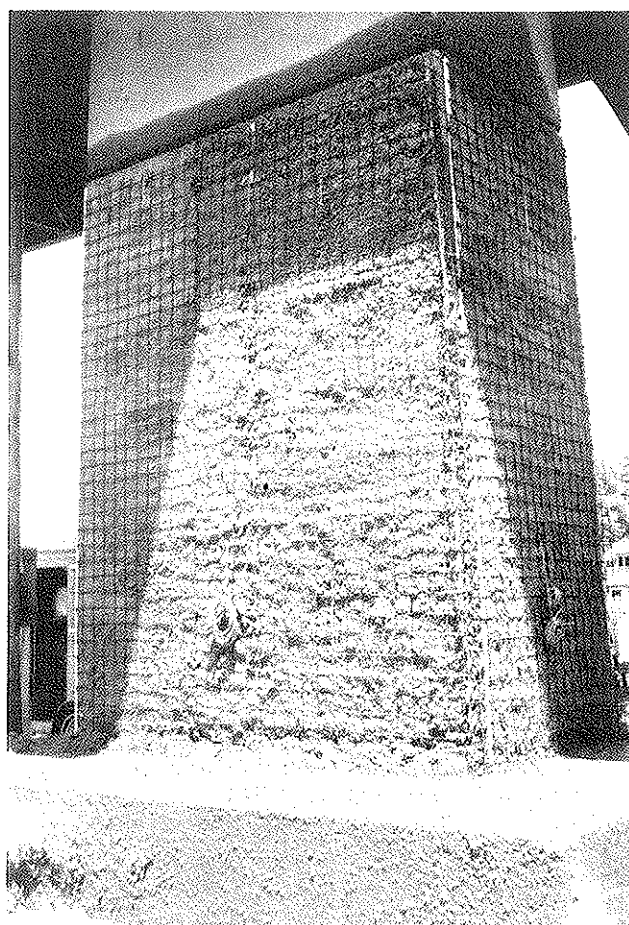
FIGURE 2 Covering of wire mesh with moist cellulose fiber.

attached to the wooden strips with staples as shown in Figure 2, and a second layer of moist fiber was applied to cover the mesh to a thickness of about 25 mm.

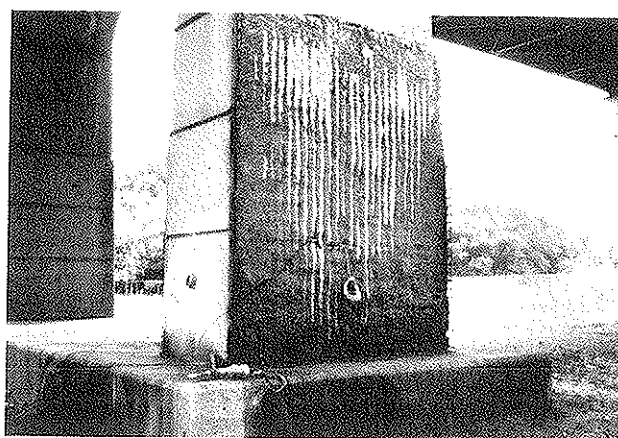
FIGURE 3 Corrosion of the mesh.

The cellulose was light brown in color and, immediately after installation, was unobtrusive. After 24 hr, a rust-stained outline of the mesh was visible, and within about 3 weeks the cellulose had a fairly uniform red-brown appearance as the result of corrosion of the mesh, as shown in Figure 3. The excess water that drained from the cellulose following the daily wetting also contained rust that stained the column plinth. After the 8 weeks of treatment, the surface of the column and parts of the plinth were heavily stained by rust. The staining was removed by blast cleaning.

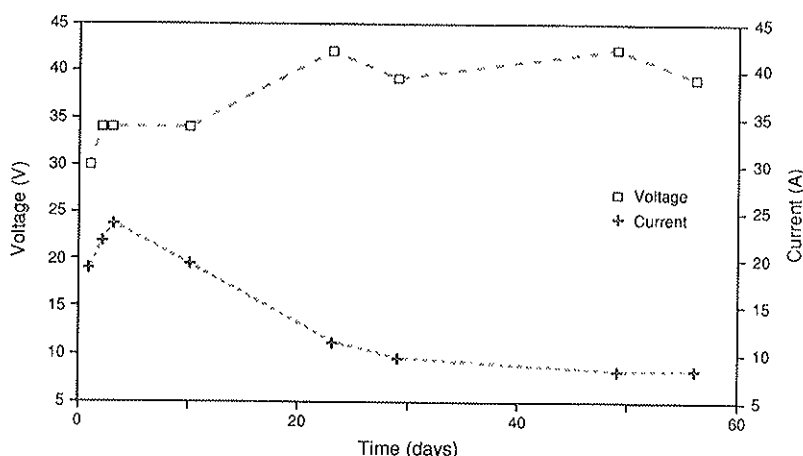
FIGURE 4 Rectifier output during treatment period.

The voltage and current throughout the treatment period are shown in Figure 4. The voltage and current fluctuated during the first 3 days. During the remainder of the 8 weeks, there was a slight increase in voltage, but a substantial decrease in current to about one-third its initial value. The total charge passed was approximately 610 A-hr/m² of concrete surface.

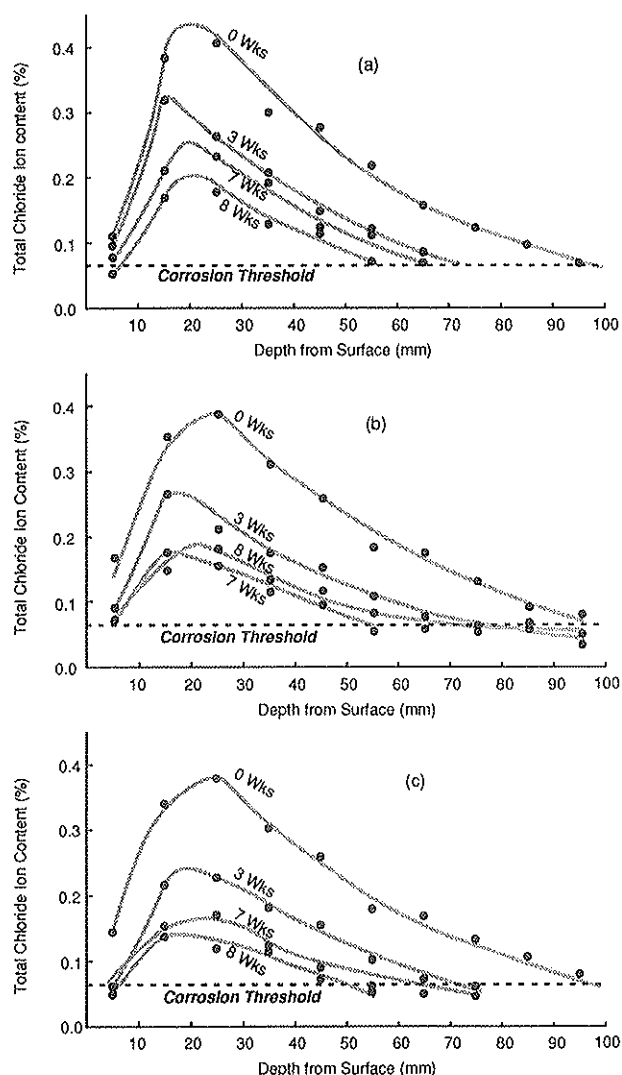
FIGURE 5 Chloride ion profiles during treatment period: (a) south face between rebars, (b) west face between rebars, and (c) west face over rebar.

Typical chloride ion profiles at various stages in the treatment process are shown in Figure 5. The profiles were established by cutting cores into 10-mm-thick slices, pulverizing each slice, and measuring the acid-soluble chloride ion content. Because the flow of drainage water over the column was uneven, the initial chloride ion content of the concrete varied considerably over each face. In order to minimize these variations and permit a valid comparison of the progress of the desalination, cores were taken vertically below each other on each face. Two sets of cores were taken on the west face, one set directly over a vertical reinforcing bar and the other set midway between adjacent vertical bars.

All the results exhibited a similar pattern: chloride ion reduction was most rapid in the early stages of treatment, there

was a reduction in the peak chloride ion content and a gradual shift in the peak value towards the concrete surface, and there was little difference between the results after 7 and 8 weeks. In all cases, the chloride ion content at the level of the reinforcement was at or slightly below the calculated corrosion threshold value for the concrete. From Figures 5b and 5c, it can be seen that proximity to the reinforcement had only a small effect, though the use of 100-mm-diameter cores would tend to mask differences in the immediate vicinity of the reinforcement.

The proportion of chloride ion in excess of the corrosion threshold value removed by the treatment was calculated from the area under the curves in the chloride ion profiles. The results are presented in Table 1. The range represents the values calculated after 7 and 8 weeks. In some cases, as for example in Figures 5b and 5c, the values were less after 7 weeks than after 8 weeks, though this effect is thought to be the result of the method of sampling.

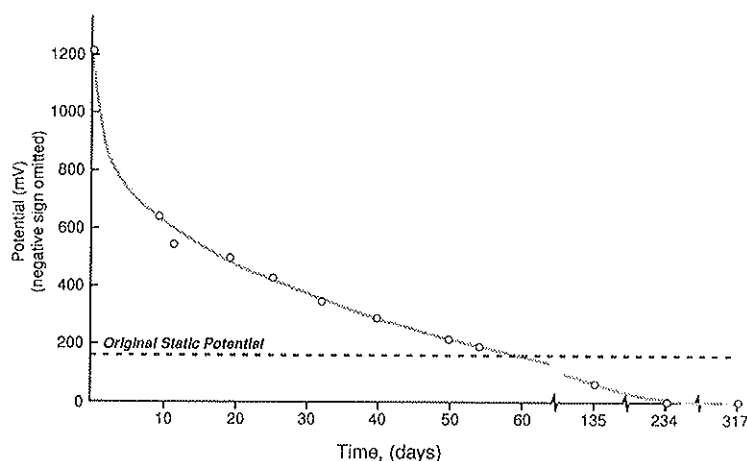
FIGURE 6 Depolarization of the west face measured on an embedded graphite electrode.

The potential of the embedded reference electrodes was measured periodically, and the rate of depolarization is shown for the case of the west face in Figure 6. Measurements were made on an embedded graphite electrode. The original static potential was reached after about 60 days. The steel continued to depolarize and zero potential was measured about 8 months after treatments. This value was confirmed by surface measurements.
