Twenty-Year Study of Asphalt Rubber Pavements in Phoenix, Arizona

The details of asphalt rubber application on city streets pioneered by the city of Phoenix, Arizona, since the mid-1960s are outlined. Problems encountered in the early use of this material are noted. Various guidelines and specifications developed by the city for the successful use of asphalt rubber are summarized. Viscosity of asphalt cement with and without an asphalt rubber seal was determined, and the importance of these results on the aging phenomenon are discussed. Many of the city's original streets with asphalt rubber application were not evaluated because they have been reconstructed. The remaining streets were inspected, and the pavement conditions for each were observed. Detailed observations of all the street pavements are summarized, and the important findings from this 20-year historical survey of asphalt rubber pavements are discussed. Conclusions on the use and advantages of asphalt rubber as a maintenance treatment for the city's streets are noted. In spite of the advantages and good engineering characteristics of asphalt rubber chip seal, there was mounting public opposition to its continued use b

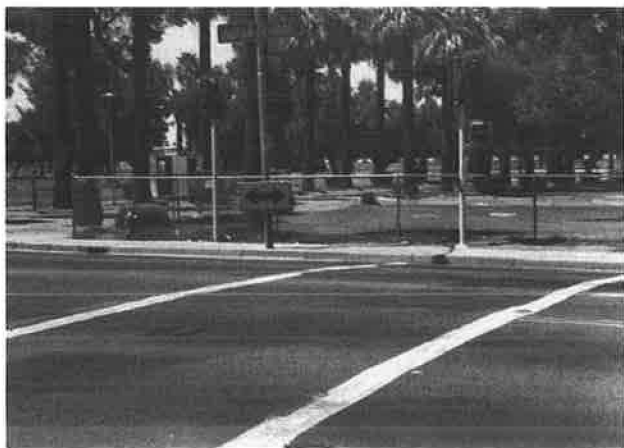
FIGURE 1 Condition of Indian School Road after 19 years.

One of the earliest applications of asphalt rubber chip seal was placed on Indian School Road from Central Avenue to 7th Street in 1971. The surface of the pavement was in poor condition and was badly cracked. Application of an asphalt rubber chip seal was a temporary measure to prevent the street from complete deterioration and failure. It was then scheduled for total reconstruction in 2 years. However, the street has performed satisfactorily with little maintenance for the past 19 years. The current condition of the street is shown in Figure 1. The traffic count on this street has increased from 30,000 average daily traffic (ADT) in 1971 to 60,000 ADT in 1990. This section will be totally reconstructed in 1991. Another application was on the I-17 frontage road and offramp at Van Buren Street in December 1968. This pavement was removed because of the major interchange improvements for I-10 and I-17 in 1989. A SAM consisting of hot asphalt rubber followed by an application of hot precoated ⅜-in. aggregate was used at this site. Diluents were not used in the asphalt rubber seal. The 1967 surface was scheduled to be replaced; however, the asphalt rubber seal saved it for 21 years.

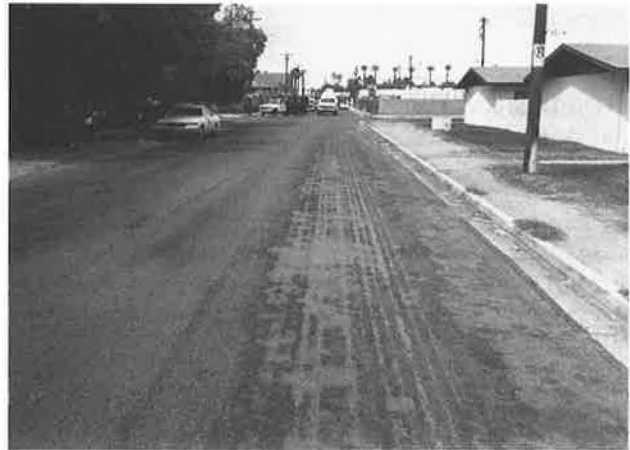
- Chip loss was observed from pavements at various locations, including both low- and heavy-traffic areas. As observed earlier, asphalt rubber loses its flexibility with time and does not retain the chips. Chip loss on a typical street edge is shown in Figure 3.

FIGURE 3 Chip loss on street edge.

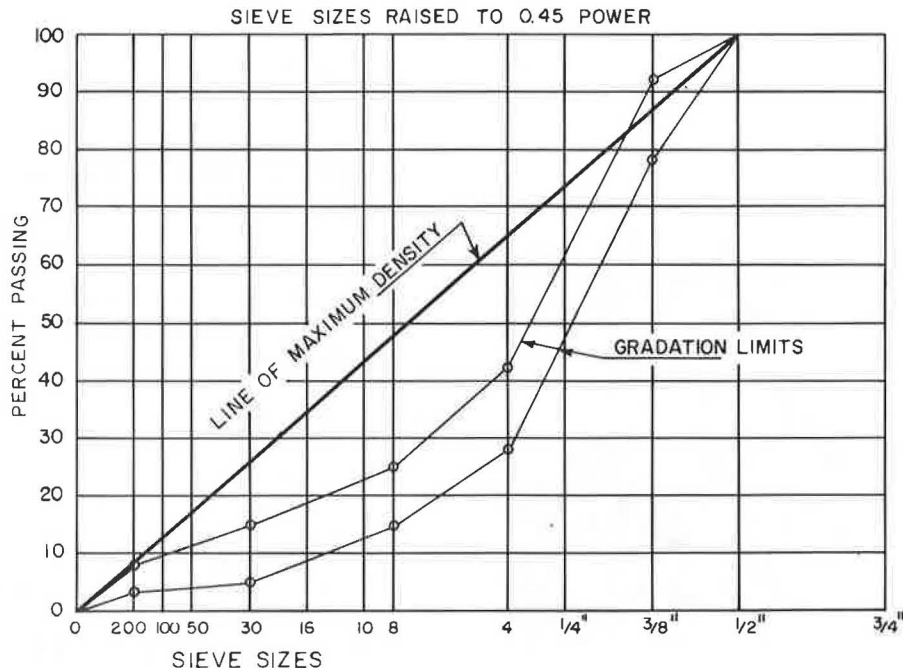
FIGURE 5 Asphalt rubber surface course mix gradation limits.

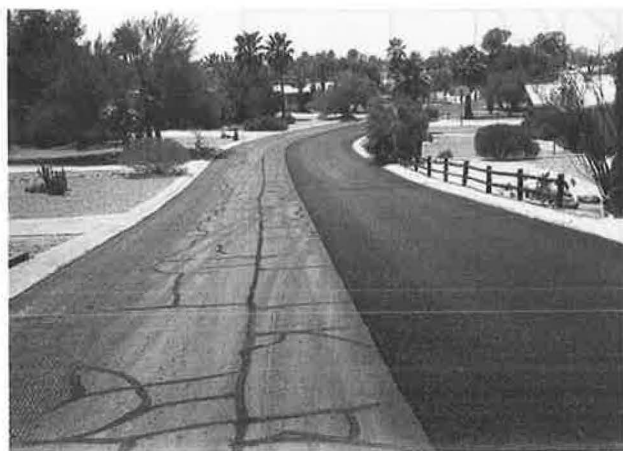
A photograph showing the typical condition of the street being overlaid with asphalt rubber hot mix is shown in Figure 6.

FIGURE 6 Overlay with asphalt rubber hot mix: condition before overlay (left); completed half (right).
