New Jersey Guide-Sign Survey

ARTHUR W. ROBERTS

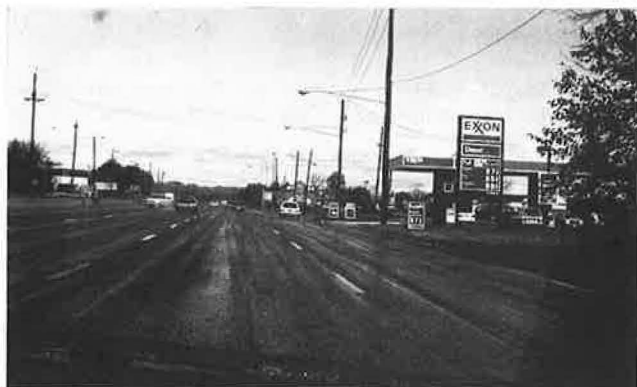
FIGURE 2 Complex environment.

1. Sign view blockage, which represents 97 percent of the cases observed. The term means that the approaching motorist's view is blocked by some fixed object. The method is accurate for this type of interference.
2. Complex environment, which represents only 1 percent of the cases observed. The term means that the environment

or the construction of the sign is such that it is easily overlooked (Figure 2). Further definition of this type of interference appears to be needed.

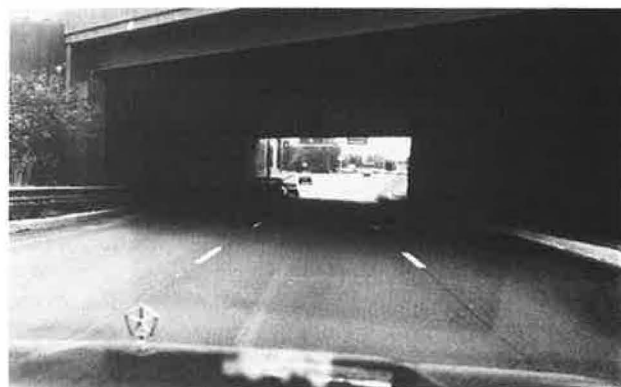
FIGURE 4 Bridge span blockage.

Trees accounted for 53 percent of the blockages observed (Figure 3). Poles accounted for 5 percent, curves and crests for 20 percent. Other signs accounted for 6 percent, and bridge spans, abutments, parapets, and piers accounted for 13 percent (Figures 4, 5, and 6).

Poles are a bothersome interference, but the interference appears to be minor in most cases. Small signs blocking large signs can be moved inexpensively. However, large signs, curves, embankments, walls, spans, parapets, and piers represent an estimated 35 percent of the problem. The correction of these interferences would require relocation of large signs, new road alignments, bridge replacement, or the reconstruction of other features, involving large capital investments.

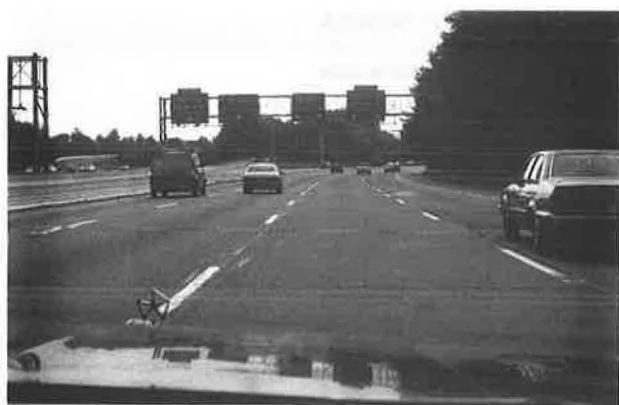
FIGURE 6 Parallel roads.

3. Ambiguous meaning, which represents only 1 percent of the cases. The term means that the sign is placed on a parallel road in such a way that the driver may be uncertain whether or not an upstream decision was correct. The identification of this category may require special training.
