Observations of Severe Abutment Backwall Damage

RAY W. JAMES, HEPING ZHANG, AND DAN G. ZOLLINGER

Field studies of highway bridge performance have led to repeated observations of severe cracking and dislocation of the backwalls of reinforced-concrete abutments. The observed distress is correlated with the presence of adjacent reinforced-concrete pavements, and the cause is attributed to the longitudinal growth of the concrete pavements. Field observations are presented and discussed. A finite element model of a representative abutment is used to study the expected stress distributions caused by several hypothesized mechanisms that might contribute to the observed damage. Methods to prevent future damage are discussed.

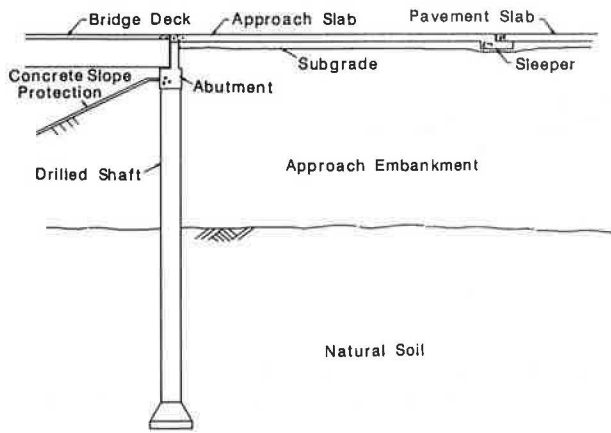
FIGURE 1 Longitudinal section through a typical bridge approach.

Figure 1 shows a longitudinal section of a representative highway bridge, approach slab, and abutment, typical of current Texas State Department of Highways and Public Transportation (SDHPT) design practice. Most commonly, the approach slab is doweled to the abutment backwall with reinforcing steel. The expansion joint at the end of the girders is usually either an open armored joint or is sealed with a prefabricated neoprene joint seal. In the case of short beams, expansion of the girders is usually provided for with a polymeric bearing pad. Drilled shafts, typically 30 in. in diameter, are commonly used to support the abutment, with shorter and smaller drilled shafts supporting the wingwalls. This relatively deep-drilled shaft foundation has been used for many years to provide

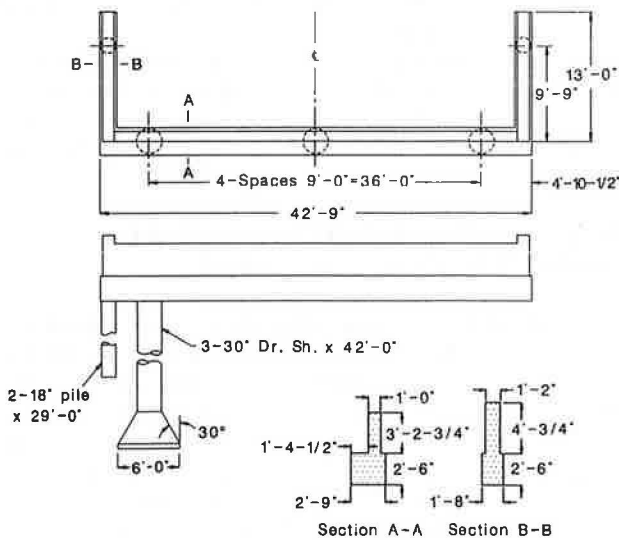
FIGURE 2 Design details for representative reinforced concrete abutment.

durable, stiff, and stable abutment foundations. Figure 2 shows selected design details for a typical abutment used under a two-lane structure.

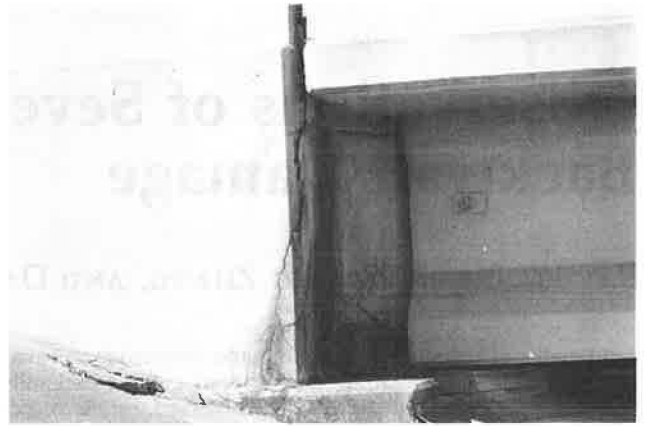
FIGURE 4 Observed abutment backwall damage, intermediate stage.

Figures 3–5 show several examples of observed backwall damage, and represent three observed stages of damage development. The various instances of observed damage are usually remarkably similar. The crack pattern shown in Figure 3, from the lower outside corner of the backwall, is the initial indication of distress in the backwall. This crack increases in length and becomes displaced, until the entire backwall is broken off at its base along the length of the abutment. In advanced stages, considerable spalling occurs, and sometimes embankment fill material is carried out of the displaced fracture.

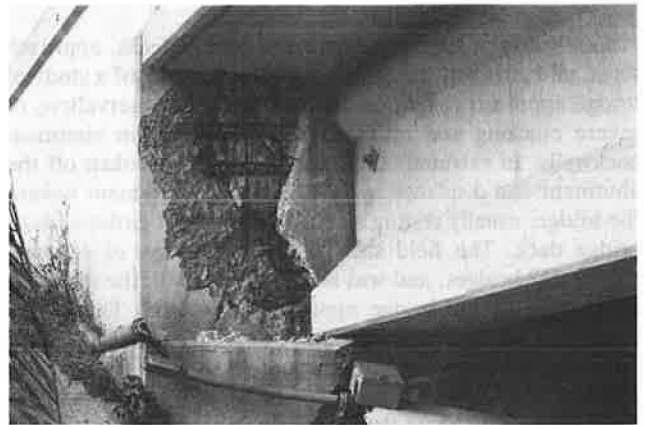
FIGURE 5 Observed abutment backwall damage, advanced stage.

The six bridges at sites adjacent to reinforced concrete pavements were all on the same section of highway, and of these six, three exhibited significant abutment backwall distress, essentially identical to that shown in Figures 3–5. In summary, three of six abutments next to continuous reinforced-concrete pavements (CRCP) were damaged, whereas none of the 77 bridges next to ACP exhibited similar damage.

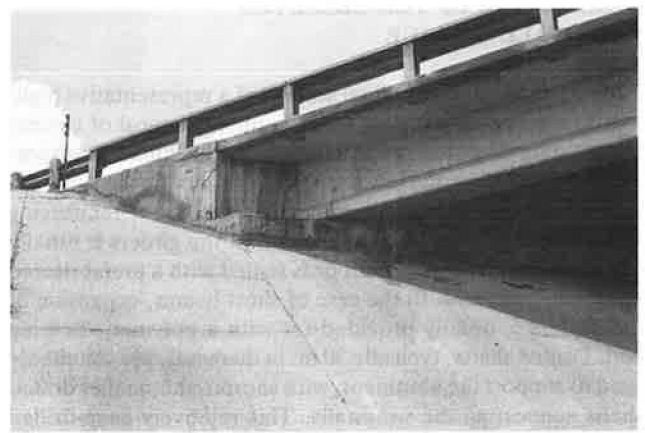
The observed damage in one case consisted of cracking and spalling of the top of the wingwall, as shown in Figure 6, apparently caused by unintended contact between the wingwall and the bridge deck. On the opposite side of the deck

FIGURE 6 Isolated instance of observed damage to abutment backwall adjacent to ACP.

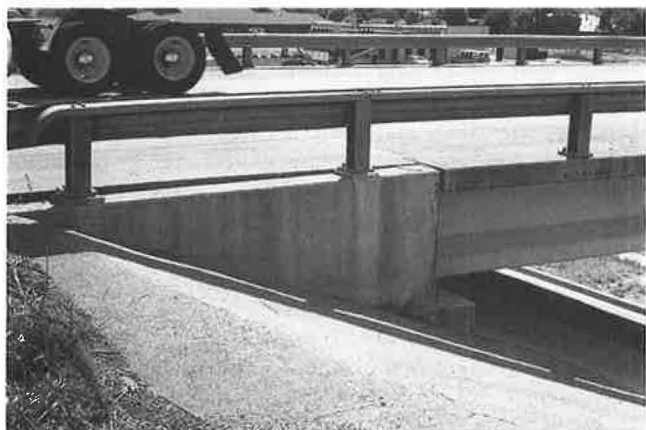
at that abutment, a similar unintended contact pressure has caused cracking and spalling of the edge of the bridge deck. The cause of the bridge or embankment movement resulting in this unintended contact is not known. It may be deduced only that either the embankment is moving toward the bridge, carrying the abutment, or the bridge superstructure is moving toward the embankment. Localized pressure by soil or pavement against the top of the backwall is expected to cause backwall damage before the backwall contacts the girder ends. In the second instance of damage to a backwall at a site adjacent to ACP, the observed damage is generally similar to the first instance, as shown in Figure 7. It is not as clear in this case that the damage is caused by bearing pressure between the wingwall and the deck, as in Figure 6, but a close inspection of the abutment reveals that the damage in this instance is isolated in the wingwall, with the backwall undamaged.

FIGURE 7 Observed damage to abutment wingwall at structure adjacent to ACP: Case 2.

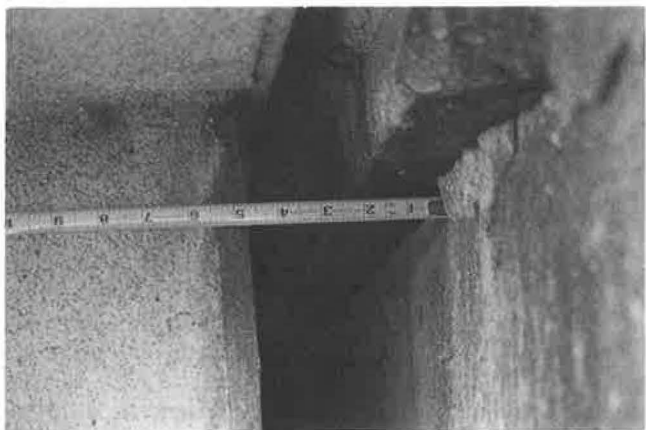
Finally, a third example of distress in a bridge abutment adjacent to ACP was observed in the initial field study. The observed distress in this example took the form of an apparently displaced approach slab, as shown in Figure 8. However, the cause of this displacement is the gross rotation of the abutment as shown in Figure 9. The embankment at this site is underlain by soft soils, and the rotation is attributed to

FIGURE 8 Approach slab apparently displaced relative to backwall.

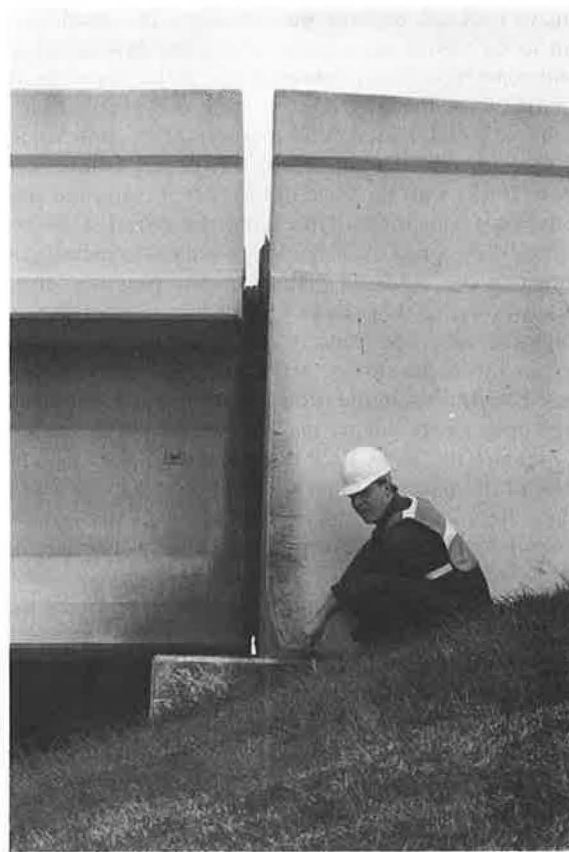
FIGURE 9 Rotated abutment and wingwall.

differential settlement. Other evidence of differential settlement is also noted at this site. The mechanism causing the observed distress is therefore different than the mechanism observed at the sites adjacent to reinforced-concrete pavements. No damage was sustained by the backwall in this instance, even though the backwall has been displaced approximately 2 in. toward the approach slab. Design drawings for this structure indicate that the approach slab is not doweled to the abutment backwall, as is commonly done in other similar structures. Because of this, the relative displacement of backwall and approach slab is not restrained and does not cause distress.

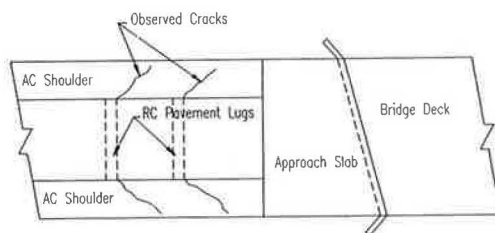
extensive backwall damage was observed, the shoulders adjacent to the CRCP were paved with a thin layer of hot-mix asphalt concrete. Cracks were observed in the paved shoulder emanating from the edge of the CRCP and propagating out into the paved shoulder at an angle roughly approximating 45 degrees toward the abutment. The points of intersection of these cracks with the edge of the CRCP coincided closely with the known locations of the reinforced-concrete pavement lugs that are designed to anchor the pavement to the subgrade, as shown in the sketch in Figure 10. The presence of these cracks is evidence that the pavement lugs are being pushed through the subgrade, causing soil failure planes whose intersections with the surface are manifested by the observed cracks. Excavations in the shoulder at one such site revealed a large open cavity behind the exposed pavement lug—further evidence that the CRCP is moving toward the abutment in spite of the pavement lugs.

FIGURE 10 Drawing of observed crack patterns in ACP shoulders adjacent to CRCP (plan view).

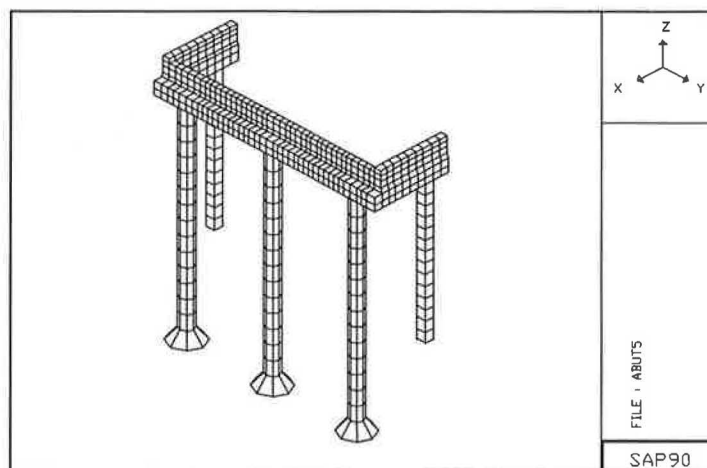
Figure 11 shows a finite element model of this abutment structure. It consists of eight-node solid elements modeling the abutment; spring elements, not shown in Figure 11, are used to model the soil-structure interaction. A microcomputer version of the finite element software SAP90 was used in this study. All numerical operations are executed in full 64-bit double precision. Assumed concrete material properties are compressive strength $f'_c = 4$ ksi, unit weight 140 lb/ft^3 , elastic modulus $E_c = 36,000$ ksi, and Poisson's ratio $\mu = 0.28$.

FIGURE 11 Finite element model of bridge abutment.

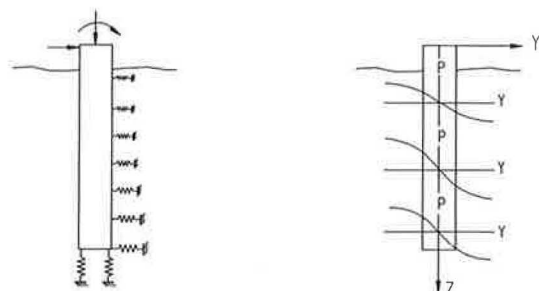
The soil-structure interaction was simplified by employing a Winkler soil model, as shown in Figure 12. The soil surrounding the shaft is represented by a set of elastic springs. Winkler's assumption states that each spring acts independently. Although this assumption does not exactly describe the soil behavior, it has been demonstrated that solutions of beam-on-foundation problems using Winkler's assumption do not differ appreciably from solutions assuming the soil to be an isotropic, elastic continuum. It is convenient to think of Winkler's model in terms of P - Y curves, also shown in Figure 12. The soil modulus E_s is then taken to be P/Y . Because the P - Y relationship is usually nonlinear, the modulus E_s is not constant, but it may be linearly approximated for small deflections. A linear approximation was used in this study. Terzaghi (3) suggested the following formula for stiff clays:

a) Idealization of soil surrounding a shaft

b) Set of p - y curvesFIGURE 12 Representation of Winkler soil model and P - Y curves.

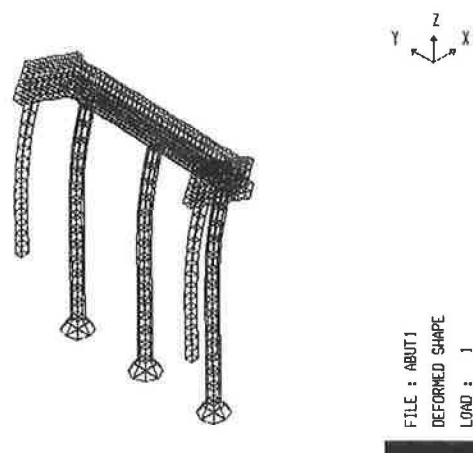
Some simulation results for load Case 1 are presented in Figure 13. In load Case 1, the approach slab is forcing the abutment backwall 1.0 in. forward, and the resulting force between approach slab and abutment backwall is approximately 228 kips. The wingwall is predicted to rotate approximately 0.37 degree. The abutment vertical settlement is about 0.35 in. The anticipated damage for this load case is cracking of the backwall or backwall-wingwall intersection, consistent with the observed damage in the field. Similar results from other load cases are not presented here. Cases 2 and 5 results indicate highest stress concentrations in the top center of the backwall, and in Cases 3 and 4, highest stresses occur at the ends of the backwall. Dead-load stresses in Case 6 are small, as are live-load stresses in Case 5. Accordingly, it may be

FIGURE 13 Predicted deformed shape for load Case I.

concluded that the mechanisms modeled in Cases 1, 3, and 4 each acting separately or together could be contributing factors to the damage observed. Because of the other observations implicating pavement growth, and because of the low probability of loss of support under the wingwall piles or the development of high lateral earth pressures on the abutment walls, Case 1 loading is considered the most likely explanation of the observed damage.
