TRANSPORTATION RESEARCH
RECORD

No. 1337

**Flexible Pavement
Construction,
Performance, and
Recycling**

Effects of Residual Aggregate Moisture on Stripping Potential of Asphalt Concrete Mixtures

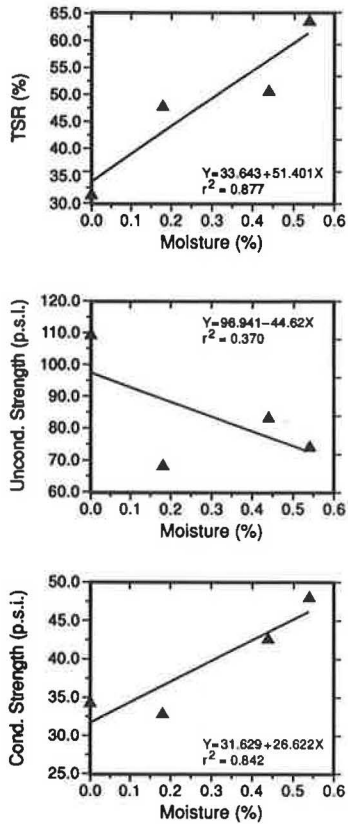
To study the effects of residual moisture, the data from Table 2 were plotted in Figures 2 through 4. These figures

FIGURE 2 Mix A, laboratory data.

show unconditioned strength, conditioned strength, and TSR versus mix moisture content. Straight lines were fit to the data using least squares criteria.

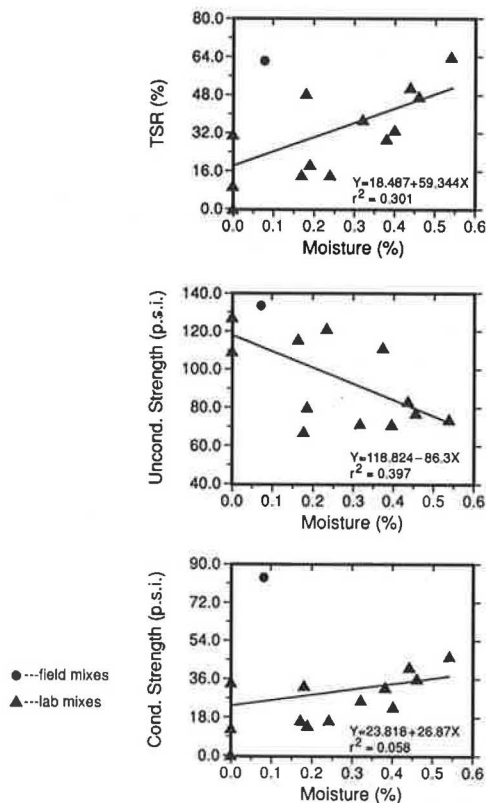
FIGURE 4 Mixes A and J, all data.

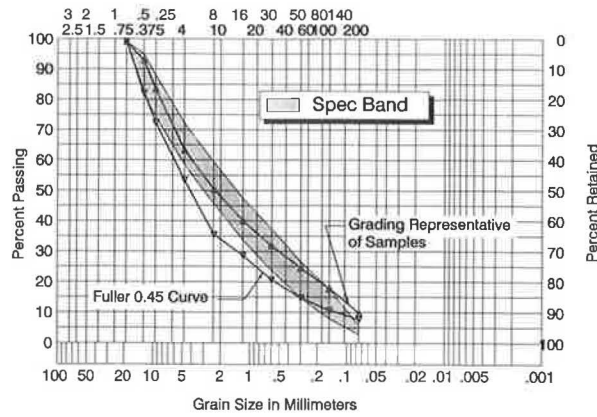
FIGURE 2 Representative grading for test section mixtures.

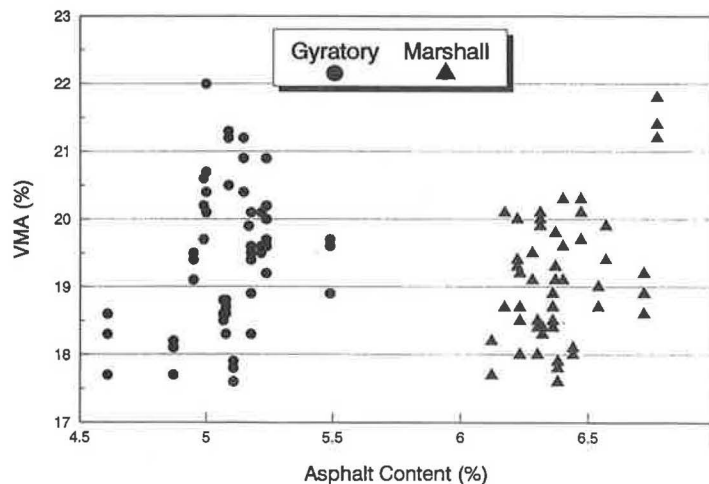
FIGURE 3 VMA of cores before traffic.

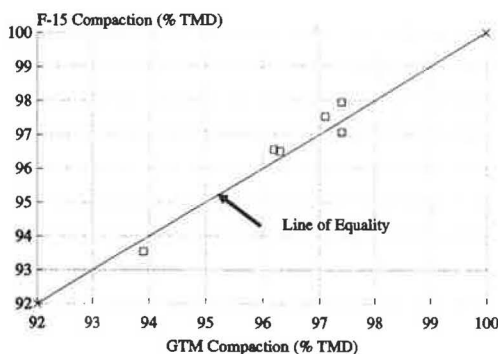
FIGURE 8 Laboratory versus traffic density.

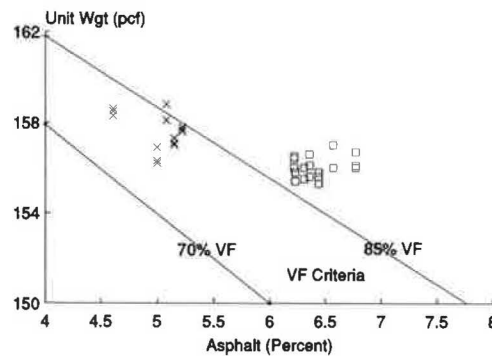
Figure 9 shows the use of two of the parameters in DOD mix designs, density and percent voids filled with asphalt (VF). The line designated as 85 percent voids filled refers to DOD limits for voids filled for absorbent aggregate. Densities of 20 Marshall and 15 gyratory core samples taken from the test sections after traffic are shown as data. When F-15 traffic was applied to the AFCESA test sections that were surfaced with the 6.4 percent binder mixture required by the Marshall design, the excessive compaction filled the mixture's air voids with asphalt. The load-carrying ability of the mix was transferred from the aggregate to the binder; plastic flow of the mixture ensued. Even the 5.1 percent asphalt mixture required by the gyratory design was trafficked into the upper boundary of criteria limits for VF. These show why the lab-

FIGURE 9 Final densities under traffic versus criteria.

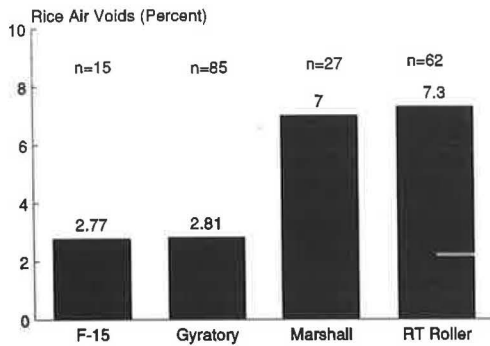
FIGURE 10 Effect of four levels of compaction on gyratory mix.

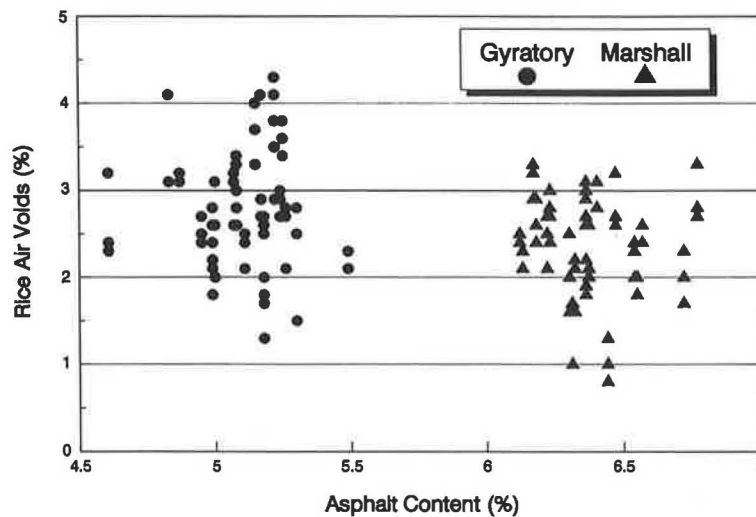
Samples of the gyratory mix were taken from the paver and compacted by GTM into 74 specimens (Figure 11). Sixty-seven percent of these compactions had less than 3 percent air voids; their average GSI was 1.057. Although these data indicated that the gyratory mix might rut, cores taken after 10,350 passes of traffic averaged 2.81 percent Rice voids, and there was little evidence of plastic flow. In fact, Figure 12 shows that densification of the gyratory mix was essentially

FIGURE 11 Voids of laboratory-compacted paver samples.

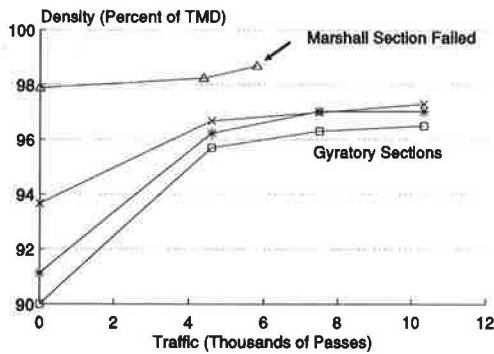
FIGURE 12 Densification under traffic.

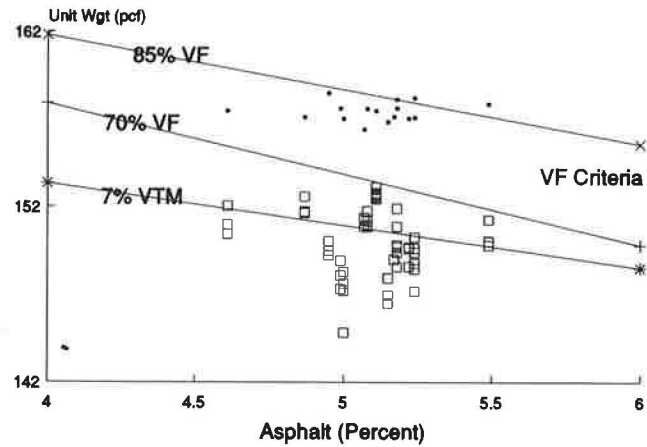
FIGURE 13 Laboratory versus initial field bulk densities of the gyratory mix.

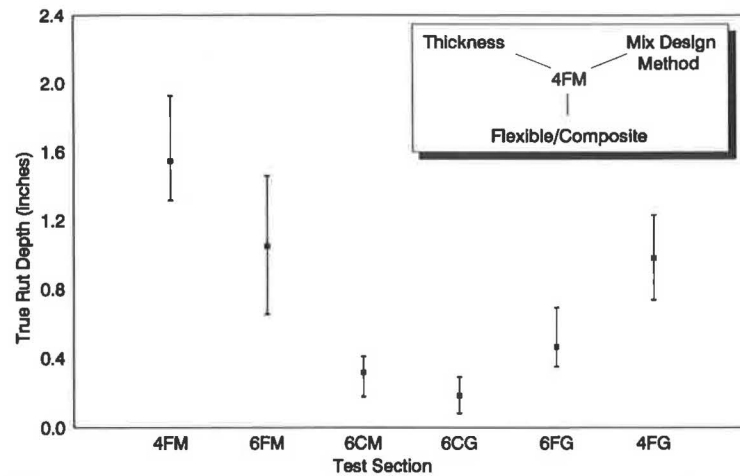
The differential rutting between 4- and 6-in. surfaces is also clear from Figure 14. Traffic over the 4-in. Marshall test sec-

FIGURE 14 Means and ranges of surface rutting after 2,324 passes.

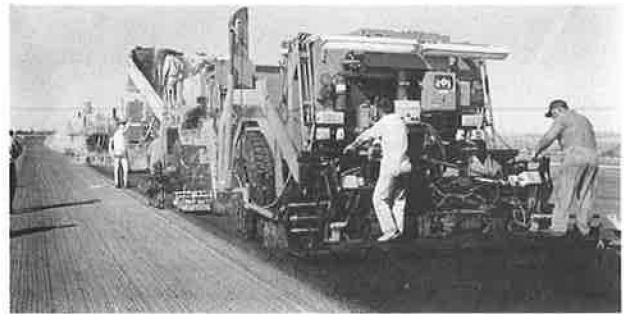
The heat reforming process [HRP-5 and HRP-6 (there are several comparable systems)], as shown in operation (HRP-5) and schematically in Figure 1, typically consists of a liquid propane gas (LPG) infrared heating system (up to three preheaters with up to 5.58 million kcal/hr total heating capacity) that can effectively heat to a depth of 50 mm and a reforming system that can apply additional heat (up to 616,000 kcal/hr),

GENERAL VIEW OF HEAT REFORMING PROCESS (HRP-5) AT SPOKANE INTERNATIONAL AIRPORT SHOWING THE TWO PREHEATERS AND REFORMER. The pre-milled (75 mm) keel section involved heater scarification/rejuvenation (50 mm) with new surface course placement (50 mm) in one pass (Remix-Repave Option) [6].

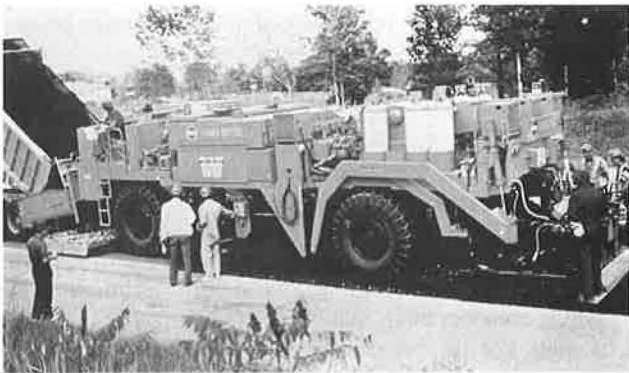
FIGURE 2 Heat reforming process (HRP-5) on Ontario Highway 5/24, showing reformer (40 mm with rejuvenation, remix option) (7).

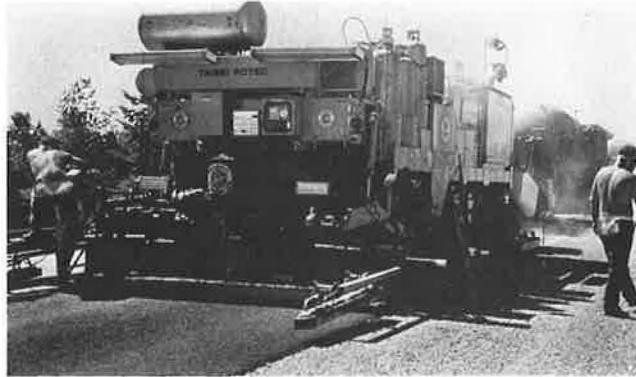
FIGURE 4 Heat reforming process (HRP-6) on British Columbia Highway 1 near Langley (40 mm without rejuvenation, reform option) (8).

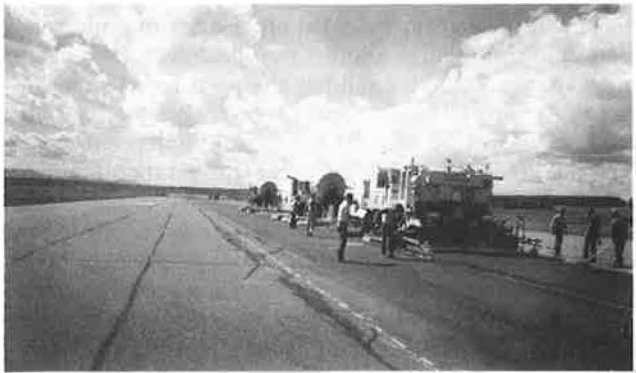
FIGURE 5 Heat reforming process (HRP-6) on Runway 15-33 at Prince George Airport (50 mm with rejuvenation, remix option) (9,10).

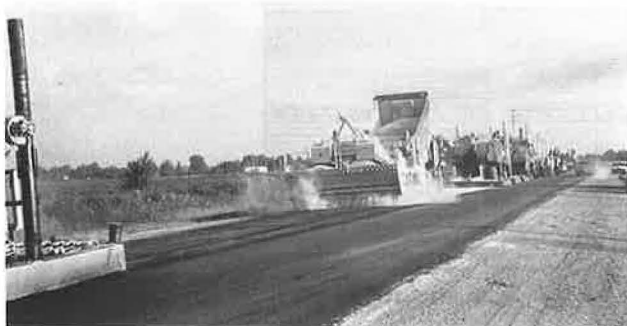
FIGURE 7 Hot manufactured sand being applied approximately 5 mm thick using a chip spreader between the first and second preheater (15).

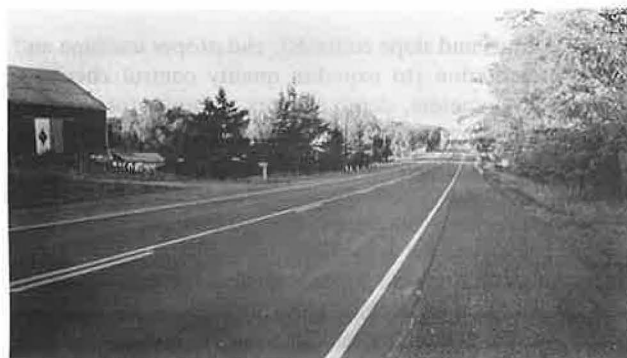
FIGURE 8 Typical rural heat reforming (HRP-5) pavement surface (John Emery Geotechnical Engineering, Limited).

To take advantage of the demonstrated quality (Figure 8) achieved with the heat reforming process (HRP-5, HRP-6, and similar equivalent systems), it is necessary for project

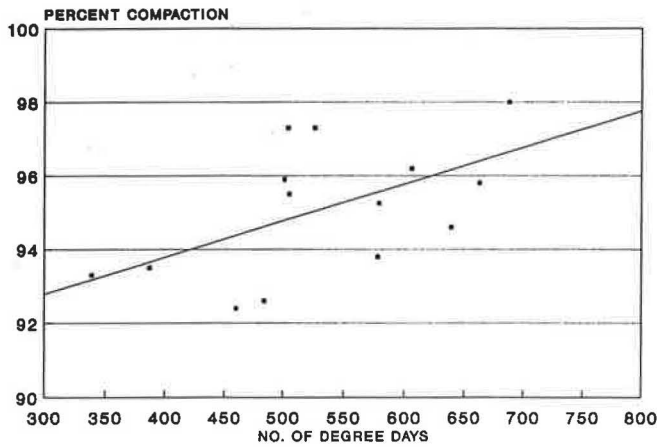
FIGURE 2 Compaction versus degree days, CIR mix.

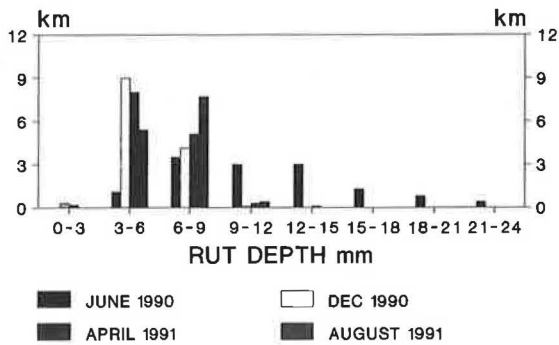
FIGURE 9 Rut classification survey, Highway 15, southbound.

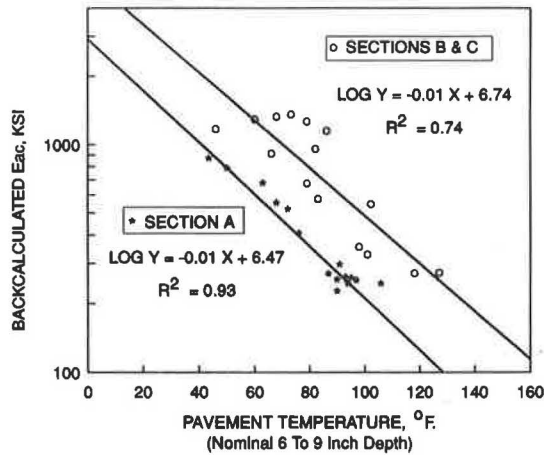
FIGURE 2 Backcalculated E_{AC} versus pavement temperature.

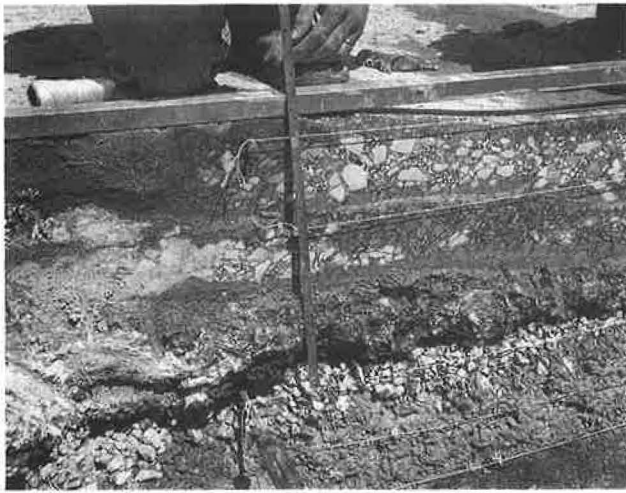
FIGURE 4 Pavement trench at Milepost 17.46, US-23–Louisia Bypass.

Measurable rutting was isolated in locations where trucks travel at relatively slow speeds (10 to 20 mph) along the northbound driving lane on steep uphill grades. The greatest amount of rutting after 2 years of service occurred at Milepost 17.46. It

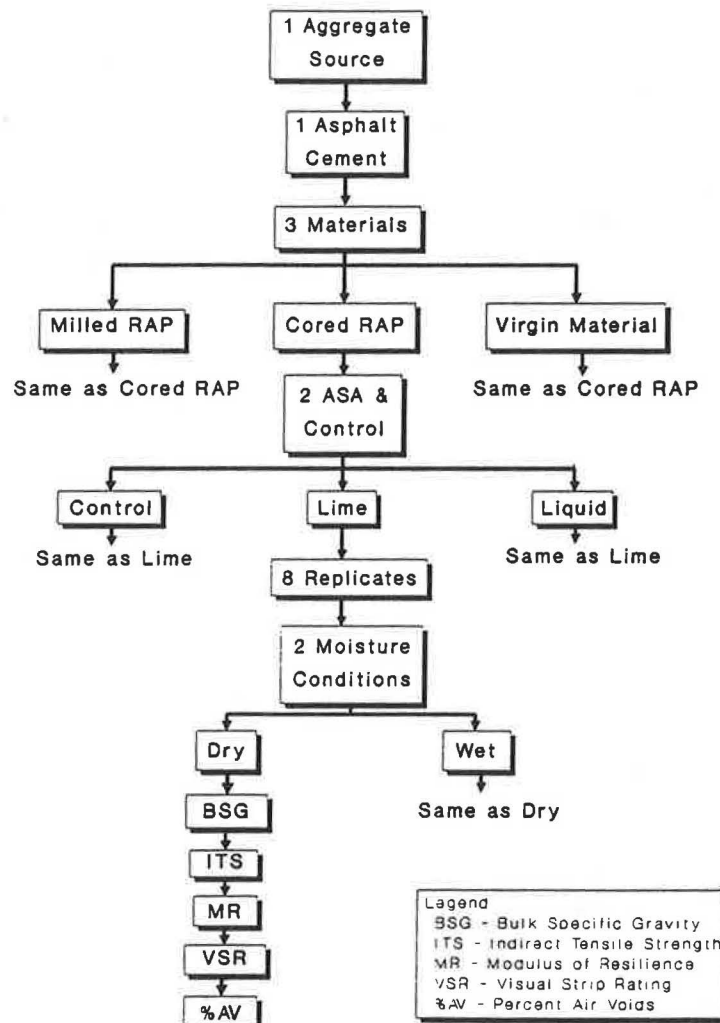
FIGURE 1 Statistical design for laboratory experiments.

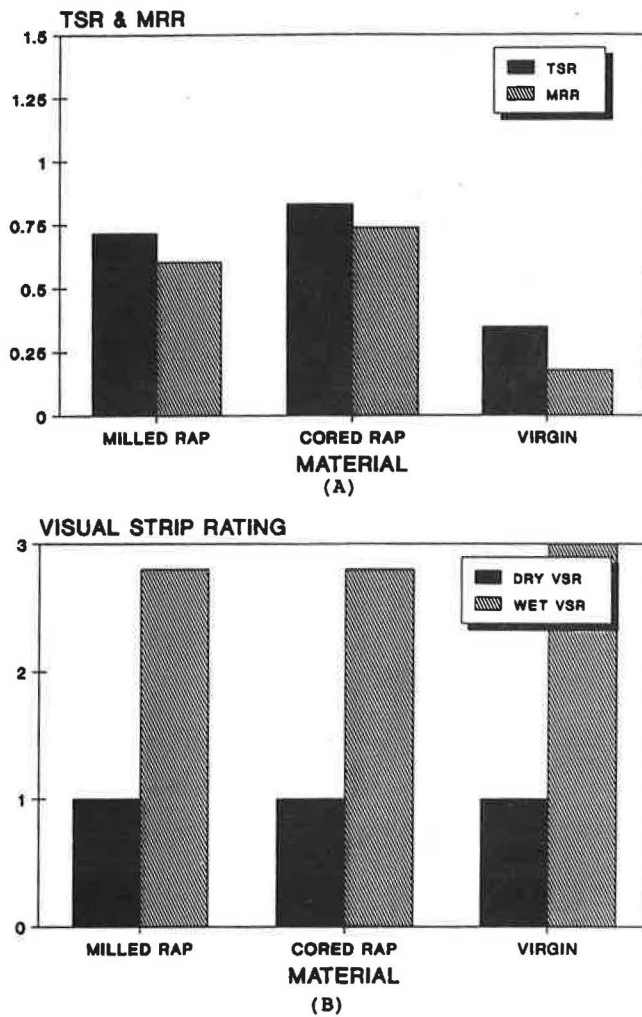
FIGURE 3 Mean tensile strength and MRR (A) and mean VSR (B) for laboratory-prepared Marshall specimens containing no antistrip additive ($N = 4$ except for dry VSR, for which $N = 8$).

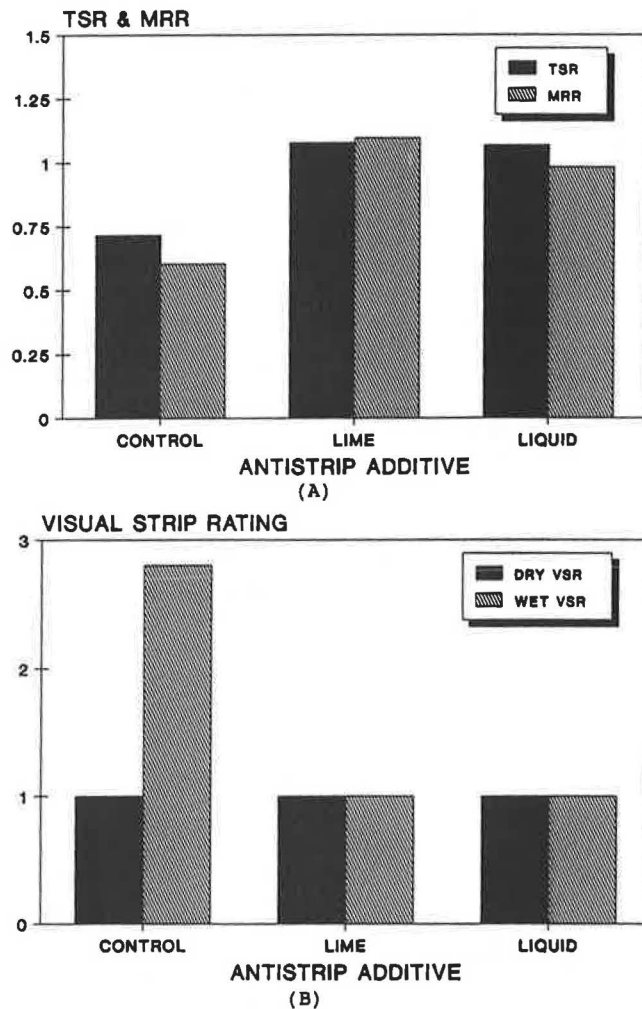
FIGURE 5 Mean tensile strength and MRR (A) and mean VSR (B) for laboratory-prepared Marshall specimens containing milled RAP material ($N = 8$ except for lime for TSR, for which $N = 9$).

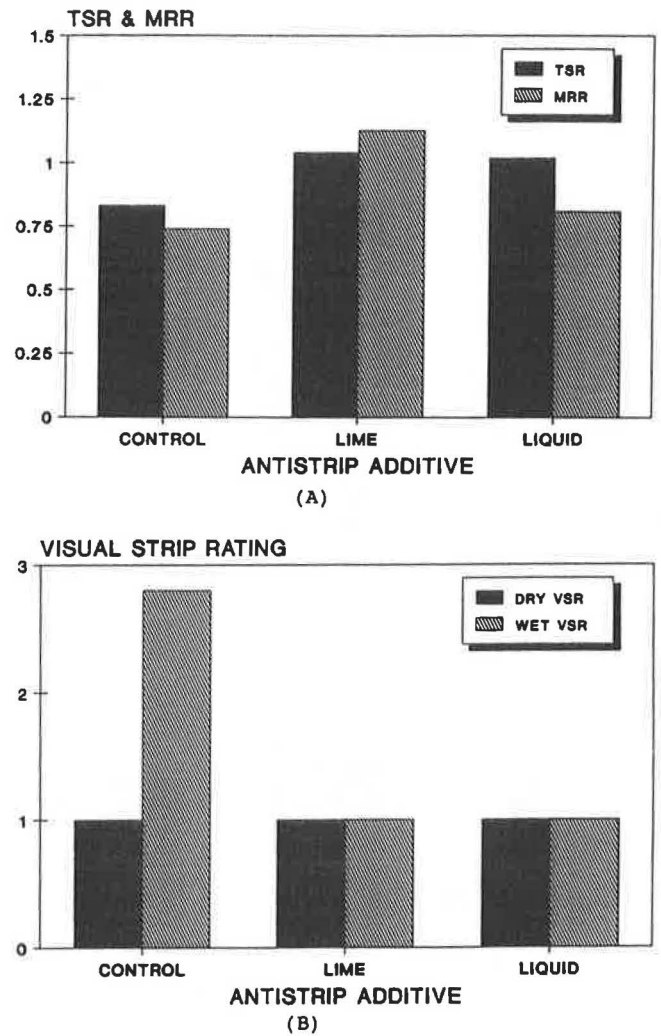
FIGURE 7 Mean tensile strength and MRR (A) and mean VSR (B) for laboratory-prepared Marshall specimens containing cored RAP material ($N = 8$).

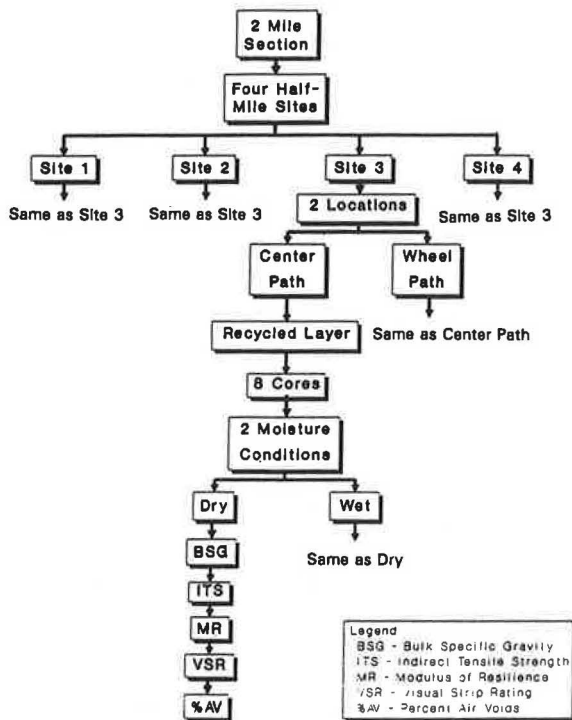
FIGURE 8 Field treatment design for recycled pavement.

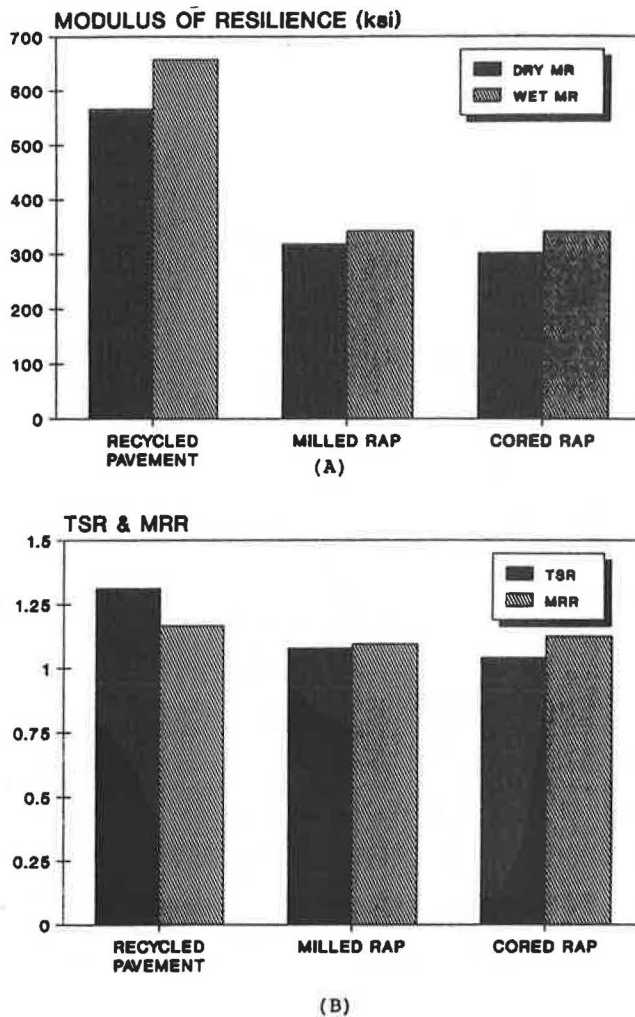
FIGURE 10 Mean MR ($N = 8$ except for recycled pavement, for which $N = 32$) (A) and mean tensile strength and MRR ($N = 8$) for recycled pavement and laboratory-prepared Marshall specimens containing milled and cored RAP.
