Turnout Rehabilitation with Bituminous Concrete Underlayments

JERRY G. ROSE

The importance of providing adequate trackbed support to maximize turnout life is emphasized. A relatively new procedure for construction and rehabilitation turnout trackbeds is described. The technique involves placing a subballast layer of bituminous (hot-mix asphalt) concrete below the ballast to provide proper support, impermeability, and positive drainage for the track structure. Design practices, installation procedures, 10-year performance evaluations, and economic studies are presented.

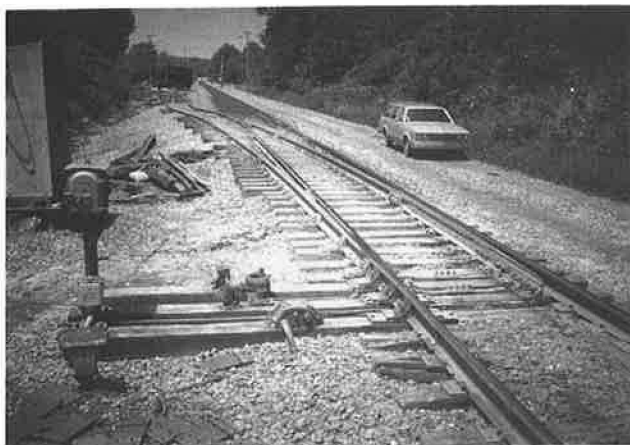
FIGURE 2 Typical pumping turnout before placement of HMA underlayment.

The primary use of HMA underlayments in turnouts is to rehabilitate turnouts that have exhibited poor performance when conventional procedures have been used, which has resulted in high maintenance costs and poor operating efficiency. Pumping of the fines (mud) from the underlying subgrade or old roadbed is the common condition (see Figure 2). Degradation of the ballast and wear of the ties are contributing factors. Geometry is adversely affected. Conventional in-place jacking and raking, plowing the mud from the shoulders, or adding a geotextile have not been successful in prohibiting the re-occurrence of mud pumping and contamination of the track.

The turnout must first be removed from the line. The contaminated mixture of mud, ballast, and old roadbed are excavated, typically dozed, to the desired grade, which ranges from 0.6 to 0.9 m (2 to 3 ft) below top-of-rail elevation, depending on the specified thicknesses of HMA and ballast.

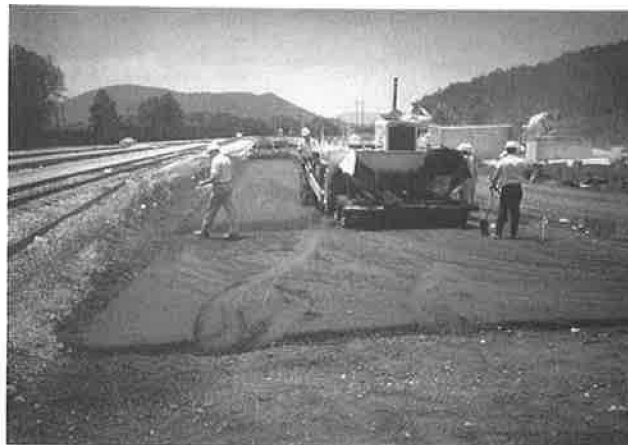
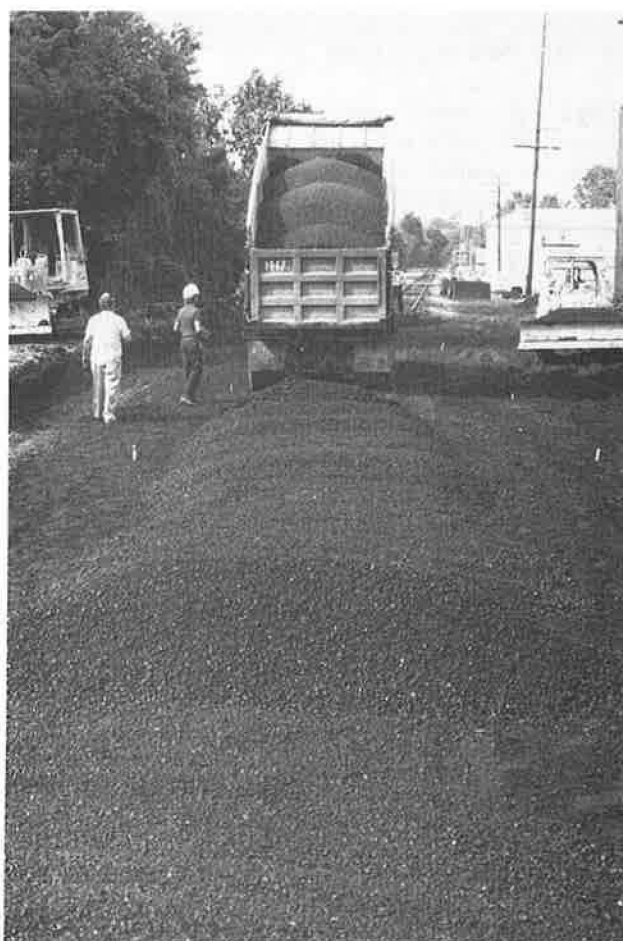
FIGURE 3 Placement of HMA with paver (*top*) and backdumping and spreading with dozer (*bottom*).

The HMA is hauled by dump truck from a hot-mix plant and is either spread with a standard highway asphalt paver or dumped on the grade and spread with a dozer blade. Precise grade and thickness control of the HMA is more difficult when the mix is spread with a blade; however, time and costs are reduced if a paver and paving crew are not required. The blade spreading technique has been used for the majority of turnout rehabilitation projects. The railroad and contractor forces already on site handle the spreading and placing activities. It is desirable to slightly slope or crown the HMA mat to prevent ponding of water and facilitate drainage away from the roadbed. Installation of drainage pipe is normally not necessary. Figure 3 depicts a typical HMA placement.

The mix can generally be placed in a single lift up to 150 mm (6 in.) thick. Compaction should follow soon before the mix cools and stiffens, which would adversely affect the compaction effectiveness. A standard roller, preferably a steel-wheel vibratory type, is commonly used to obtain a well-compacted mat with minimum air voids.

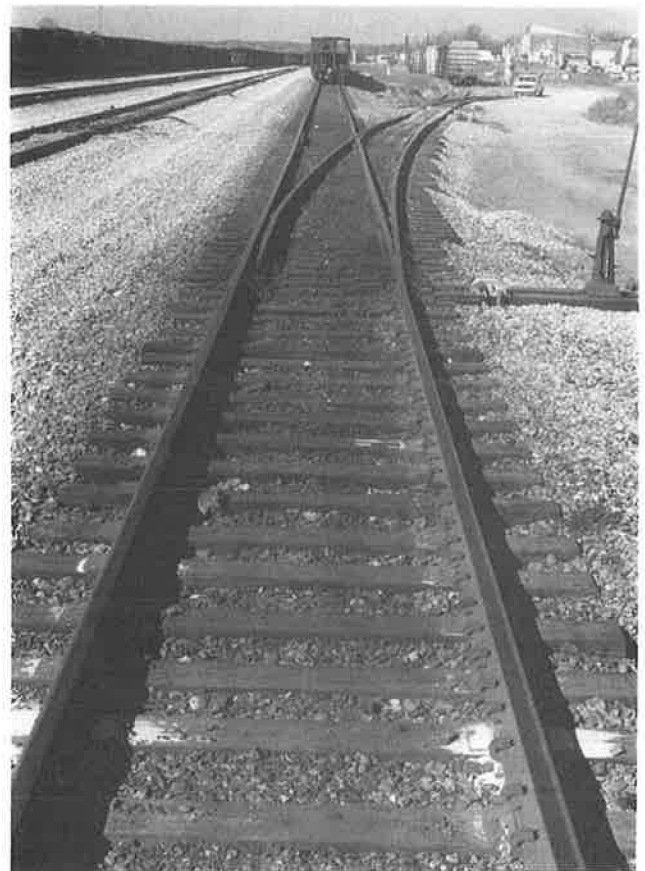
FIGURE 4 CSX Ravenna Yard mainline HMA turnout after 10 years of service.

One of the first turnouts underlain with HMA was in 1981 on a Number 10 turnout on the L&N (now CSX) mainline through this East-Central Kentucky yard. An estimated 15 MGT of mostly 0.91-t (100-ton) coal trains use the mainline through the yard. The old turnout and contaminated ballast were removed as part of a general rehabilitation of the yard. An HMA mat 200 mm (8 in.) thick, 35.7 m (117 ft) long, and 4.3 to 7.3 m (14 to 24 ft) wide was placed on the old roadbed. After the preassembled new turnout was positioned on the HMA mat and joined to the mainline, 150 mm (6 in.) of ballast was unloaded and the track was pulled, aligned, and surfaced with conventional maintenance equipment.

Precise maintenance records were not available before 1981; however, the local maintenance crew indicated that the particular turnout had been a muddy spot for many years and had required a considerable number of raises, ballast, and tamping to keep the track in service. In the 10 years since it was rehabilitated, no maintenance has been required, and the turnout has remained high and dry with no fouling or settlement (Figure 4). The abutting track has performed poorly compared with the turnout. A skin lift was applied to the mainline during 1991.

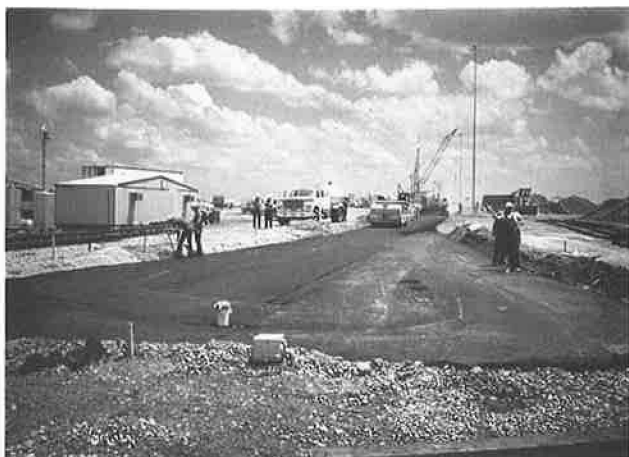
FIGURE 5 Santa Fe Flynn Yard hump track with HMA in place.

four turnouts) at their 20 MGT Flynn Yard in Oklahoma City. This decision followed the favorable 3-year performance of a similar HMA underlayment on the trimlead track at the other end of the bowl. The original hump trackbed, built in 1981 and consisting of lime stabilized soil and ballast, had exhibited periodic major pumping and associated track irregularities. Cranes were used to remove the 183+ m (600+ ft) of line track and four turnouts. Next, the fouled ballast and lime-treated soil were excavated. An HMA mat 150 mm (6 in.) thick was placed in one lift (Figure 5) by means of a highway paving machine. The width and length of the mat varied from 3.7 to 16.5 m (12 to 54 ft) and 191 m (625 ft), respectively. Repositioning the original trackwork and applying 200 mm (8 in.) of ballast completed the installation. A recent view is shown in Figure 6.

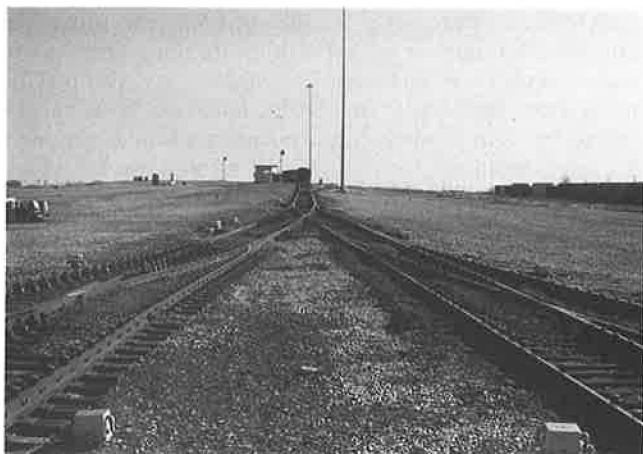
FIGURE 6 Santa Fe Flynn Yard HMA hump track after 7 years of service.

The cost of the HMA underlayment was minimal compared with the total project costs. Since 1985 the hump and scale lead trackage, including the turnouts, have required only one skin lift and have exhibited no settlement or pumping. Detailed data on long-term HMA mixture characterization and

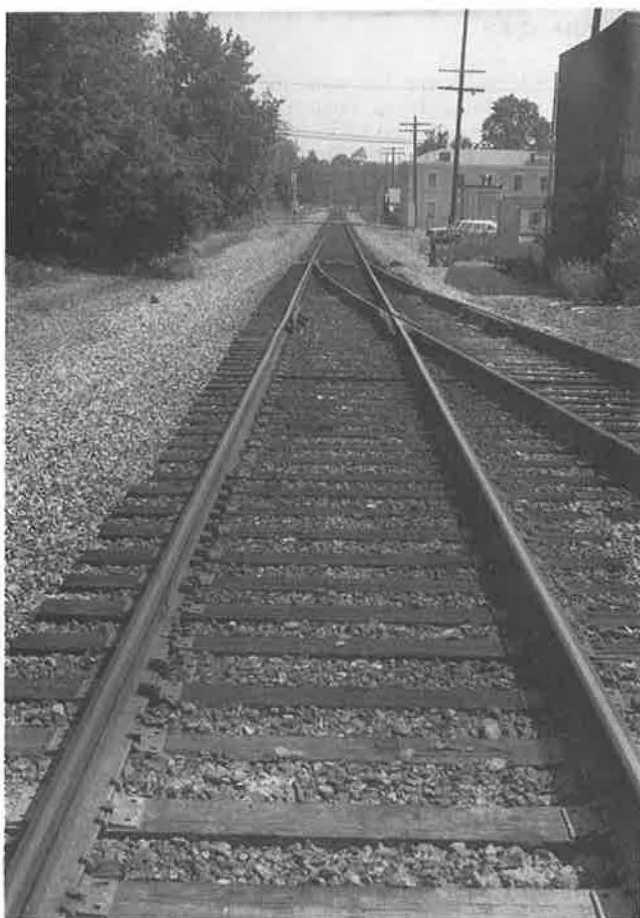
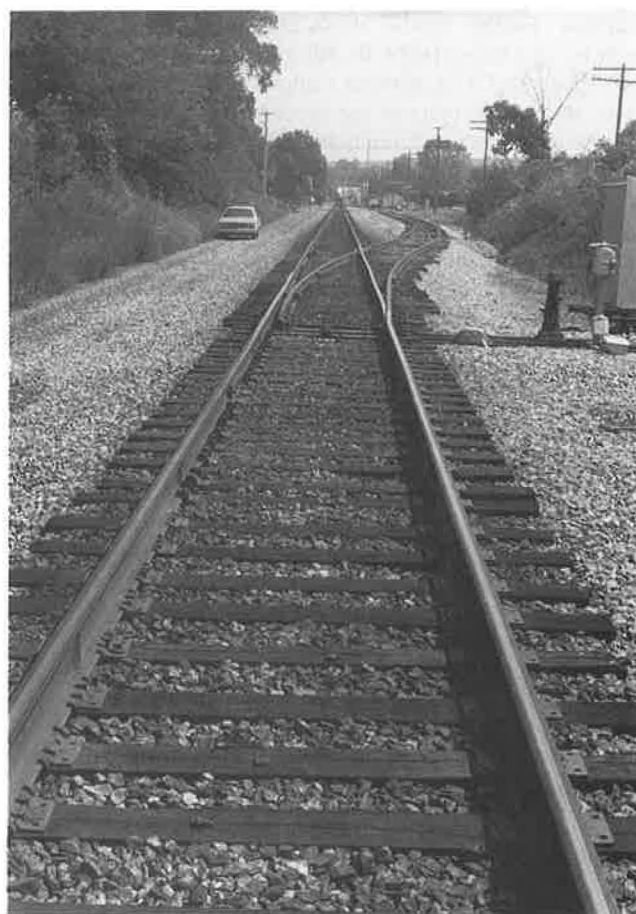
FIGURE 8 CSX Falmouth, Kentucky, mainline HMA turnouts north (left) and south (right).

Two Number 10 turnouts at this town on the CSX Transportation single-track 40+ MGT mainline south of Cincinnati were rehabilitated in 1986 with underlayments to demonstrate the applicability of the technique under traffic. The turnouts had historically required periodic trackbed maintenance with accompanying slow orders. Two dozers and a loader were used to remove the old trackwork and excavate the fouled ballast and several layers of fabric. The HMA was back-dumped and spread with a dozer to a 125-mm (5-in.) thickness, 3.7- to 6.1-m (12- to 20-ft) width, and 46-m (150-ft) length. The dumping, spreading, and compacting of the HMA required less than 1.5 hr. The new trackwork was immediately dragged on the compacted HMA mat and joined to the existing track. Ballast totaling 125 mm (5 in.) thickness was dumped, and the turnouts were tamped and aligned.

first 6 months. Total savings for the following 5 years is \$2,650 \times 5, or \$13,250 per turnout. In addition, traffic interruptions due to maintenance curfews and slow orders have been eliminated, which has provided additional savings. The excellent performance of the turnouts is depicted in Figure 8.

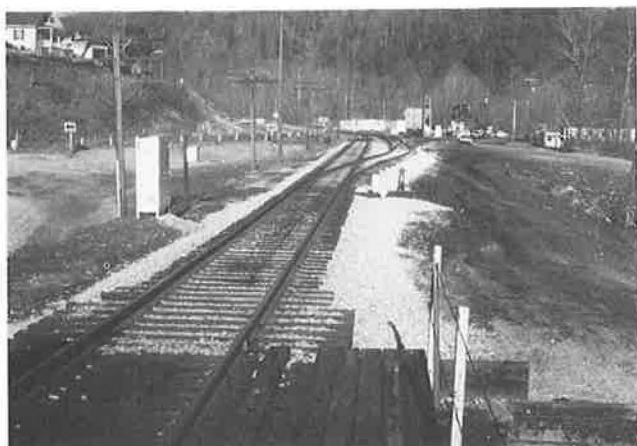
FIGURE 9 CSX Livingston, Kentucky, mainline HMA turnout and bridge approach installation.

This represents a more recent (1988) HMA turnout rehabilitation project on which the costs and performance have been closely monitored. Included in the 90-m (300-ft)-long section on the CSX 50 MGT single-track mainline in southeast Kentucky were a Number 10 turnout for the Livingston sidetrack and the approach to north end of the Rockcastle River bridge. The turnout and bridge approach had required periodic trackbed maintenance for several years. A geotextile had been placed previously under the turnout, but had not rectified the chronic pumping and instability problems. It was decided to remove the badly deteriorated turnout and underlying materials and replace them with an HMA underlayment and new ballast and turnout.

The track was out of service for 8 hr. Dozers were used to remove the track and excavate 330 mm (13 in.) below bottom of ties. The 109 t (120 tons) of HMA was backdumped on the grade, spread with the dozers, and compacted to a 125-mm (5-in.) thickness in 45 min. A 200-mm (8-in.) thickness of granite ballast and a new wood tie turnout were installed along with the existing track panels (Figure 9).
