TRANSPORTATION RESEARCH  
**RECORD**

No. 1347

**Maintenance of  
Highway Structures**

*A peer-reviewed publication of the Transportation Research Board*

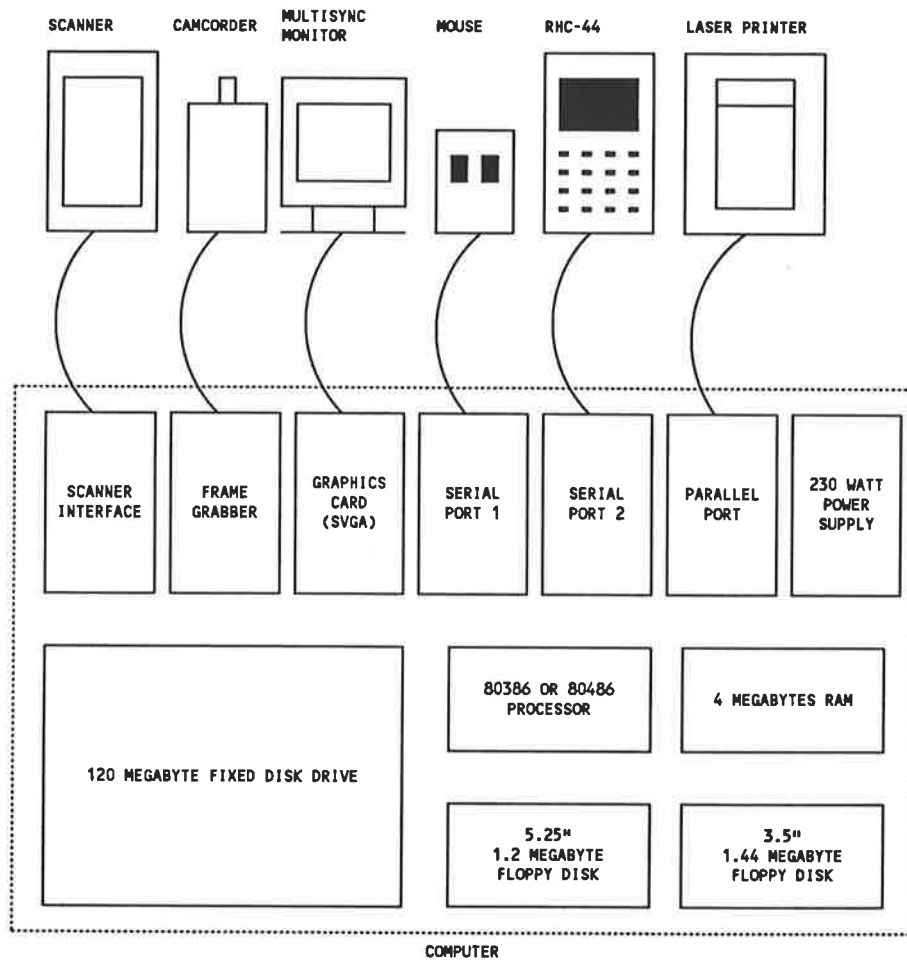
FIGURE 1 Schematic of recommended hardware configuration for automated bridge inspection system.

An MS-DOS PC based at the district inspection office is required to control the transfer and assembly of inspection data into a report. Because the computer-automated bridge inspection system depends heavily on computer graphics, a PC with a fast processor, large amount of internal memory, and high-quality video and storage subsystems is necessary. Figure 1 shows a schematic of the computer configuration recommended for the computer-automated bridge inspection system.

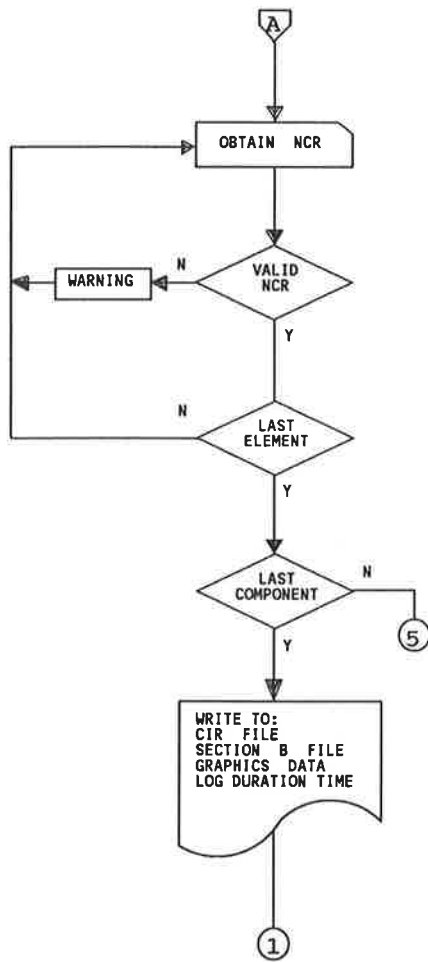
FIGURE 4 Data acquisition flowchart, NCR input.

The NCR input section has built-in features to ensure that all components and elements are addressed. NCRs of elements that have comments in the Comprehensive Report of Deficiencies, Section B of the report, are automatically affixed with an asterisk. The user of the report then knows to

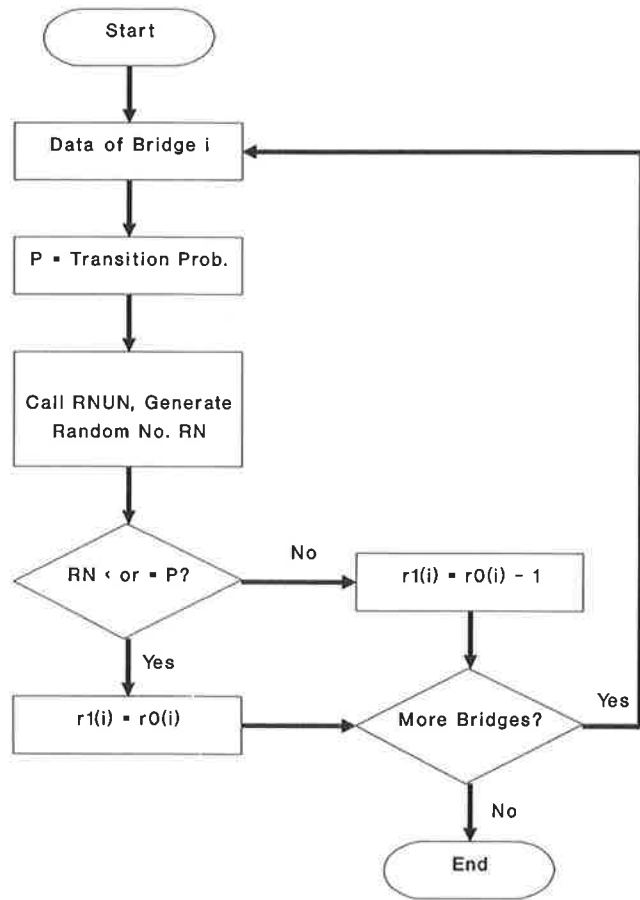
**FIGURE 1** Flowchart of simulation prediction program.

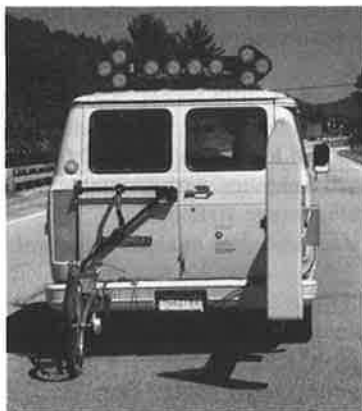
FIGURE 1 Radar equipment.

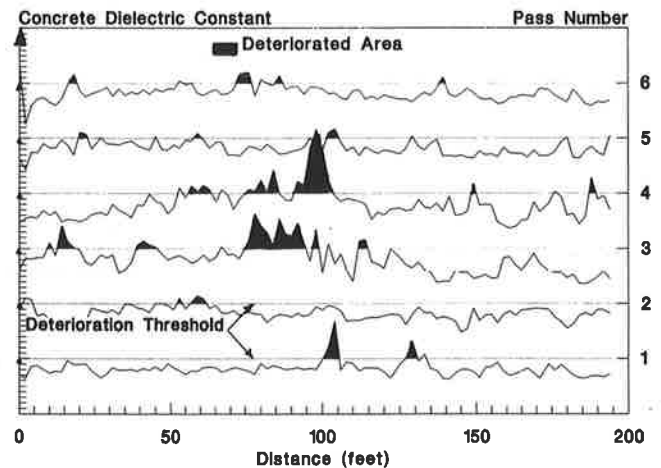
FIGURE 2 Concrete dielectric constant versus distance along deck.

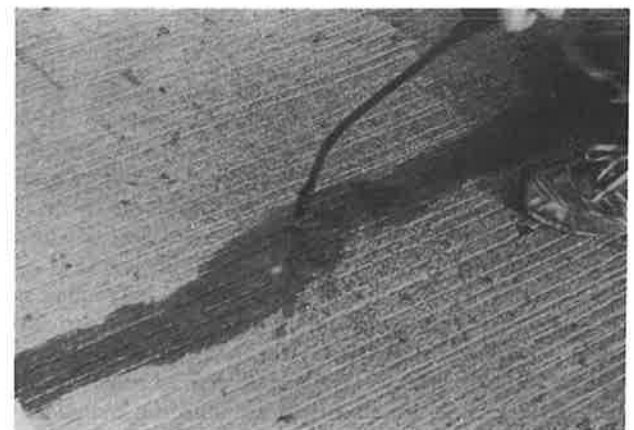
**FIGURE 1** HMWM monomer applied to cracks in tined bridge. To maintain good skid number, excess resin in valleys must be broomed over deck surface before it gels.

Each monomer was mixed in 1- or 2-gal batches and poured into 2-gal spray cans that were used to apply it to the cracks. HMWM monomer gels rapidly when contained in large quantities, and therefore 1 gal or less of mixed monomer was placed in a spray can. The monomer was applied to the cracks at the rate of 200 ft/gal. According to the inspector, many spray cans became inoperable because the monomer gelled in the nozzle or in the line between the nozzle and the container. The special provision required three applications to each crack. However, because of the narrow width of many of the cracks and because the first application tended to seal the top of the cracks, only the wider cracks received more than one application. As can be seen in Figure 1, the deck surface within 3

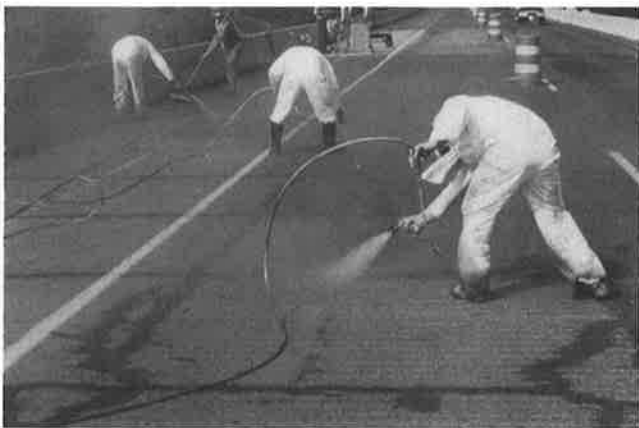
**FIGURE 2** Airless spray guns were used to apply HMWM resin to surface of tined bridge deck. Note that work crew is wearing rubber boots and gloves, impermeable coveralls, and canister breathing masks.

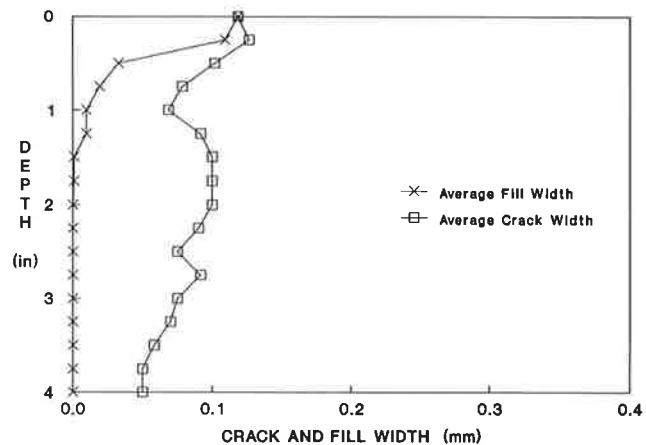
**FIGURE 5** Average crack width and crack width filled versus depth (tined bridge), all cracks, Spans 8 and 9 (T-70-M). At surface, average fill width = 0.12 mm and average crack width = 0.12 mm.

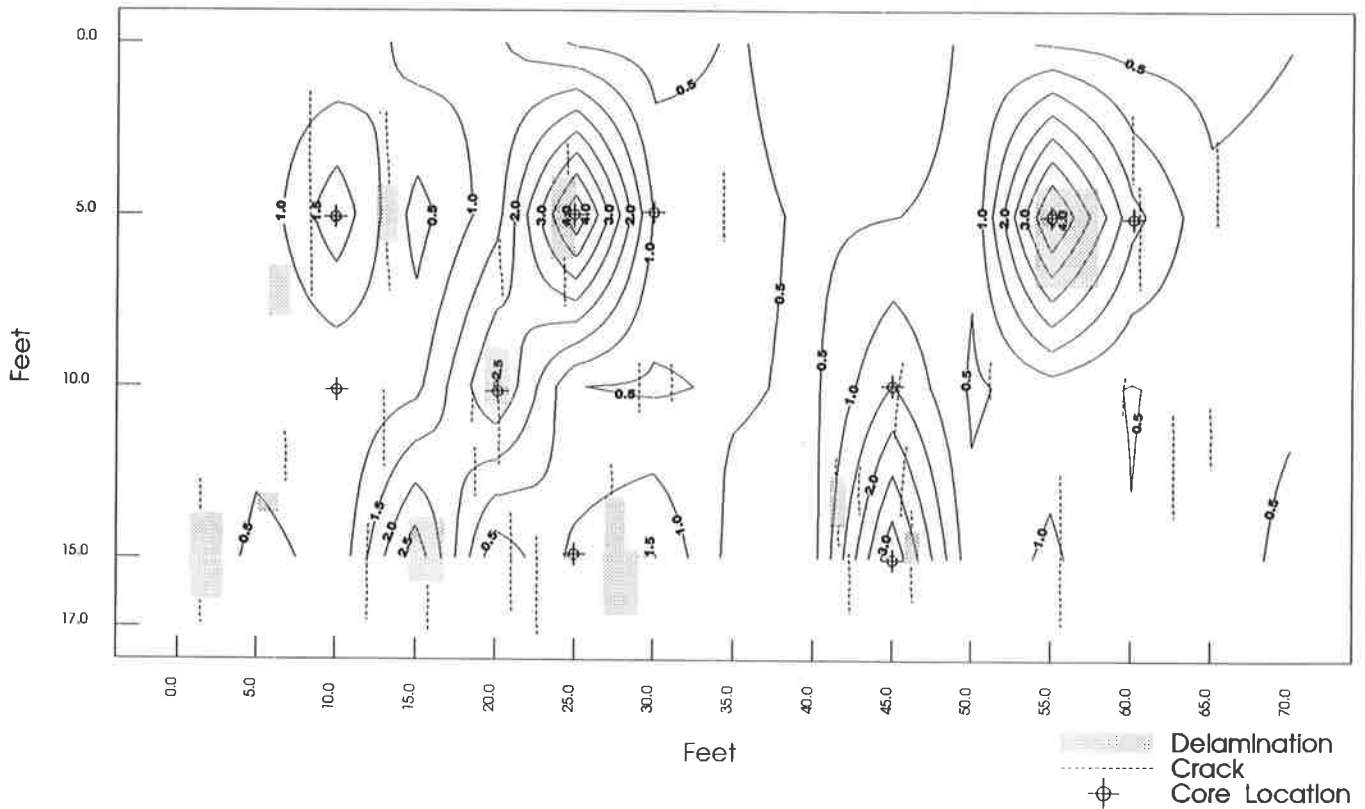
**FIGURE 2** Contour map of rebar corrosion rates (mA/ft<sup>2</sup>) observed in a section of Structure 09302.

The variation in rebar corrosion rate with location in a concrete deck, as shown in Figure 2, also raises an interesting question: Is there any possible relationship between the instantaneous corrosion rates that are obtained during a survey and the current physical condition of the rebars? To provide

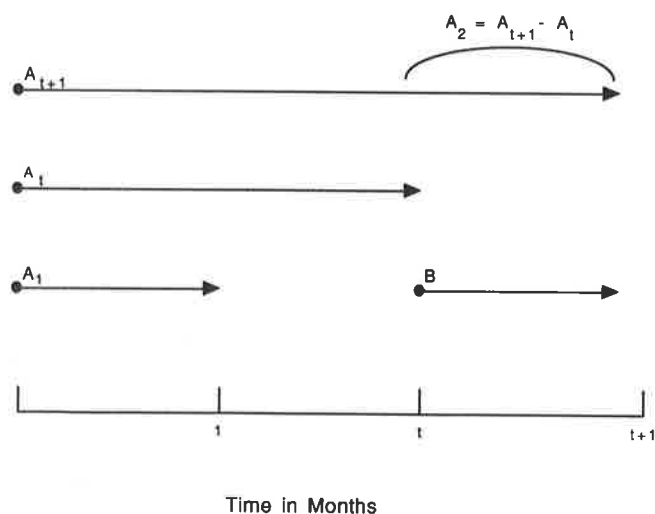
FIGURE 1 Planned interval test design. Each arrow represents immersion of corrosion coupons in solution for duration shown ( $t = 2$  for 3-month test).
