Evaluation of Frost Action Mitigation Procedures for Highly Frost-Susceptible Soils

MICHAEL H. MACKAY, DAVID K. HEIN, AND JOHN J. EMERY

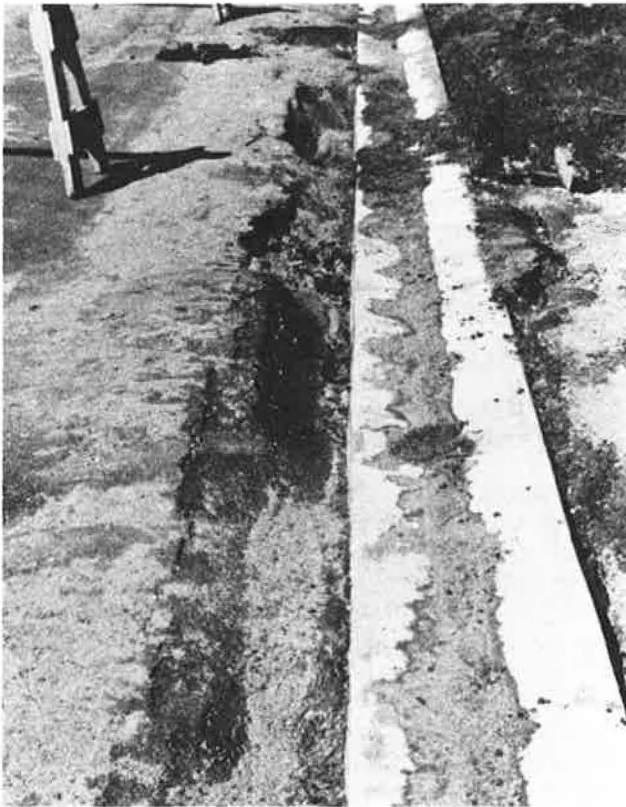
FIGURE 3 Severe differential frost heave of 1-year-old subdivision pavement with shallow continuous subdrains behind curb.

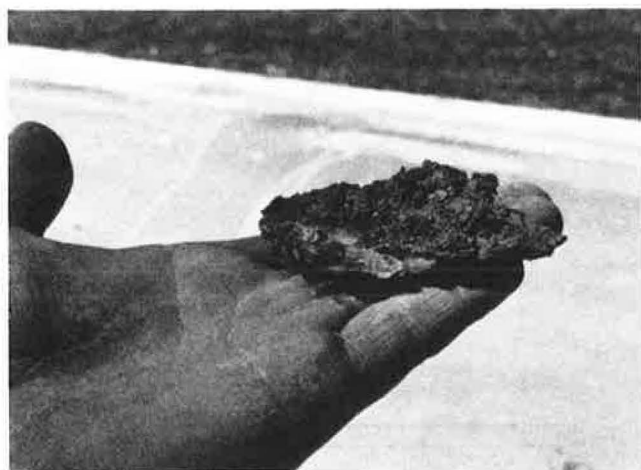
FIGURE 4 Ice lens removed from frost-susceptible silty subgrade at about 1.5 m. This excavation work was completed in late July after normal summer weather in the District Municipality of Muskoka.

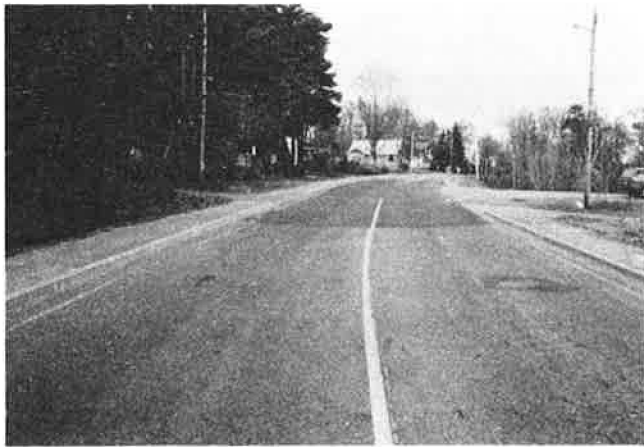
FIGURE 6 Severe differential frost heave of approximately 10-year-old District Road 2 pavement. The extensive padding has been replaced nearly annually to restore surface drainage and ride through the intersection.

After 10 winters, District Road 2 is considered to be in poor condition (Figure 6). Severe frost-related distress is observed in both urban and rural sections. The urban section distress is more obvious because of the presence of curbs. Severe differential movement of the upslope edge of the pavement and curb has taken place to such an extent that full width padding of the roadway has been necessary to maintain surface drainage. Longitudinal and transverse cracking related to frost heaving and distortions of the pavement confirm that the frost treatments used are not adequate for this road-

way and are the principal reason for the low serviceability of this road after only 10 years.
