# Minnesota Bridge Rail–Guardrail Transition Systems

KING K. MAK, GLENN R. KORFHAGE, AND J. A. KINDOM

Summarized are the results of crash testing and evaluation of two W-beam guardrail-to-concrete safety-shaped bridge-rail transition designs developed by the Minnesota Department of Transportation. The first, integral end-post design, is intended for use with new construction and reconstruction in which replacement of bridge railings is required. The second, separate end-post design, is intended for use as retrofits to existing bridge railings on 3R and 4R projects. Three crash tests were used to evaluate the integral end-post design. Results of the crash tests indicated that the integral end-post design met all impact performance evaluation criteria according to guidelines outlined in NCHRP Report 230. Two versions of the separate end-post transition design were evaluated, each with one crash test. Results of the first crash test indicated that the initial separate end-post design did not meet the impact performance evaluation criteria according to guidelines outlined in NCHRP Report 230. The vehicle pocketed and impacted the end of the concrete bridge end post, resulting in an u

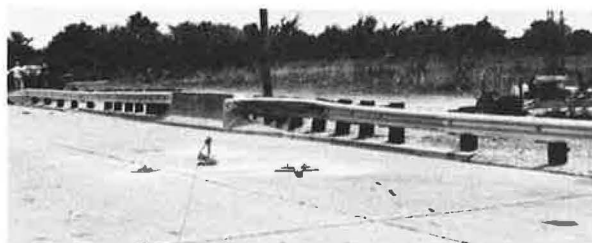
FIGURE 2 Integral end-post transition after Test 1.

The transition installation received moderate damage, as shown in Figure 2. There was residual deformation to the nested rail in the area of the first seven posts. In addition,

vehicle tire marks were observed on Posts 2–5 and on the first 4.0 ft (1.22 m) of the concrete bridge parapet. However, there was no apparent structural damage to the concrete bridge parapet. Also, there was no debris or detached elements to show potential for penetration of the occupant compartment or to present undue hazard to other vehicles.

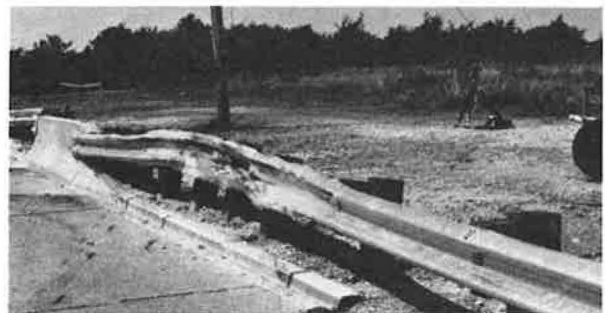
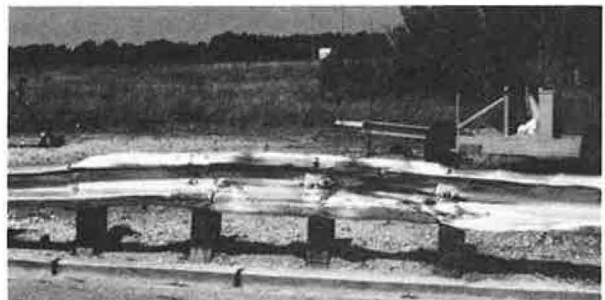
FIGURE 4 Integral end-post transition after Test 3.

The installation received moderate damage, as shown in Figure 4. There was residual deformation to the rail from Posts 2 through 10, but no apparent structural damage to the concrete bridge parapet. Also, there was no debris or detached elements. The vehicle received severe damage, the majority of which occurred to the right front quarter of the vehicle. The right front wheel and control arm were severely bent and pushed 7.0 in. (17.8 cm) rearward. In addition, the entire front end was shifted 4.0 in. (10.2 cm) to the left. The floor pan and drive shaft were also damaged.

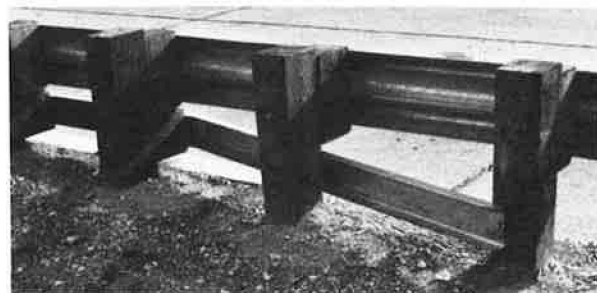
**FIGURE 7** Photographs of improved separate end-post transition design test installation.

The center of the rub rail was 11 in. (27.9 cm) below that of the W-beam. The rub rail was blocked out with 6- × 8- × 8-in. (15.2- × 20.3- × 20.3-cm) wooden blockouts so that the face of the rub rail aligned with that of the W-beam. The total length of the rub rail was 25 ft (7.62 m), spanning from the concrete end post to Post 9, after which the rub rail was bent slightly backward for termination at the back of Post 11. At its connection with the concrete end post, the lower flange of the channel rub rail was cut to accommodate the lower sloped surface of the concrete safety shape so that the face of the rub rail would remain vertical. A special end shoe was fabricated to cover the exposed end of the rub rail. Photographs of the completed installation are shown in Figure 7.

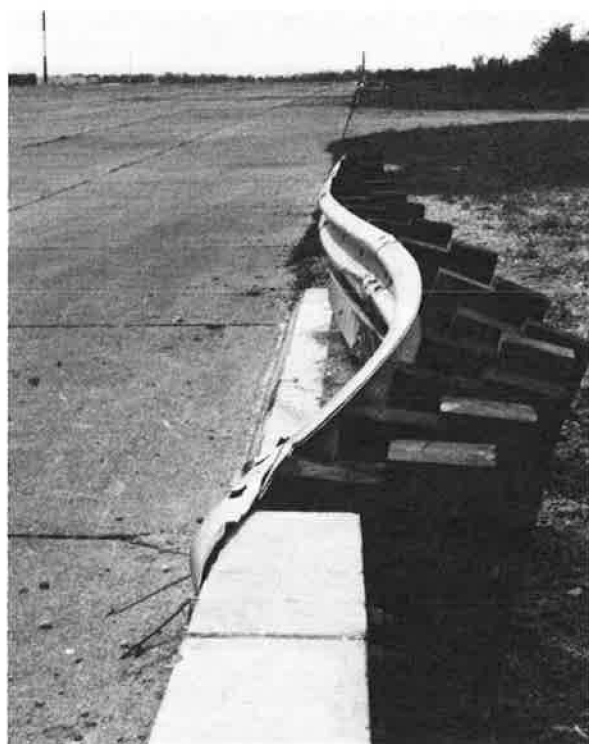
**FIGURE 8** Improved separate end-post transition after improved design test.

The transition system received moderate damage, as shown in Figure 8. There were tire marks all along the rub rail, and some of the bolts were damaged from contact with the vehicle wheel rims. The maximum permanent deformation of the W-beam rail element was 1.3 ft (0.4 m) between Posts 5 and 6. Maximum permanent deformation of the rub rail was 1.25 ft (0.38 m), also between Posts 5 and 6. There were no detached elements or debris.
