TRANSPORTATION RESEARCH RECORD

No. 1367

Development and Evaluation of Roadside Safety Features

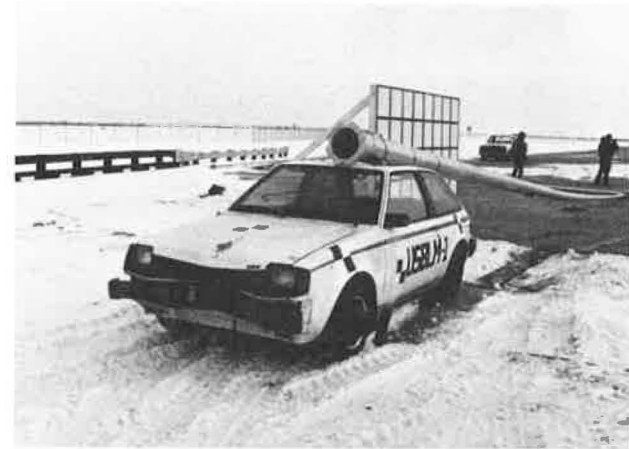
FIGURE 6 Vehicle and installation damage, Test USBLM-1.

The vehicle damage was minimal, with a maximum crushing distance of 9 in. in the bumper and slight damage to the roof. There was no intrusion of the passenger compartment, and the vehicle was repaired for use in Test USBLM-2.

The surface of the steel pole at the point of impact was not dented or deformed. There was only a slight deformation near the top of the support pole caused by the impact with the concrete. The permanent lower slipbase assembly was undamaged.

The damage to the vehicle and the installation is shown in Figure 6. The TAD (12) and VDI (13) vehicle damage classifications are shown in Figure 4. The occupant impact velocity was determined to be 7.6 ft/sec, which is much less than the 15 ft/sec suggested in NCHRP Report 230 (9). The maximum occupant ridedown deceleration was 3.5 g, which is less than the 15 g recommended in NCHRP Report 230 (9). The vehicle change in speed, calculated from impact to first loss of contact, was 6.1 ft/sec, which is lower than the 15 ft/sec required by AASHTO (10) and the 16 ft/sec required by FHWA (11).

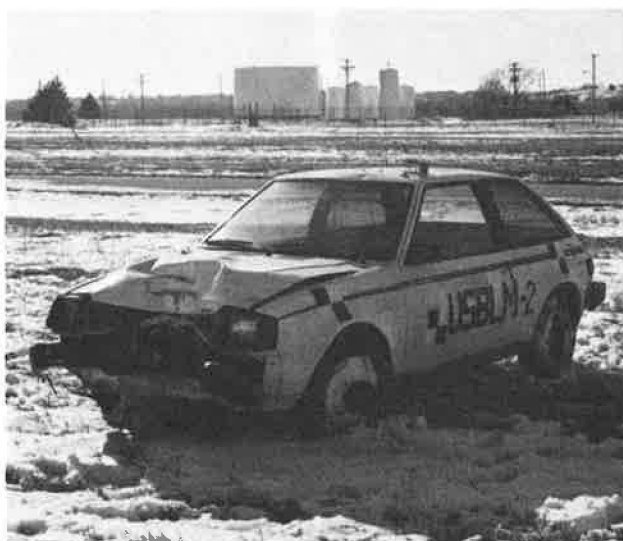
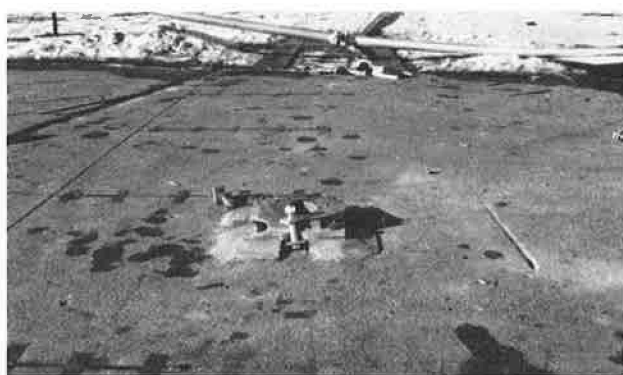
FIGURE 9 Vehicle and installation damage, Test USBLM-2.

The only damage sustained by the vehicle was to the bumper, which had a maximum crushing distance of 12 in. There was no intrusion of the occupant compartment.

The surface of the steel pole at the impact point was not dented or deformed. The support pole was deformed slightly more than in the first test. This deformation occurred at the top of the support pole and was caused by the impact of the pole on the concrete apron. The permanent lower slipbase assembly was not damaged.

The damage sustained by the vehicle and the installation is shown in Figure 9. The TAD (13) and VDI (14) damage classifications are shown in Figure 7.

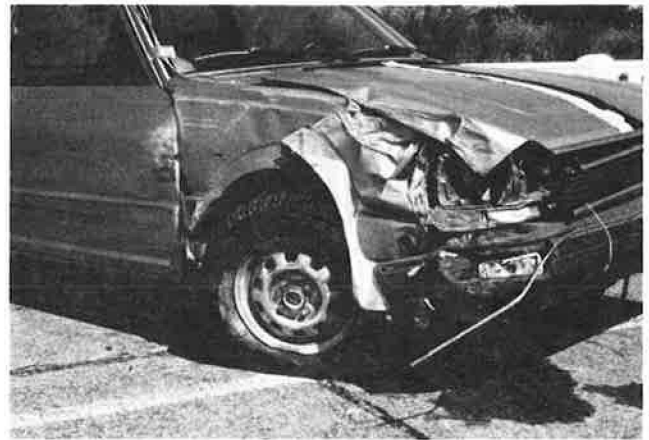
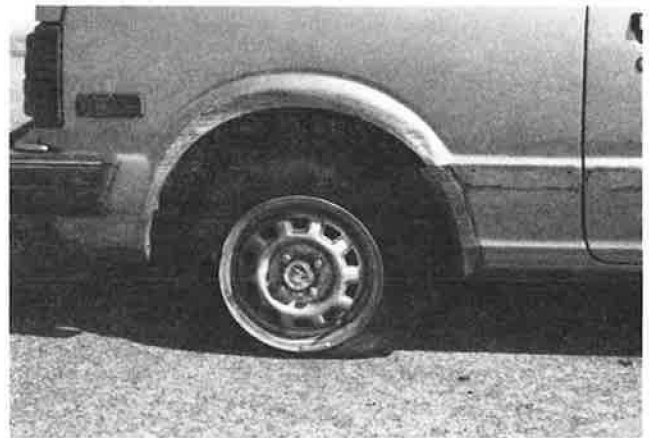
FIGURE 10 Damage to right side of vehicle, Test 1185-5.

The vehicle sustained moderate damage to the right side, as shown in Figures 10 and 11. Maximum crush at the right front corner at bumper height was 9.0 in. (22.9 cm). The right front and rear rims were bent and the tires damaged. There was damage to the hood, grill, bumper, right front and rear quarter panels, right door, and rear bumper.

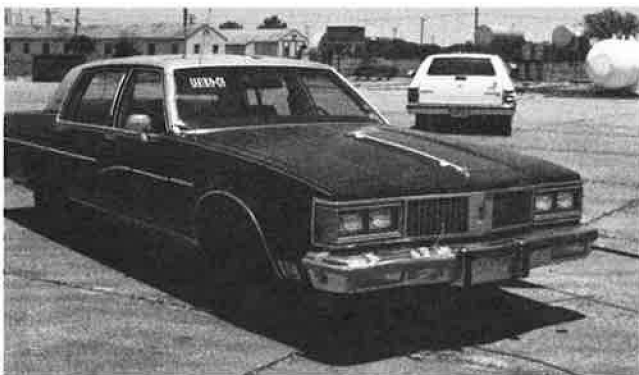
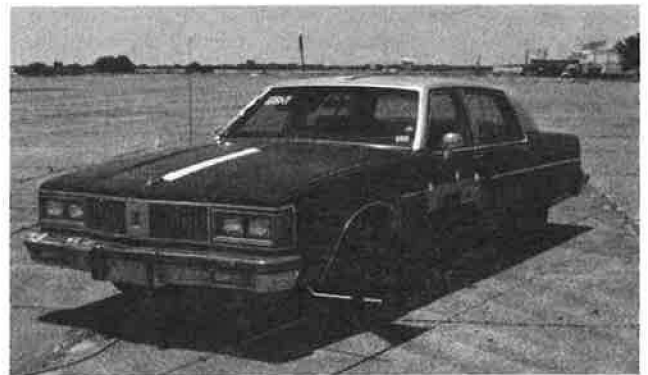
FIGURE 13 Vehicle before Test 1185-6.

A 1982 Oldsmobile 98 (Figures 13 and 14) was directed into the bridge rail installation using a reverse tow and guidance system. Test inertia mass of the vehicle was 4,500 lb (2,043 kg). The height to the lower edge of the vehicle bumper was 12.25 in. (31.1 cm); the height to the top of the bumper was 20.75 in. (52.7 cm). The vehicle was free-wheeling and unrestrained just before impact.

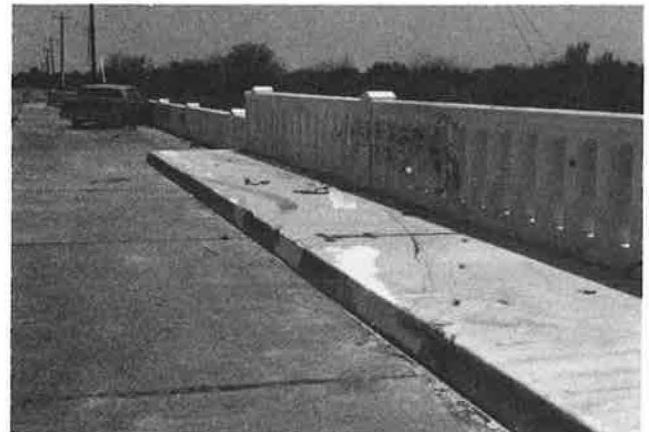
FIGURE 15 Bridge rail after Test 1185-6.

As can be seen in Figure 15, the rail received moderate cosmetic damage. Tire marks on the face of the bridge rail extended 15 ft (4.6 m) from the point of impact. Some scraping and gouging occurred along the edges of the portholes.

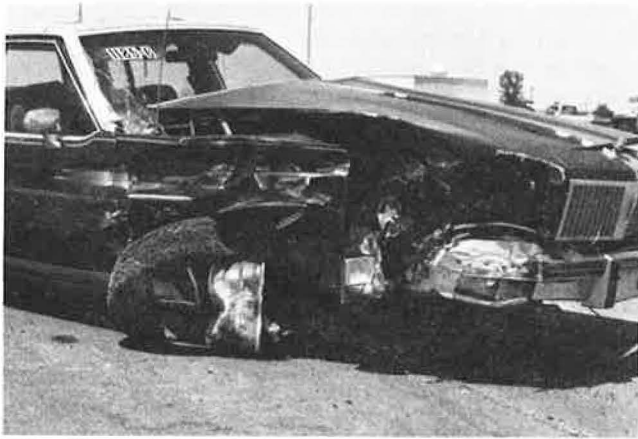
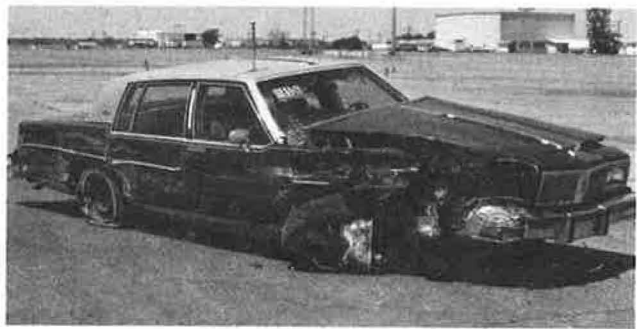
FIGURE 16 Damage to right side of vehicle, Test 1185-6.

The vehicle sustained damage to the right side (Figures 16 and 17). Maximum crush at the right front corner at bumper height was 14.0 in. (35.6 cm). The floorpan and subframe of the vehicle were bent, and the right A-arm, tie rod, and sway bar were damaged. The windshield was cracked, and the roof bent. The right front and rear rims were bent, and the tires were damaged. There was damage to the hood, grill, front

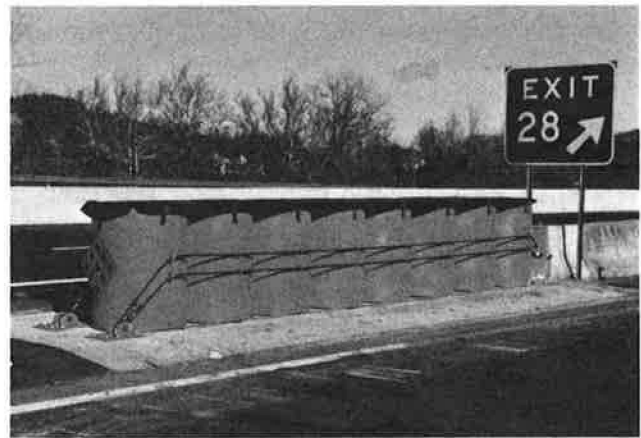
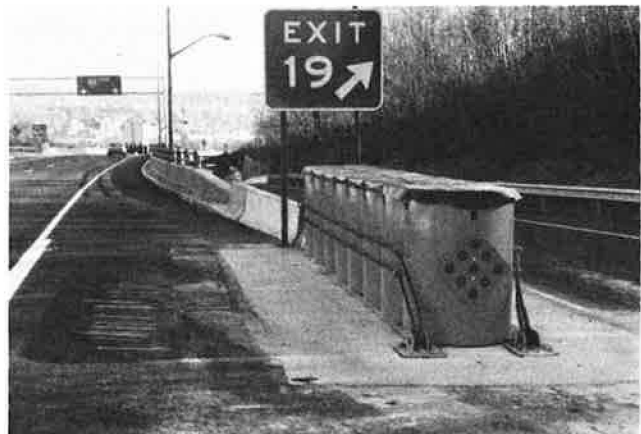
(see Figures 5 and 6). Although these posts comply with breakaway standards, it was decided to change the sign supports at these sites in order to prevent them from interfering with the safety performance of NCIAS and the concrete barrier curb. The new configuration uses a narrower exit sign on a single post support that is mounted atop the backup struc-

ture with four bolts. In addition to improving safety, the new sign mount may reduce repair efforts because it is less likely to be damaged in the raised position.

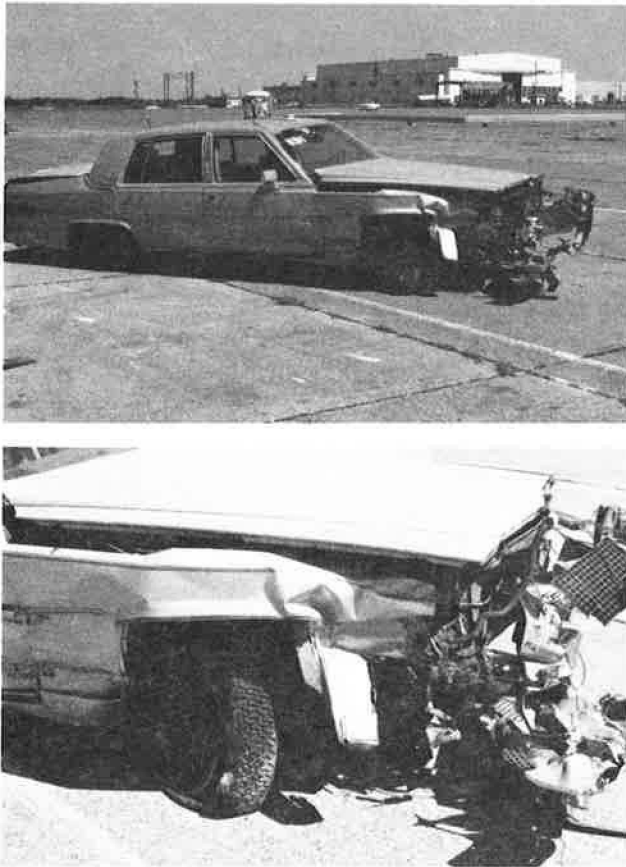
FIGURE 4 Photographs of damage to vehicle after Test 7147-2.

The vehicle sustained moderate damage to the right side, as shown in Figure 4. The tie rod was bent, and the windshield was broken. There was damage to the bumpers, hood, grill, radiator and fan, right front and rear quarter panels, and right front and rear doors. The wheelbase on the right side was shortened from 121.5 in. (3.09 m) to 116.0 in. (2.95 m). The right front and rear tires and rims were damaged from contact with the posts. Maximum crush of the vehicle was 13.0 in. (33.0 cm) at the right front corner at bumper height. However, essentially no intrusion or deformation of the passenger compartment occurred. Note that much of the damage to the front of the vehicle was the result of the vehicle impacting the end of a concrete barrier near the end of the vehicle trajectory. It should also be noted that the test vehicle had a fiberglass header panel, which made the damage to the front of the vehicle appear worse than it really was. A summary of the test results is presented in Figure 5.

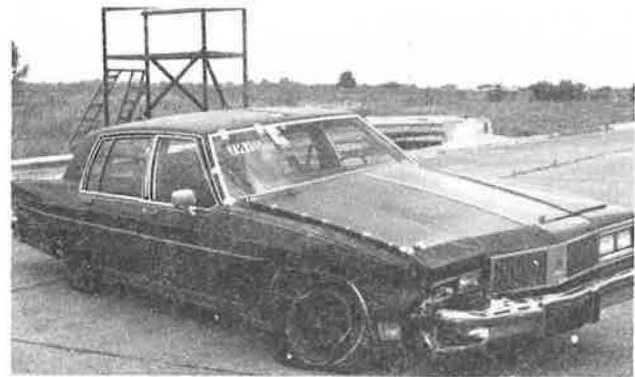
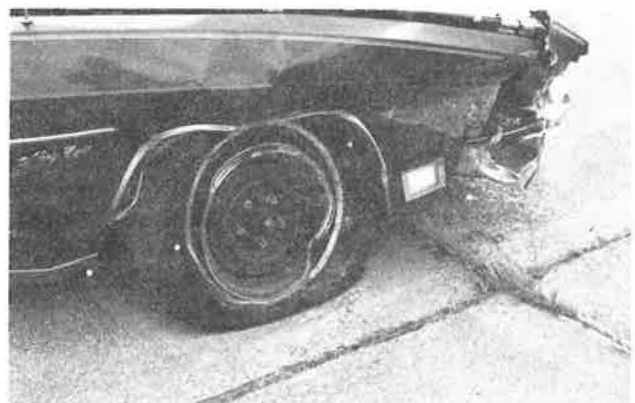
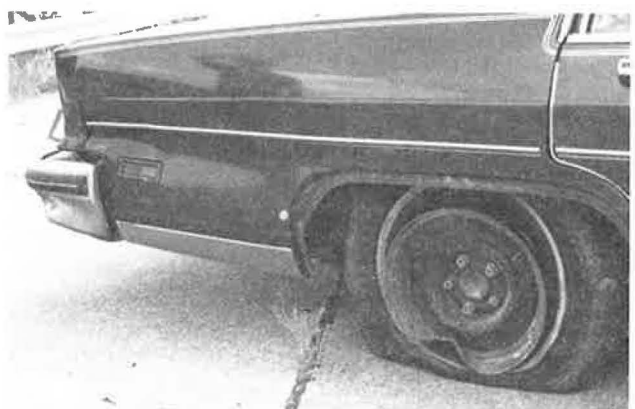
FIGURE 9 Photographs of damage to vehicle after Test 7147-5.

As shown in Figure 9, damage sustained by the vehicle was minor, given the severity of the impact. The upper control arm on the right side was damaged. There was damage to the bumpers, hood, grill, right front and rear quarter panels, and right front and rear doors. The wheelbase on the right side was shortened from 119.0 in. (3.02 m) to 117.0 in. (2.97 m). The right front and rear tires and rims were damaged from

contact with the posts. Maximum crush of the vehicle was 8.0 in. (20.3 cm) at the right front corner at bumper height. However, there was no intrusion in or deformation to the occupant compartment. A summary of the test results is presented in Figure 10.

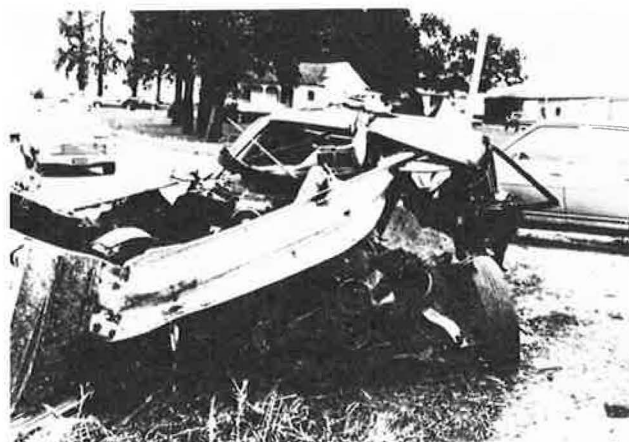
FIGURE 1 Unprotected or unmodified guardrail ends are lethal roadside hazards.

When it was recognized in the mid-1960s that unprotected or unmodified guardrail ends were lethal roadside hazards (Figure 1), the highway community moved toward what appeared at the time to be a good, economical solution—the turned-down end. Turning the first section of the W-beam down and anchoring it at ground level certainly solved the spearing problem. Turndowns were considered good practice to enhance “the forgiving roadside” and were widely implemented throughout the United States (1,2).

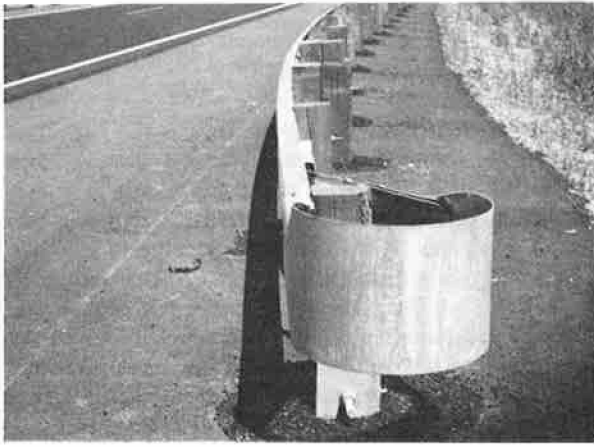
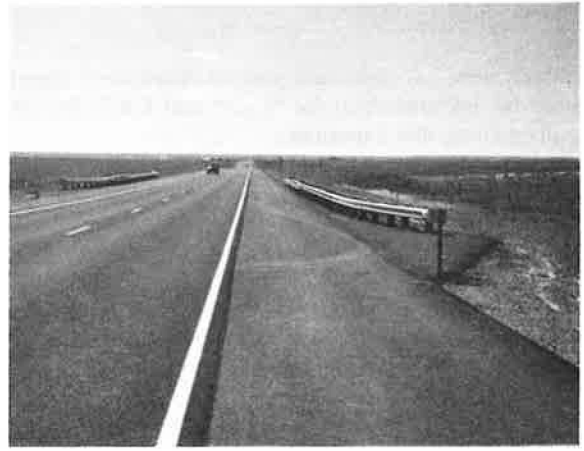
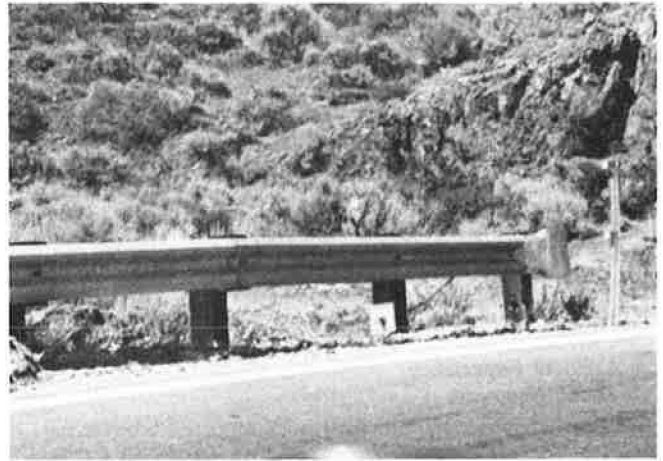
FIGURE 7 Properly and improperly installed BCTs.

- (1) Parabolic flared BCT. PROPER
- (2) Parabolic flared BCT, local shoulder widening*.
- (3) Straight steel slip base post BCT (offset < 9"). IMPROPER
- (4) Straight wood post BCT (0 offset). IMPROPER
- (5) Cable tension member across the wrong diagonal of the first opening. IMPROPER

* Since the grade of the soil is not at the same grade of the ACP shoulder addition the vehicle trajectory just before impact may be adversely affected.

Examples of proper and improper installations are shown in Figure 7.

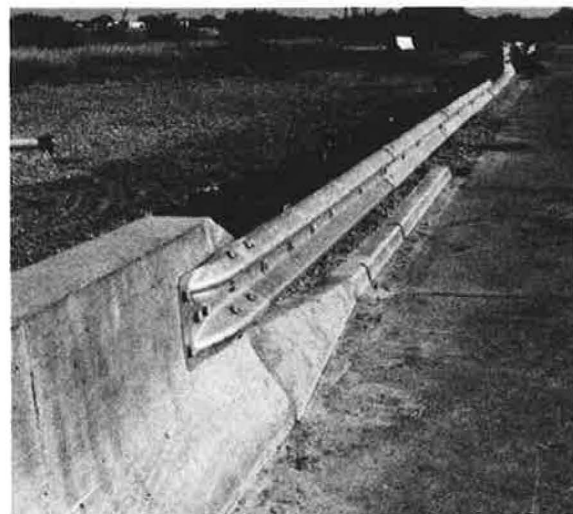
FIGURE 1 Photographs of integral end-post transition design test installation.

- A 1,800-lb (817-kg) passenger car impacting the transition at a speed of 60 mph (96.5 km/hr) and an angle of 20 degrees. The point of impact was just downstream from guardrail Post 5, 8 ft 6¼ in. (2.6 m) from the end of the bridge parapet. This test is intended to assess the potential for wheel snagging on the posts or for the tire to wedge in the area between the W-beam and the curb transition section.

- A 4,500-lb (2,041-kg) passenger car impacting the transition at a speed of 60 mph (96.5 km/hr) and an angle of 25 degrees. The point of impact was 1 ft (0.3 m) downstream from guardrail Post 9, 23 ft 4¾ in. (7.1 m) from the end of the bridge parapet. This test was intended to assess the effect of the curb section on impact performance and the potential

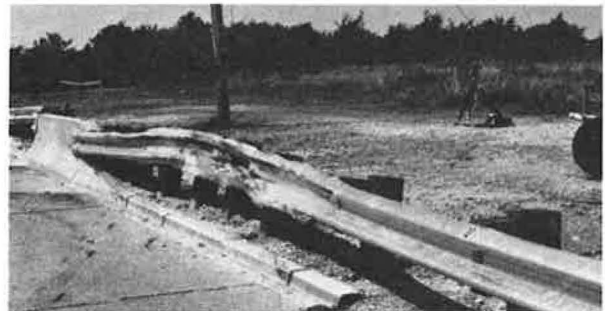
FIGURE 4 Integral end-post transition after Test 3.

The installation received moderate damage, as shown in Figure 4. There was residual deformation to the rail from Posts 2 through 10, but no apparent structural damage to the concrete bridge parapet. Also, there was no debris or detached elements. The vehicle received severe damage, the majority of which occurred to the right front quarter of the vehicle. The right front wheel and control arm were severely bent and pushed 7.0 in. (17.8 cm) rearward. In addition, the entire front end was shifted 4.0 in. (10.2 cm) to the left. The floor pan and drive shaft were also damaged.

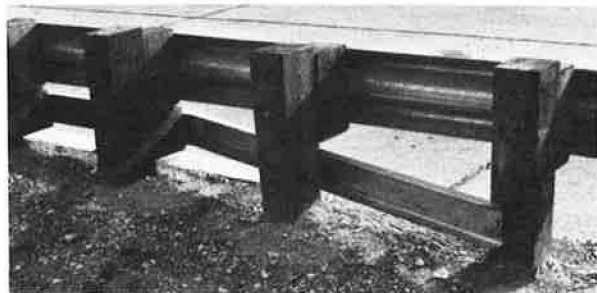
FIGURE 7 Photographs of improved separate end-post transition design test installation.

To eliminate the potential for the vehicle to underride the W-beam, the separate end-post design was improved by incorporating a C6x8.2 rub rail into the transition design. The rub rail was mounted directly beneath and parallel to the W-beam.

The center of the rub rail was 11 in. (27.9 cm) below that of the W-beam. The rub rail was blocked out with 6- × 8- × 8-in. (15.2- × 20.3- × 20.3-cm) wooden blockouts so that the face of the rub rail aligned with that of the W-beam. The total length of the rub rail was 25 ft (7.62 m), spanning from the concrete end post to Post 9, after which the rub rail was bent slightly backward for termination at the back of Post 11. At its connection with the concrete end post, the lower flange of the channel rub rail was cut to accommodate the lower sloped surface of the concrete safety shape so that the face of the rub rail would remain vertical. A special end shoe was fabricated to cover the exposed end of the rub rail. Photographs of the completed installation are shown in Figure 7.
