Active Advance Warning Signs at High-Speed Signalized Intersections: Results of a Study in Ohio

PRAHLAD D. PANT AND XIAO H. HUANG

The effectiveness of several active advance warning signs at high-speed signalized intersections in Ohio was evaluated. The signs included the Prepare To Stop When Flashing (PTSWF), Flashing Symbolic Signal Ahead (FSSA), Continuously Flashing Symbolic Signal Ahead (CFSSA), and Passive Symbolic Signal Ahead (PSSA) signs. The research was designed as a before and after study with control sites. The measures of effectiveness included vehicular speeds at various segments of the intersection approach, vehicle conflict rates, and ratings by drivers. The study found that the effects of the signs on drivers varied among intersections with tangent and curved approaches. The PTSWF or FSSA signs generally encouraged high speed when the flasher was inactive and the signal indication was either green or yellow. Fewer motorists related the PTSWF sign to the traffic signal. In general, active advance warning signs should be discouraged at high-speed signalized intersections, particularly at intersections with tangent approach. At high-speed signalized intersections w

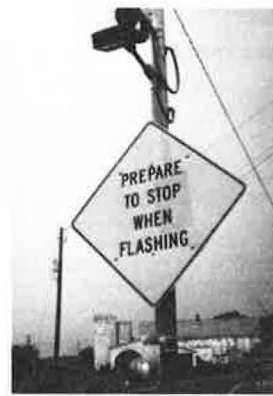
FIGURE 1 Advance warning signs: (a) PTSWF, (b) FSSA, (c) CFSSA, and (d) PSSA.

1. PTSWF sign—The PTSWF sign is the most commonly used advanced warning sign at high-speed signalized intersections in Ohio.
2. FSSA sign—The FSSA sign was selected for the study because of the general trend in the nation toward using symbolic signs for traffic control and operations. This sign was never used in Ohio before.
3. CFSSA sign—In Ohio, the CFSSA sign is often used at intersections with curved approach.
4. PSSA sign—The PSSA is only the Signal Ahead sign and no flashers are used. It is the most commonly used sign at signalized intersections.

The PTSWF and FSSA signs had yellow flashers at top and bottom that were activated near the end of the green interval and remained active until the end of the red interval. The CFSSA sign had one to two flashers that were active all the time.

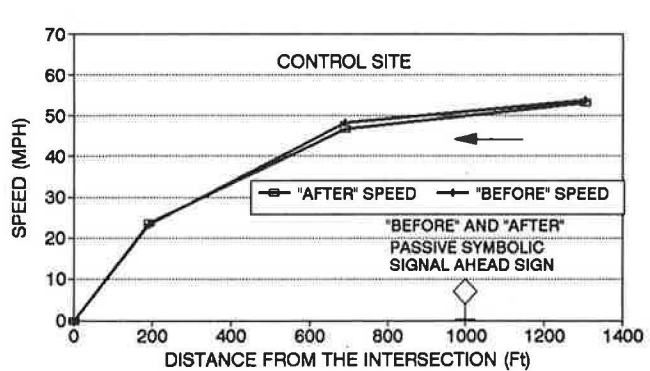
- (1) Signal is red when vehicle arrives at the decision zone
- (2) Signal is red when vehicle arrives at the stop line
- (3) Vehicle stops at the stop line

FIGURE 5 Mean speed on study site and control site (condition: red-red-stop).

ditions were plotted graphically. Samples of the graphs are presented in Figures 4 and 5. Data for other sites could not be included in this paper for space reasons.
