Seismic Retrofitting of Rectangular Bridge Columns for Shear

LAURA L. BERNARDS, DAVID I. MCLEAN, AND EDWARD H. HENLEY, JR.

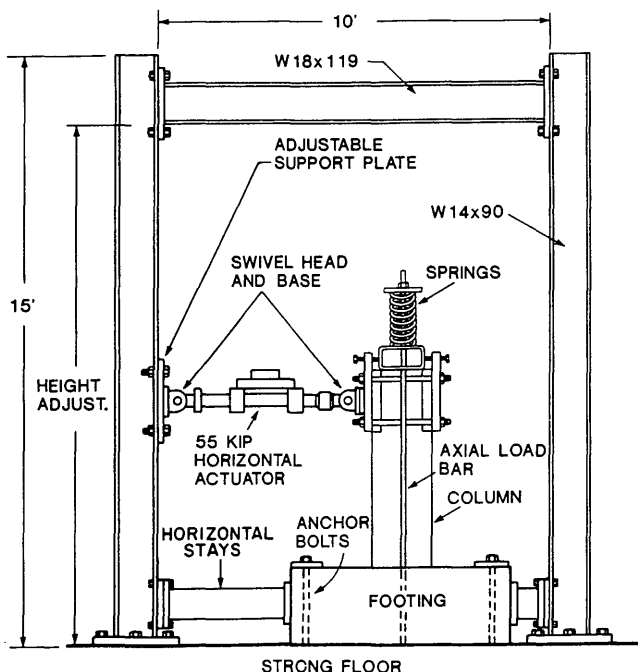
FIGURE 4 Test setup.

Figure 4 shows the test setup for the column specimens. The specimens were tested using reversed cyclic lateral loading about the strong axis of the section under a constant axial load. Anchor bolts were used to secure the footing to the strong floor, and sliding of the specimen was prevented by horizontal stays. An axial load level of $0.09f'_cA_g$ was applied to all columns, equivalent to a stress level of 360 lb/in.² on the 8- by 12-in. cross section. The axial load varied by at most ± 12 percent during testing.

The cyclic lateral load was applied at 30 in. above the top of the footing by a 55-kip capacity actuator operated under displacement control using a closed-loop servohydraulic system. The sequence used was chosen to display the general hysteretic characteristics and ductility of each specimen and consisted of an increasing displacement pattern to various multiples of the yield displacement of the column. Two cycles were used at each displacement to displacement ductility levels of $\mu = 1, 2, 4, 6$, and 8, unless premature failure of the column occurred.

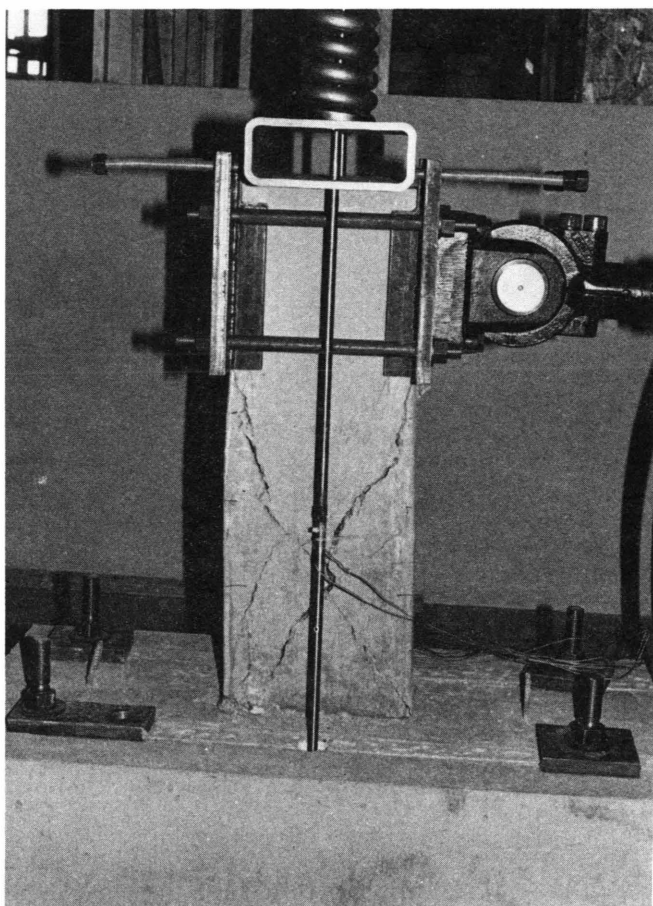
FIGURE 5 Shear cracking in control column specimen.

Column 2, which represented existing field conditions, displayed a classic shear failure with an x-pattern of cracking developing as the testing progressed. The failed control specimen is shown in Figure 5. Results from this column served as the reference for all retrofitted columns. In this specimen, shear cracking and yielding of the ties occurred early on in testing, beginning in the first cycle to $1 \Delta_y$. Referring to the load-displacement hysteresis shown in Figure 6, there was a sharp degradation in load-carrying capability during the second cycle to $2 \Delta_y$, after which the load continued to drop until almost no load was carried. This column was evaluated as having a displacement ductility level of $\mu = 1$.

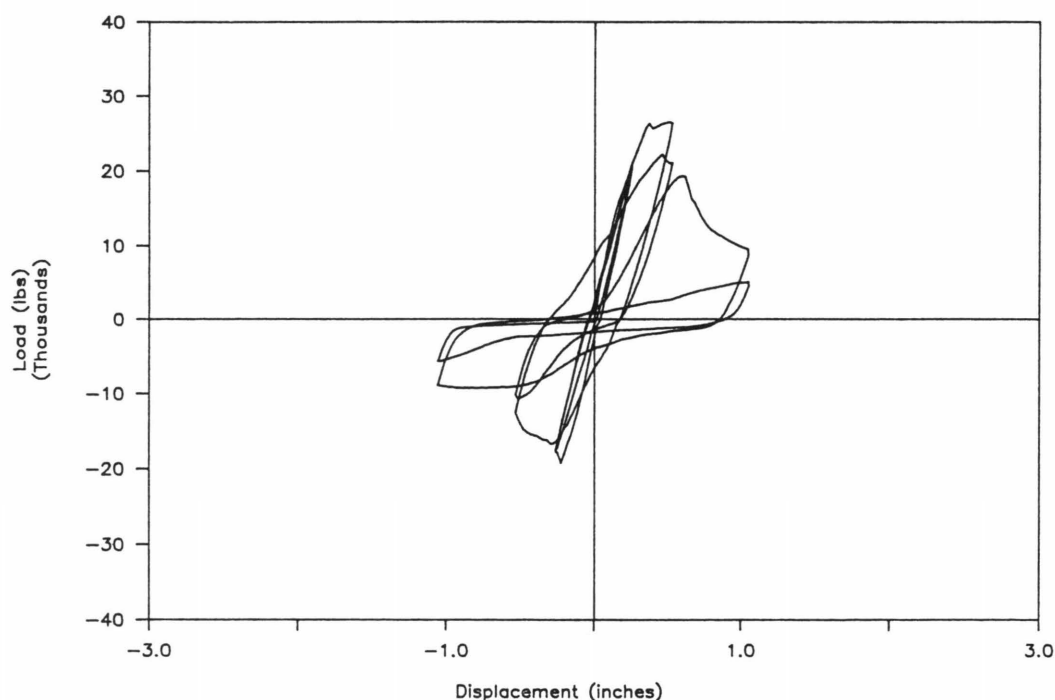
FIGURE 6 Lateral load displacement curves for Specimen 2.

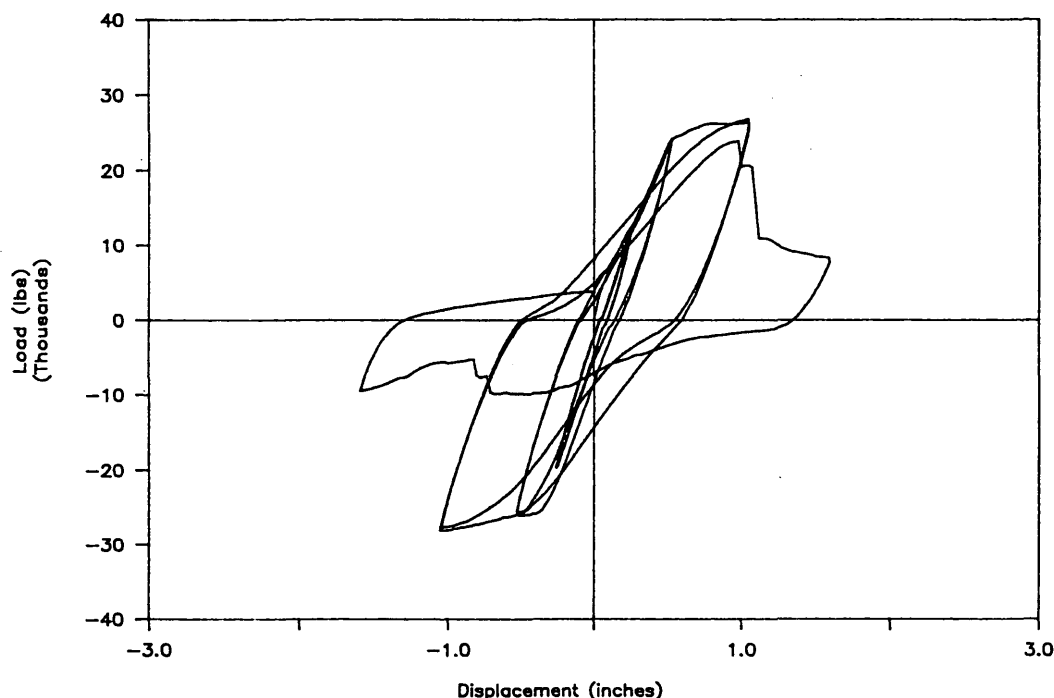
FIGURE 9 Lateral load displacement curves for Specimen 5.

between retrofit hoops than in Column 3, held its load into the first cycle to $6 \Delta_y$, when the external bars began to fail in the threads. However, in this specimen, the bars necked down in a ductile manner before fracturing, with failure of the bars beginning at the middle of the column and working downward. When the retrofit hoops fractured, shear cracks began to open up, as in the control column, followed by a substantial buckling of the longitudinal reinforcement and destruction of the column core (see Figure 8). As with Column 3, the lateral load capacity showed an increase of 7 percent over that of the control column. Column 5 displayed an increase in ductility capacity over that of Column 3, with good performance through $\mu = 4$. A load-displacement hysteresis plot for Column 5 is shown in Figure 9.

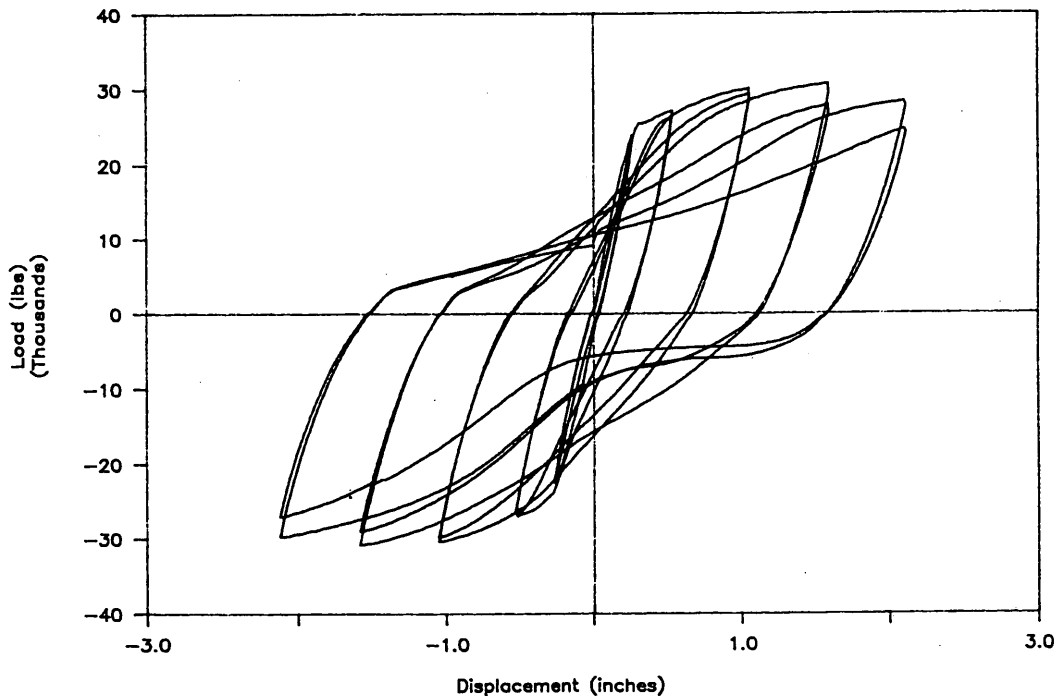
FIGURE 11 Lateral load displacement curves for Specimen 6.

also performed well with good load-carrying capability through a ductility of $\mu = 8$. Even though the steel jacket in Column 6 was 75 percent thicker than that in Column 4, the lateral load capacities were the same. From the load-displacement hysteresis plot of Column 6 shown in Figure 11, the width of the loops, which are slightly wider than those in Column 4, indicates good energy dissipation throughout the test sequence. As in Column 4, buckling of the longitudinal bars and steel jacket occurred near the base of the column beginning during the cycles to $4 \Delta_y$. However, the extent of buckling was slightly reduced by the use of a thicker jacket. Cracking was again seen in the footing around the base of the column because of the downward shifting of the plastic hinge zone. Internal tie yielding was prevented using this retrofit scheme, and no shear cracks were seen in the column after the jacket had been removed.
