TRANSPORTATION RESEARCH RECORD

No. 1371

Bridge, Culvert, and Tunnel Research

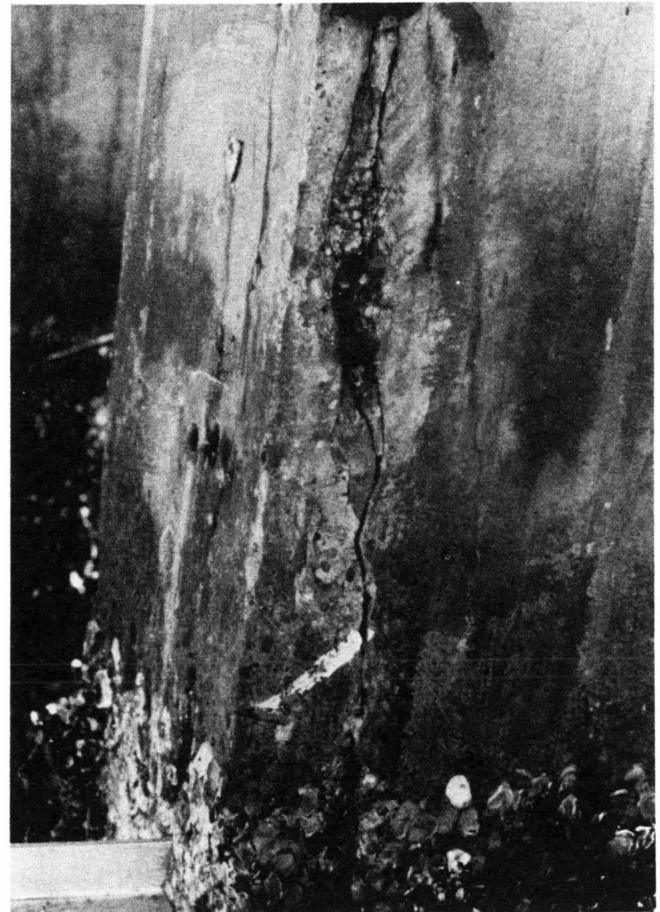
FIGURE 1 Excessive vertical cracking and spalling of concrete in a pile (B. B. McCormick Bridge, Jacksonville).

Figures 1 and 2 show the extent and severity of concrete deterioration of some of the in-service concrete bridge structures tested in this study. Concrete cracking due to corrosion of the embedded steel reinforcement and subsequent spalling of concrete cover is the most predominant type of concrete deterioration encountered in marine concrete bridge structures in Florida. Figure 1 shows a severely deteriorated pile from the B. B. McCormick Bridge substructure located on the FAIW in Jacksonville. Extensive vertical cracking of concrete is seen from the steel corrosion. The corrosion of the embedded steel reinforcement in the pile is in an advanced state and the steel can readily be seen through the gap created in the material because of localized loss of concrete cover. This is a typical pattern of concrete distress that is demonstrated in the form of continuous vertical cracking running parallel to the edge of the pile and extending several feet above the high-tide level into the splash zone. The tidal zone,

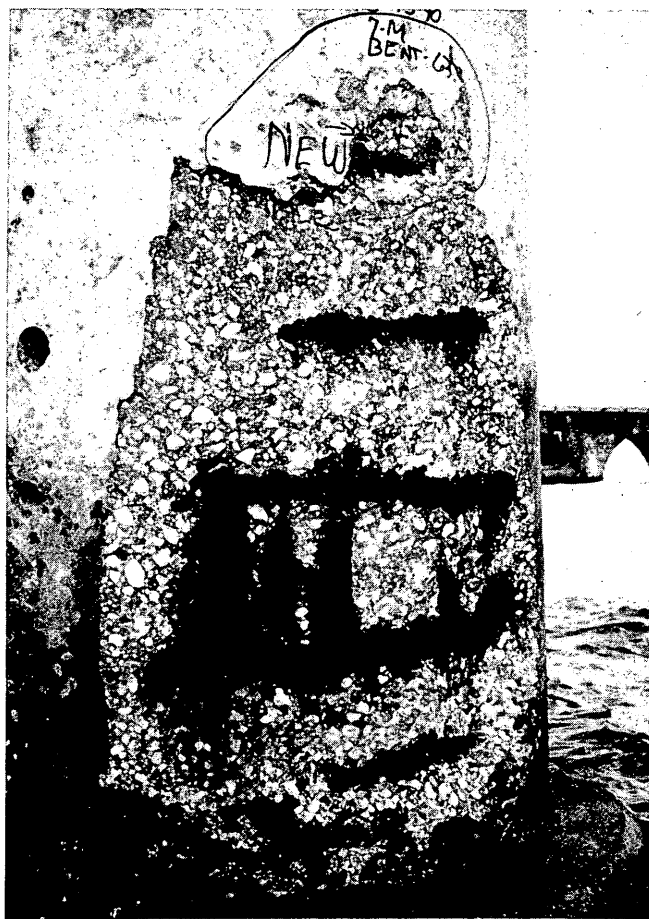
FIGURE 2 Excessive steel corrosion and extensive concrete spalling in a pier (Seven-Mile Bridge, Florida Keys).

The extent and severity of concrete deterioration of in-service bridge structures in Florida are clearly manifested in Figure 2, which shows a massive structural element of the Seven-Mile Bridge substructure located in the Florida Keys, which is considered to be an extremely aggressive (highly corrosive) environment. Corrosion of the embedded steel reinforcement in this case is in the most advanced state in which decomposition of the material and disbondment from the surrounding concrete are accompanied by a complete loss of concrete cover, which in turn can lead to severe structural damage. In this particular pier, the concrete deterioration extends to about 9 ft above the tidal zone. This is contrary to the general observation that the most severe deterioration is likely to take place in the tidal zone where the concrete is exposed to various types of physical and chemical forces. As demonstrated in Figure 2, concrete deterioration caused by corrosion or other chemical and physical attacks is not a phenomenon that is encountered only in the tidal zone and that can readily be repaired or treated locally; it is a more extensive problem that has the potential to cause severe structural damage.
