Field Tests of Resistance to Chloride Ion Penetration on Sealed Concrete Pavement

RICHARD K. SMUTZER AND LUH-MAAN CHANG

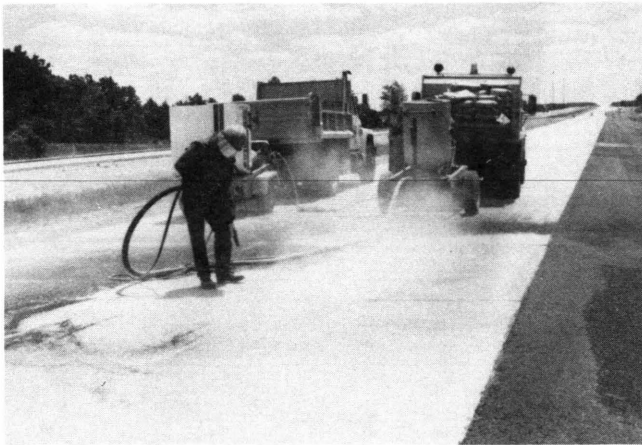
FIGURE 3 Sandblasting operation cleaning the concrete surface, removing the curing compound.

The field work for preparing and sealing the pavement sections was conducted on June 4, 1987. The weather conditions were fairly clear and warm with temperatures near 26.7°C (about 85°F). Before the test areas were sealed, the PCC surface of the evaluation strip was sandblasted by the INDOT Gas City Maintenance Section to remove the curing compound (i.e., a Type II AASHTO M148 curing compound), surface dirt, and cement latency. The curing compound was applied at approximately 3.69 m²/L (150 ft²/gal), and the pavement concrete was allowed to cure more than 28 days before PCC sealers were applied. The pavement surface was then swept and blown clean.

Figures 3 through 7 illustrate the chronological sequence of the operation from blasting to applying the sealer and sampling. Both blasting and sealer application were done on the same day.

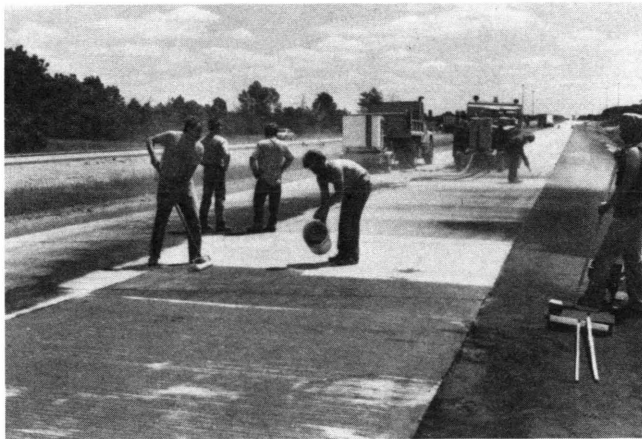
FIGURE 4 Applying sealers, flooding surface, uniformly distributing with roller.

- Silane was poured across the 33.48 m² (360 ft²) test area. A thick-napped roller was used to squeegee and spread it uniformly over the test area. The sealer was applied at a rate of 2.46 m²/L (100 ft²/gal), which is somewhat heavier than the recommended rate, which is 3.07 m²/L (125 ft²/gal).
- Blend was poured across the 33.48 m² (360 ft²) test area. A stiff-bristled broom was used to spread the material uniformly over the test area. Then the material was groomed further to work the material into the concrete surface. The

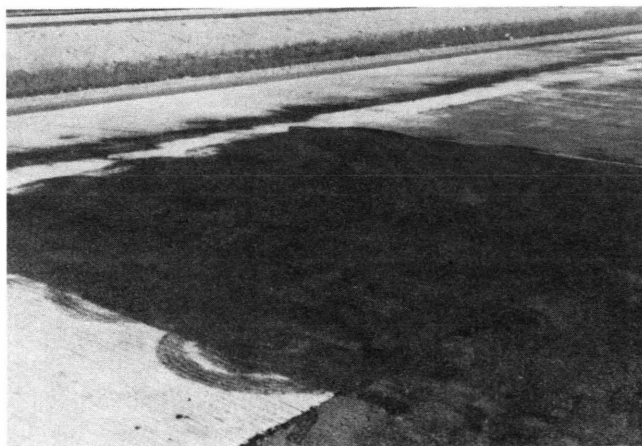
FIGURE 5 Epoxy sealer applied and sanded.

- EPS 1 and EPS 2 were applied on separate areas of the test strip. Each EPS was mixed after combining the resin and hardening components. Each EPS was applied by pouring the material across the 16.74 m^2 (180 ft^2) test area, then a thick-napped roller was used to squeegee and spread the sealer uniformly over the test area. Each EPS was applied at a rate of $2.21 \text{ m}^2/\text{L}$ ($90 \text{ ft}^2/\text{gal}$); the recommended rate was $2.21 \text{ m}^2/\text{L}$ ($90 \text{ ft}^2/\text{gal}$) to $2.70 \text{ m}^2/\text{L}$ ($110 \text{ ft}^2/\text{gal}$). Once applied, the EPSs were allowed to begin the set before sand veneer was spread over the surface to add skid resistance.

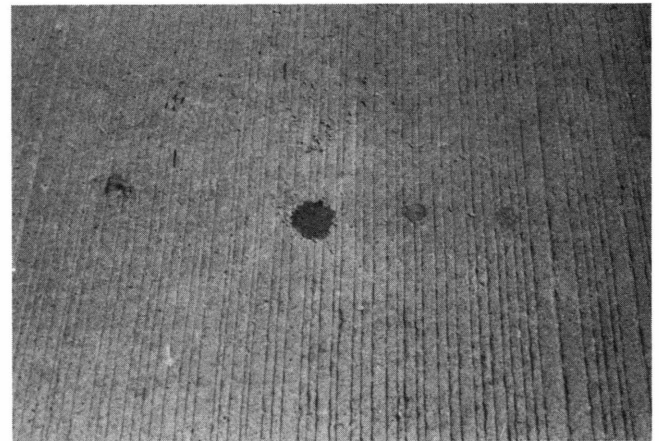
FIGURE 7 Close look at Location 30 after 3 years of sampling.

The surfaces of test and control areas were observed at the time of each sampling. After 3 years of exposure the first EPS test area had sealer still evident in the tinning. Most of the sealer appeared to be worn away on the surface. The second EPS had sealer still evident in the tinning and between wheel-paths. There were no significant signs of surface scaling or aggregate pop-outs in any test or control area along the evaluation strip.
