# Application of Cracking and Seating and Use of Fibers To Control Reflective Cracking

YI JIANG AND REBECCA S. MCDANIEL

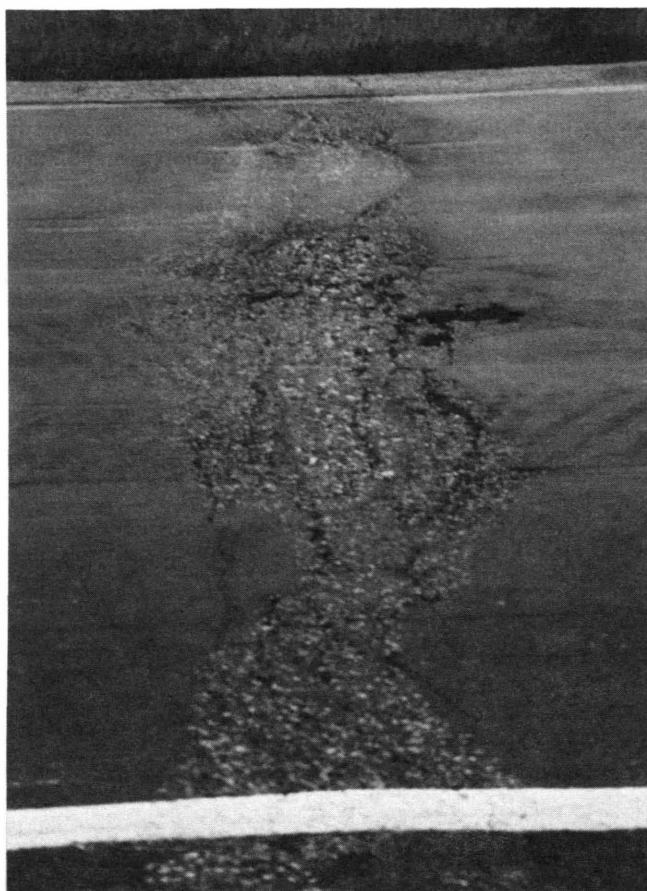
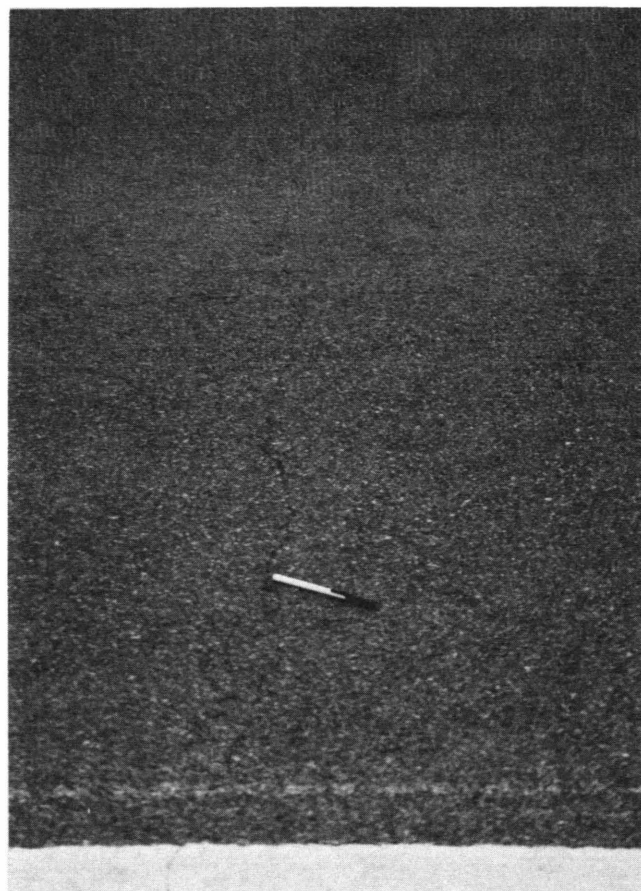
crack openings ranged from 0.25 to 2 in. (0.6 to 5.1 cm) on the control sections, but from 0.04 to 0.25 in. (0.1 to 0.6 cm) on the cracked and seated sections. The wide openings of the reflective cracks on the control sections served as entrances for water to get into the pavement and therefore caused the asphalt mixture near the cracks and the concrete joints underneath to deteriorate. The deterioration of the joints then in turn further accelerated the deterioration of the asphalt overlay. On the other hand, the transverse cracks on the cracked and seated sections had much less deterioration, lower severity, and narrower opening. Figure 6 presents a picture of deteriorated pavement around a reflective crack in Treatment A and a picture of a typical transverse crack on a cracked and seated section. Picture A shows that raveling (dislodging of aggregate particles) and weathering (loss of asphalt binder) have occurred on the pavement around the reflective crack on the control section, and a pothole has also developed in the area. Picture B shows that the transverse crack on the cracked and seated section has a much lower severity.

**FIGURE 6** Examples of transverse cracks: *left*, deteriorated pavement around a reflective crack on control section; *right*, typical transverse crack on cracked and sealed section.
