TRANSPORTATION RESEARCH
RECORD

No. 1425

**Field Performance of
Subsurface Drainage**

Field and Laboratory Comparison of Pavement Edge Drains in Kentucky

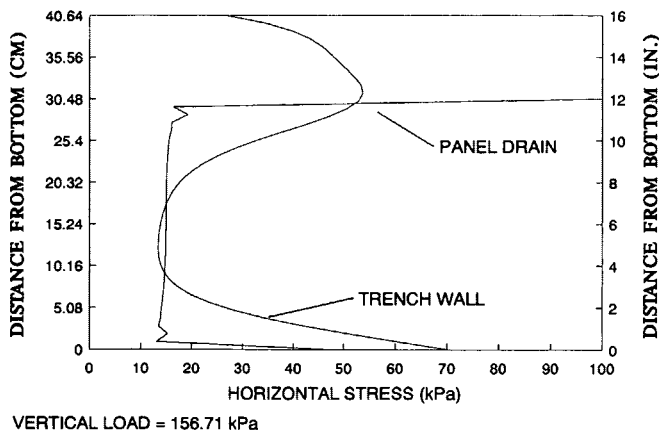
FIGURE 8 Finite element modeling (stressed introduced at panel).

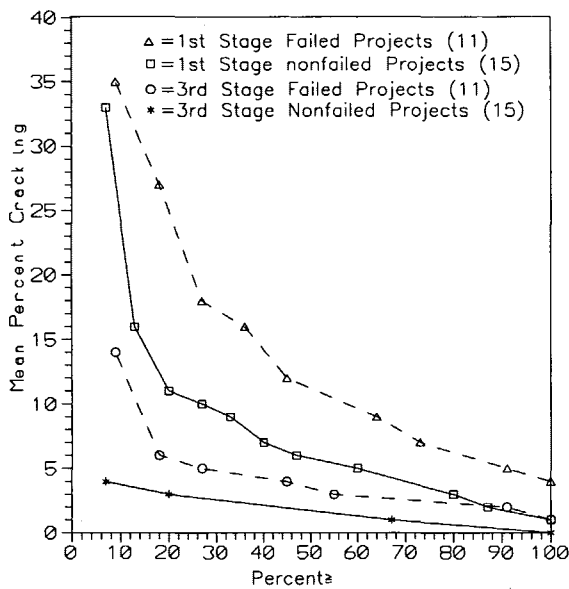
FIGURE 3 Cumulative frequency distribution, first- and third-stage cracking.

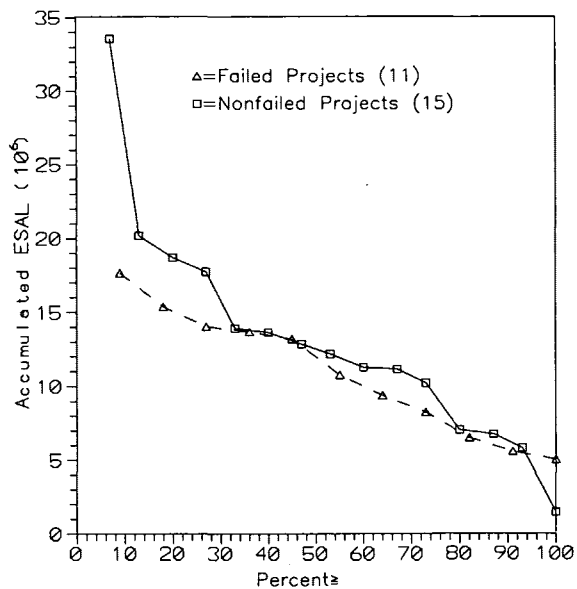
FIGURE 5 Cumulative frequency distribution, ESAL.

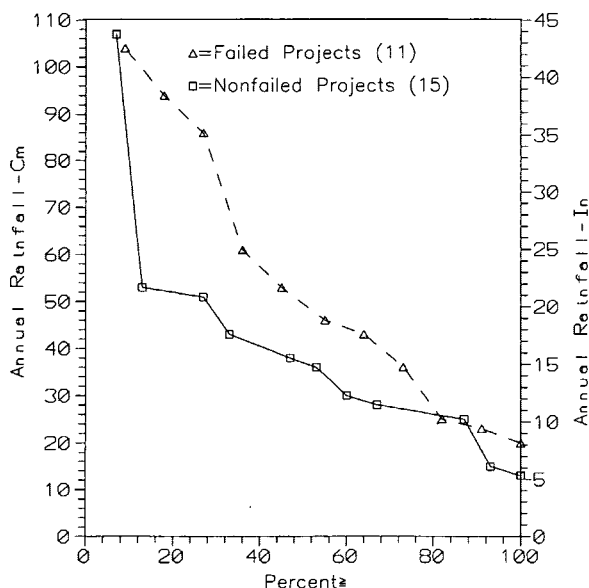
FIGURE 6 Cumulative frequency distribution, annual rainfall.

Ultimately, environmental conditions were found to significantly affect the performance of the JPCP. Figure 6 shows a trend toward higher annual rainfall at projects that failed (however probabilities were not significant at 95 percent confidence, as shown in Table 4). Figure 7 shows that annual heating degree-days are higher at failed projects (differences are significant at 95 percent confidence in Table 4) but annual cooling degree-days are generally similar. These plots were influential in showing how the environment affects the JPCP as well as suggesting the need for explicit consideration of environmental variables in PCCP design. The points plotted

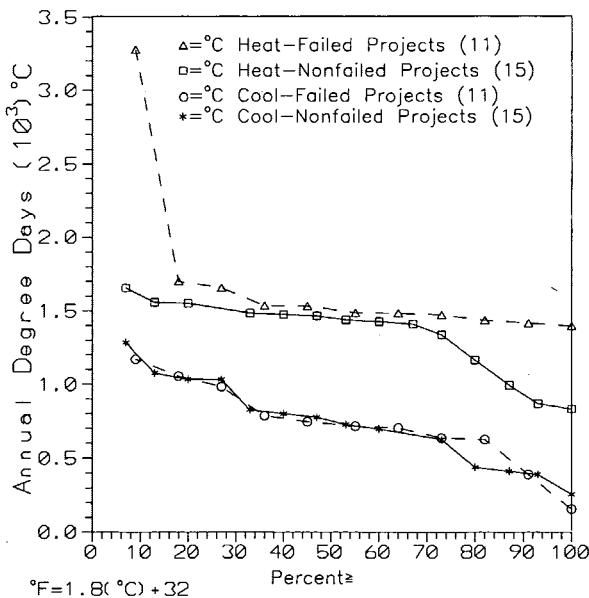
FIGURE 7 Cumulative frequency distribution, annual heating and cooling degree-days.

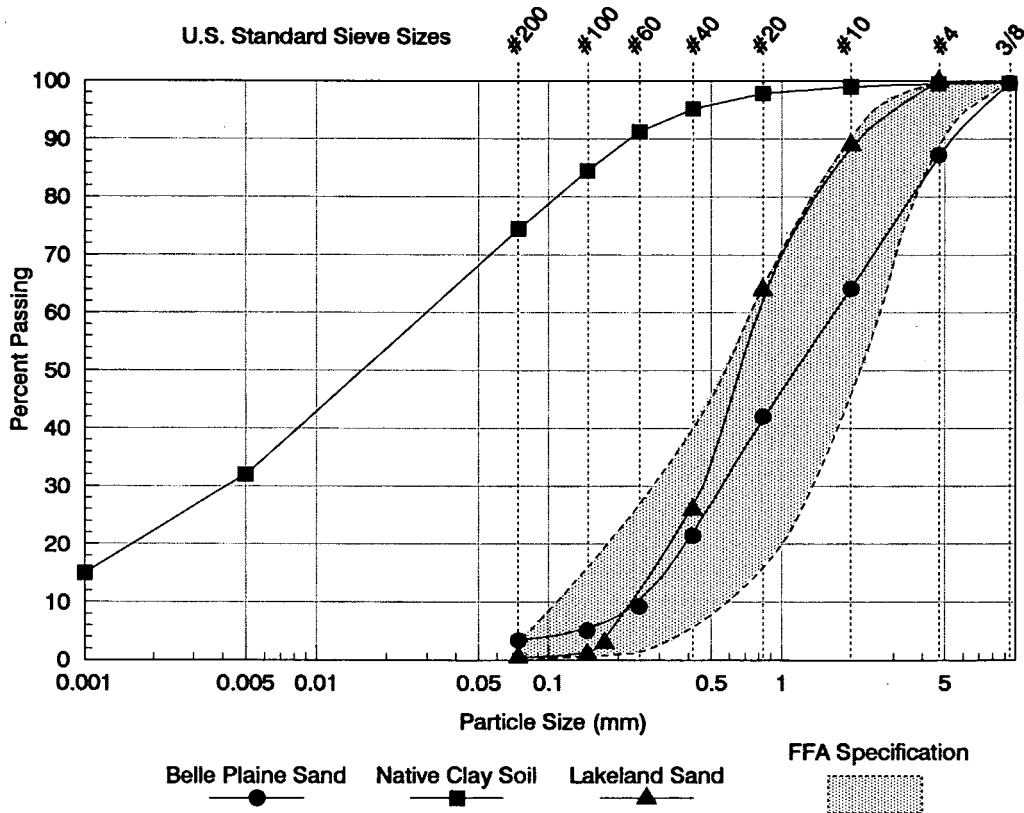
FIGURE 3 Mechanical sieve analysis of soils used and specification band for FFA.

A 75-mm (3-in.) inside diameter × 100-mm (4-in.) outside diameter polyethylene pipe (AASHTO M252) was mechanically laid in the bottom of the trench. The backfill material was a relatively clean sand, unprocessed, from a local pit (Belle Plaine sand). It had a standard Proctor density of 1950 kg/m³ (120 lb/ft³) at 11 percent optimum moisture and modified Proctor density of 2100 kg/m³ (129 lb/ft³) at 11 percent optimum moisture. The mechanical analysis of these two materials (Belle Plaine sand and native soil) as well as the Mn/DOT specified gradation band for FFA are shown in Figure

Research in both the field and laboratory leads to the conclusion that granular materials anywhere in the FFA gradation band (Figure 3), even though they may differ slightly in gradation and Proctor density, are likely to exhibit similar percent of Proctor and DCP penetration indexes for similar compactive efforts. The following generalizations can be drawn between penetration indexes and percent of Proctor for this set of research data: (a) penetration indexes of 75 mm (3 in.) per blow or less generally indicate compaction at or above 93 percent of standard Proctor, (b) penetration indexes greater than 125 mm (5 in.) per blow generally indicate compaction at or less than 89 percent of standard Proctor, and (c) percent of standard Proctor values from 89 to 93 percent yield variable penetration index values, ranging from 50 mm (2 in.) to greater

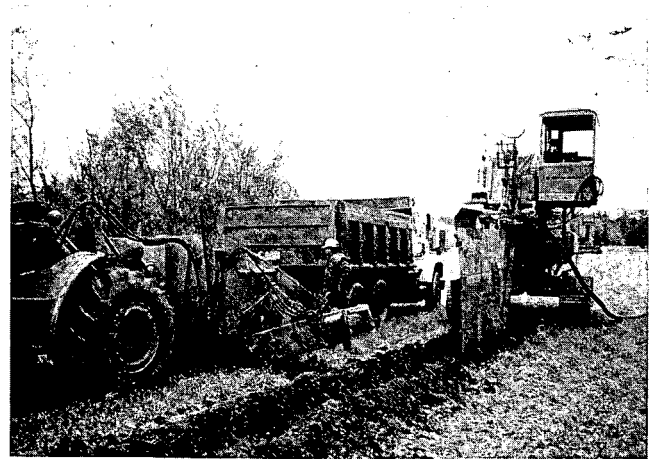
FIGURE 4 Dynapac trenching machine, truck delivering filter aggregate, and shouldering attachment on front-end loader, which places filter aggregate into trench.

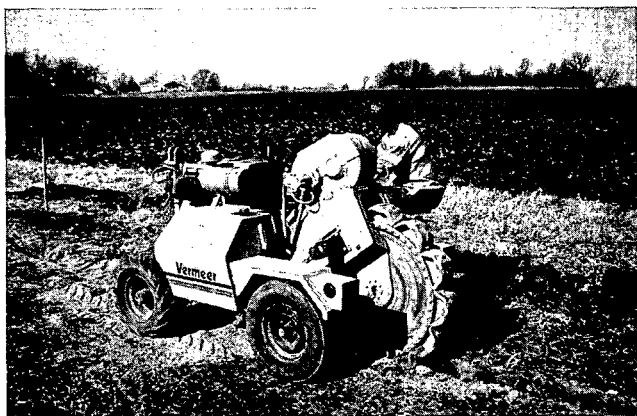
FIGURE 7 Vermeer ditcher stitcher.

The wheel is a vibratory compactor made by the Vermeer Manufacturing Company, under the model name Ditcher Stitcher. It has a gross weight of 1170 kg (2580 lb) and has a rated force of 3629 to 7257 kg (8,000 to 16,000 lb) operating at 1600 rpm (Figure 7). The trench was compacted using the Vermeer wheel's maximum force. The compaction wheel itself has the ability to drop below ground level to a depth of 660 mm (26 in.). The Vermeer compactor was chosen for the research because a local contractor was using it and it was

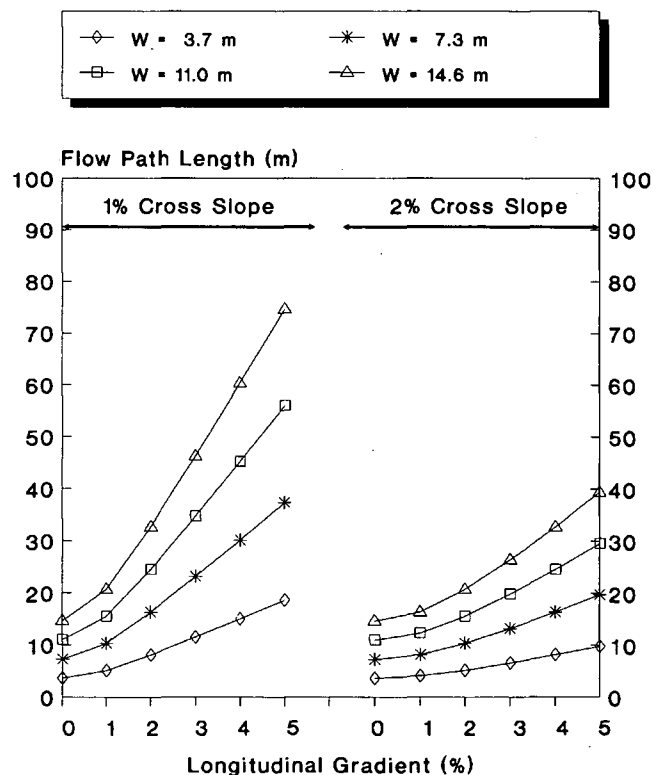
FIGURE 3 Drainage path lengths.

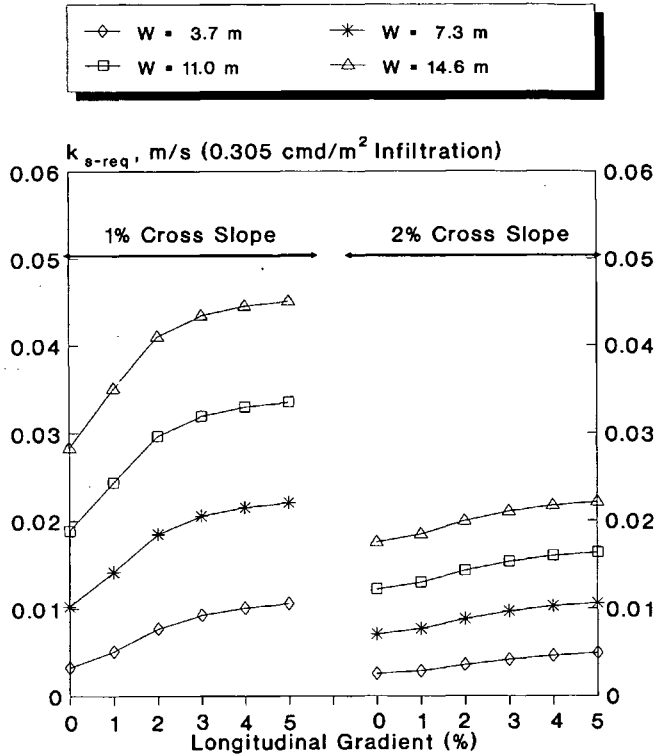
FIGURE 4 Required permeability for 10-cm OGPM.

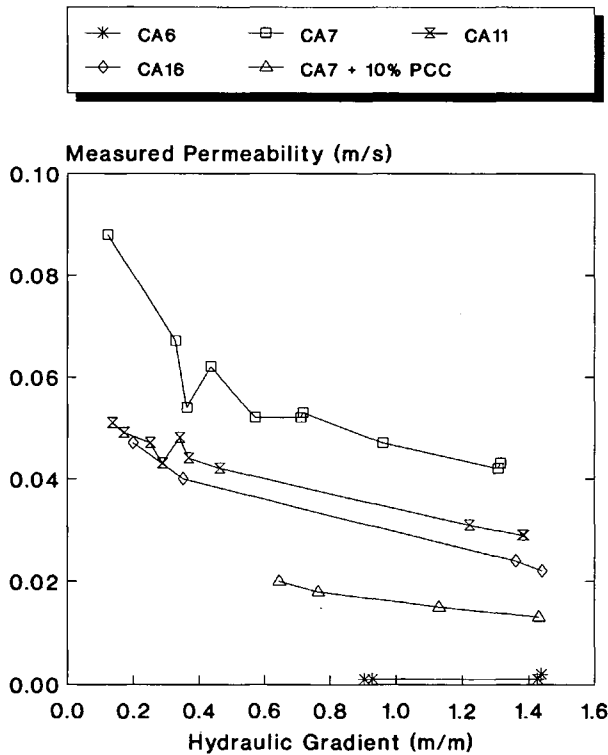
FIGURE 7 Measured permeabilities using IHR-525 flow chamber.

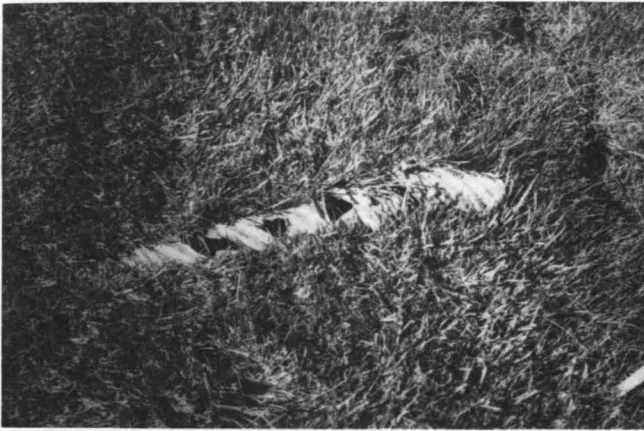
FIGURE 6 View of exposed and damaged outlet pipe.

In most cases, outlet markers were not present or were bent or lying beside the outlet pipes. Rodent screens on outlet

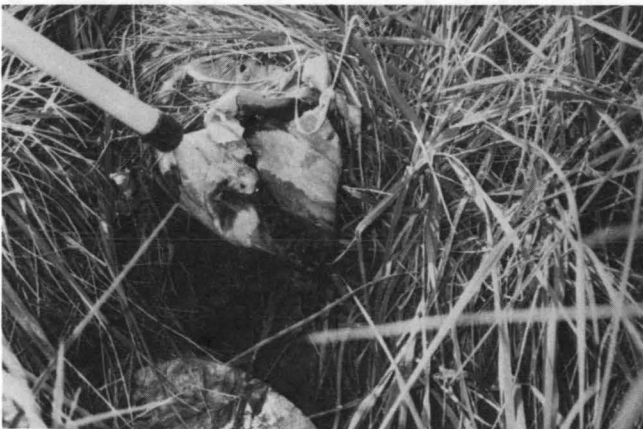
FIGURE 7 View of crushed outlet pipe.

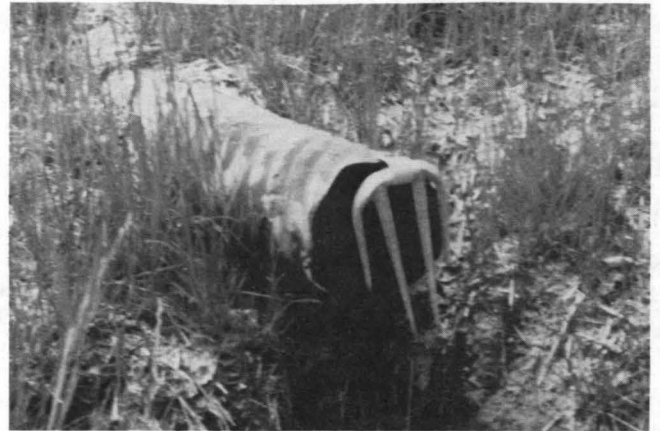
FIGURE 8 Spear-type rodent screen.

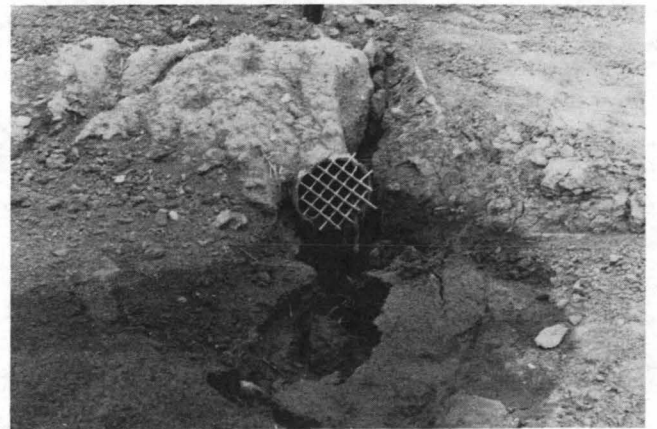
FIGURE 9 Erosion around newly constructed outlet pipe.

The presence of a headwall and erosion control apron or riprap protection around outlet pipes was observed to have a positive effect on the water outflow. In the absence of this

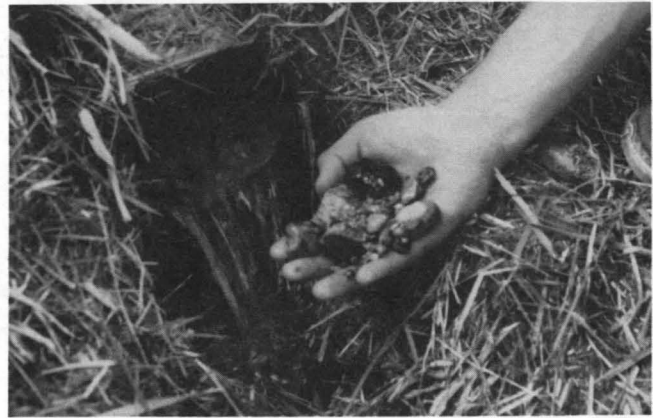
FIGURE 10 Gravel from punctured outlet pipe.

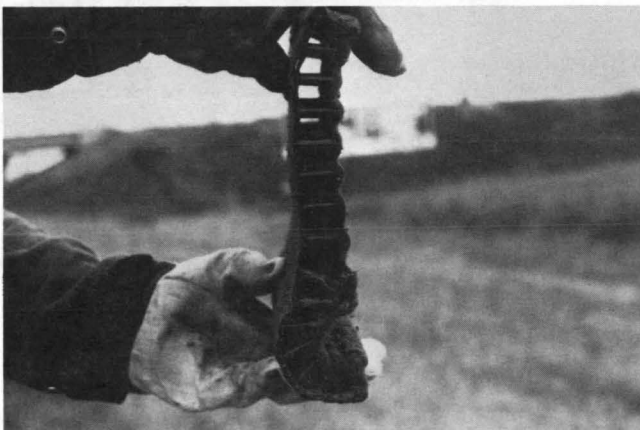
FIGURE 13 View of J-buckling in exposed fin drain.

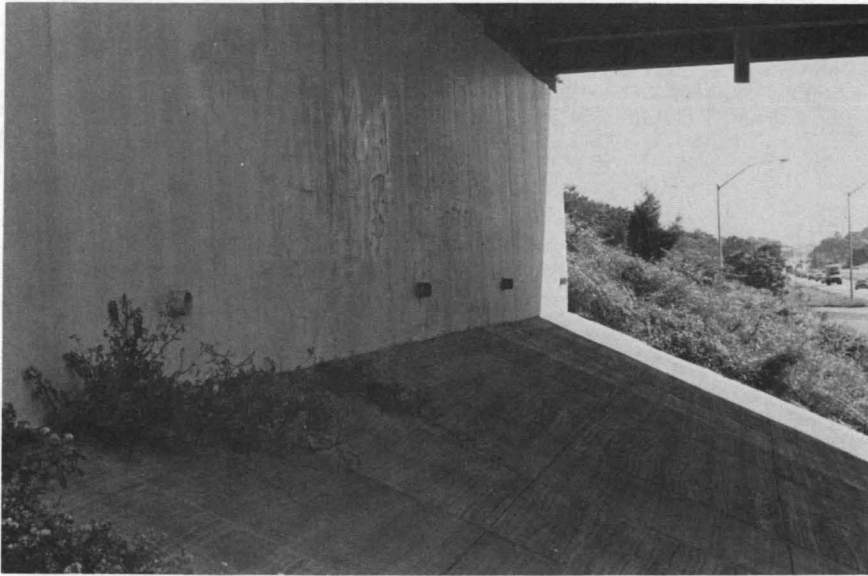
FIGURE 2 Short vertical metal pipe that spills directly onto abutment slope.

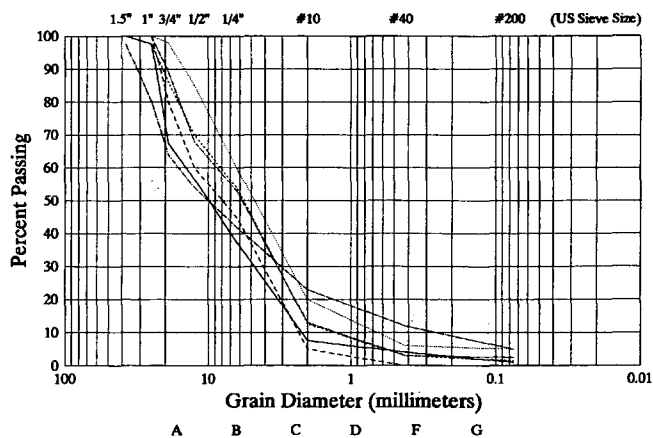
FIGURE 1 Aggregate gradations.
