# Durability of Geosynthetic Soil Reinforcement Elements in Tanque Verde Retaining Wall Structures

DONALD G. BRIGHT, JAMES G. COLLINS, AND RYAN R. BERG

The findings of an investigation into the stability and durability of high-density polyethylene (HDPE) geogrid soil reinforcing elements used in grade separation structures on a project at the Tanque Verde-Wrightstown-Pantano Roads intersection in Tucson, Arizona, is documented. The project represents the first use of geogrid reinforcement in concrete-faced, mechanically stabilized earth retaining walls in a major transportation-related application in North America. The reinforced soil walls were constructed in 1984 and 1985, and the geogrids have been in service for 8 to 9 years in an elevated temperature environment that accelerates the mechanisms of degradation. The combined effects of age and temperature exposure made this project a candidate for evaluation of geosynthetic reinforcement stability and durability. A sample retrieved from the project was subjected to a series of laboratory procedures and tests. Results of the tests are presented as topological analysis, ultimate tensile strength, ultimate tensile strain, 1,000-hr

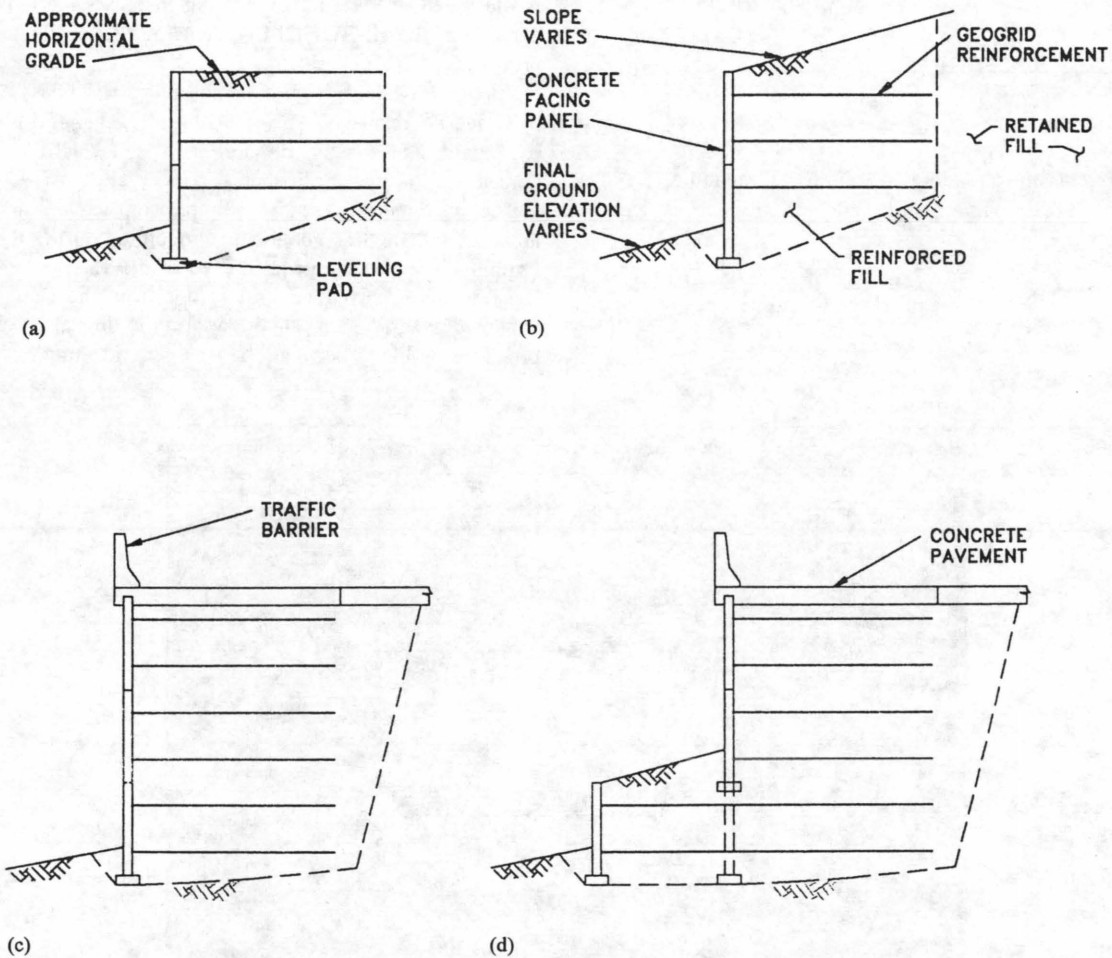
The precast concrete wall face panels are 0.15 m thick, 3 m wide, and full height. Four cross-section wall geometries, as illustrated in Figure 2, were used for the 46 wall structures. Comprehensive details of the wall design are presented in a value engineering study, the design report (1), and in the project construction drawings (2). Two of the Type D wall sections were instrumented in September 1985 and have been monitored since then. The goal of the instrumentation program is to assess the performance of the wall structures. Stresses and strains in the soil and strain in the geogrid are monitored with pneumatic load cells, inductance coils, and resistance strain gauges. Internal and external wall temperatures are monitored with resistance thermometers. Panel displacements during and immediately after construction were monitored using optical survey techniques. Brief descriptions of the instrumentation program and instrumentation readings during and immediately after construction have been presented by Berg et al. (3). Reports of the post-construction monitoring program have been presented by Desert Earth Engineering (4,5).

FIGURE 2 Four wall geometries used in Tanque Verde retaining wall structures. *a*, Type A wall; *b*, Type B wall; *c*, Type C wall; *d*, Type D wall.

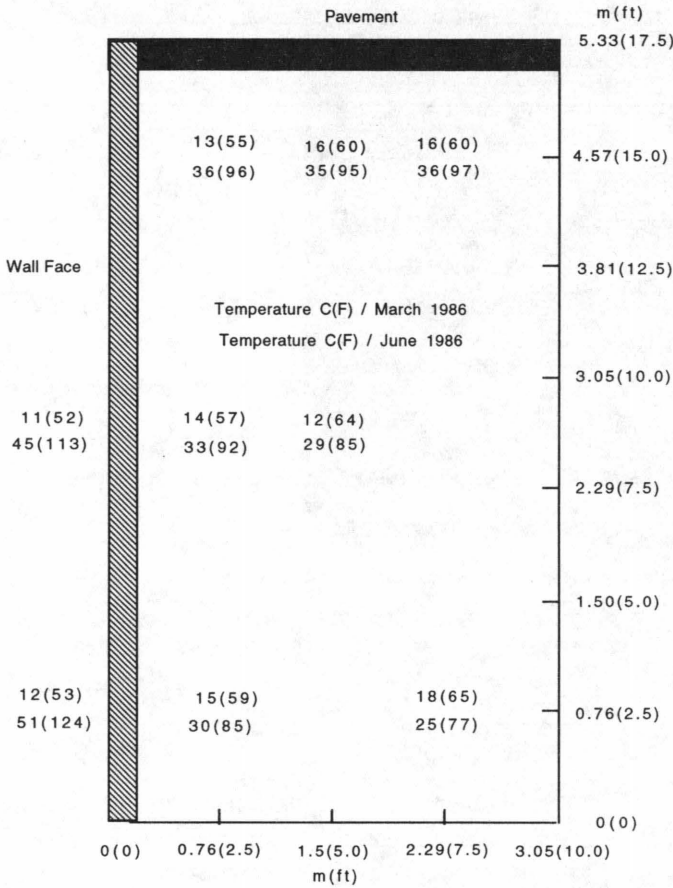
Based on resistance thermometer readings from one of the two monitored Type D wall sections, transient temperatures up to approximately 49°C (120°F) on the concrete wall face panels were recorded, and up to approximately 38°C (100°F) behind the panels. Figure 3 shows the temperature readings at various elevations within a Type D wall section as recorded in March and June 1986.

FIGURE 3 Temperature readings within a wall section.

Tanque Verde project, both at the same loading of 31.7 kN/m. After 1,000 hr, both specimens exhibited a parallel response to the same constant, sustained loading, indicating that the mechanism by which creep occurs is the same. This behavior indicates that more than 8 years of exposure to an elevated temperature environment has not changed the creep response of aged versus production SR2 geogrid. Figure 13 shows the creep response of exhumed and archived SR2 geogrid specimens at the design loading, 29 kN/m for a total strain response of less than 10 percent. The archived geogrid has been in storage since its manufacture in 1984. At about 1000 hours, the two specimens are becoming asymptotic to less than 8.5 percent total strain. The two response curves are essentially parallel, indicating that the mechanism by which creep occurs is the same within the two geogrid specimens. Although these two geogrids are from different lot numbers, as discussed earlier, their response with time to a constant, sustained load is essentially the same; in addition, the mechanism by which the geogrid specimens respond is identical and thus has not changed over more than 8 years' duration and exposure to different aging temperatures, ambient and elevated, as documented in Figure 3.

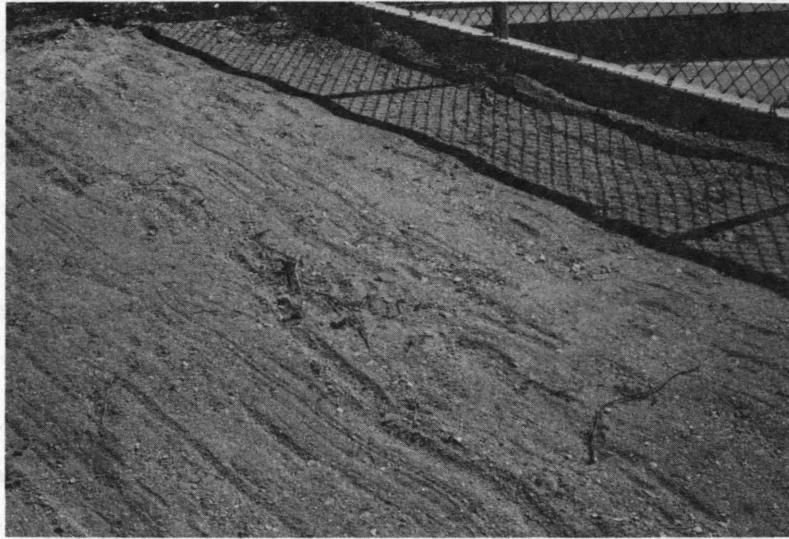
A sample 1 m wide by 2.5 m long of the geogrid soil reinforcing elements from the Tanque Verde project was exhumed in August 1993. The sample was hand excavated from a Type A wall (Figure 2) adjacent to Tanque Verde Road (Figure 4). Figure 5 shows the ground surface before excavation; Figure 6 shows the texture and composition of the excavated reinforced fill. The sample was located 0.3 to 0.4 m beneath the finished grade behind the wall face, as shown in Figure 7. Once the bulk of reinforced fill was removed with shovels, the geogrid was brushed clean with a small whisk broom to avoid exhumation damage. Figure 8 shows the geogrid brushed clean before its removal. Figure 9 is a representative close-up of the geogrid before its removal. Also this geogrid sample was exhumed from above a very active ant nest.

**FIGURE 5** Ground surface at excavation site of SR2 geogrid sample.

Photographs of the exhumation site at the Tanque Verde–Wrightstown–Pantano Roads intersection are presented as Figures 4 and 5. Figure 6 shows the texture and nature in the reinforced

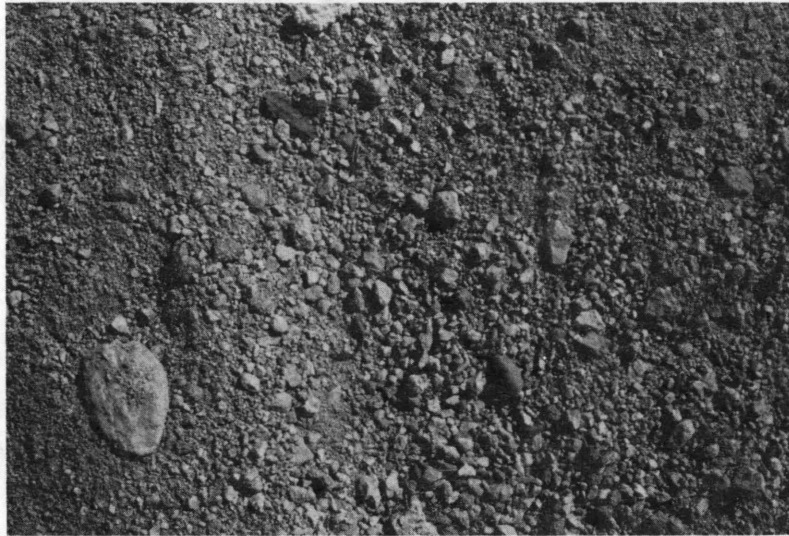
**FIGURE 6** Representative texture and composition of excavated reinforced fill.

fill, which was well-compacted and uniform. Figure 8 shows no broken or cut ribs over the surface of the exhumed geogrid sample; thus this sample experienced no significant installation or exhumation damage. There was no evidence of surface degradation due to attack by the resident ant colony; apparently the ants simply were not interested in a geogrid of HMW HDPE. Typically oxidation starts on the surface and progresses inward. An oxidized surface of a polyolefin, like polyethylene, will appear dull or tarnished. But surface quality is glossy, as evident in Figure 9, indicating no oxidative degradation in progress. Thus topological analysis by scanning electron microscopy was not warranted.

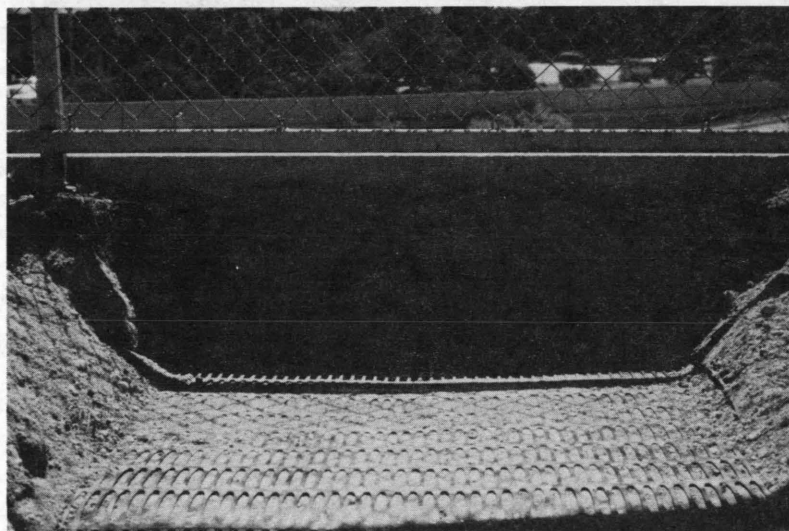
**FIGURE 7** Uncovered SR2 geogrid toward Type A wall.

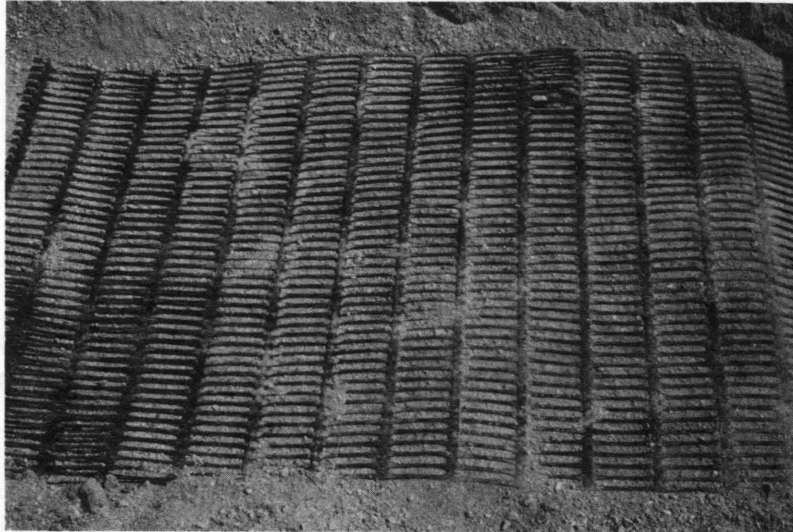
**FIGURE 8** SR2 geogrid brushed clean, showing no evidence of physical damage.

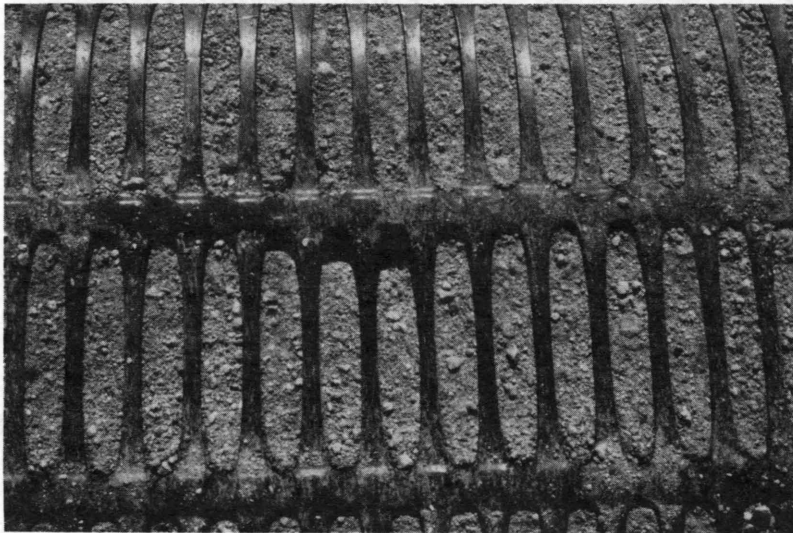
**FIGURE 9** Close-up of SR2 geogrid, showing no evidence of physical damage and presence of a glossy surface.

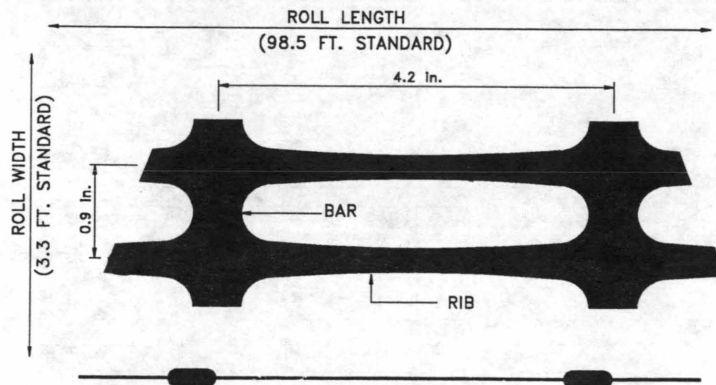
The soil reinforcing element used on this project is a Tensar SR2 geogrid. It is a uniaxial product fabricated by punching, reheating, and drawing an extruded sheet of high molecular weight, high-density polyethylene (HMW HDPE). The geometry of the geogrid is illustrated in Figure 10. Drawing increases the molecular orientation of the HMW HDPE, enhancing the tensile and modulus properties of the geogrid.

**FIGURE 10** Geometry of SR2 geogrid

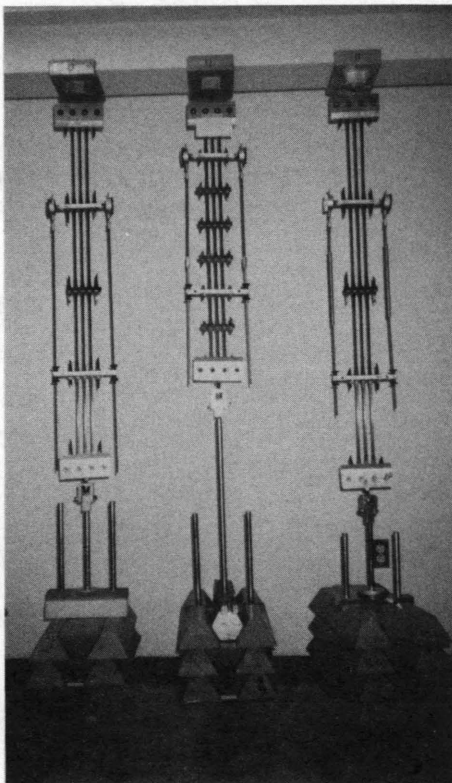
Physical and mechanical test results and resin properties are summarized in Table 2. For tests using multiple specimens, results in Table 2 are reported as arithmetic averages with standard deviation. Figure 11 shows the unconfined tension creep evaluation of the exhumed SR2 geogrid in progress. Figure 12 shows the creep response of specimens taken from two rolls of SR2 geogrid manufactured in the 1984–1985 era, but within 1 year, and loaded to 31.7 kN/m, equivalent to 2,170 lb/ft. One roll was chosen for quality control (QC) testing following its manufacture; the other roll went into the Tanque Verde project and was exhumed more than 8 years later for evaluation. Figure 13 shows the creep response of specimens taken from two rolls of SR2 geogrid manufactured in the 1984–1985 era also, and within 1 year; both specimens are loaded to the design loading of 29 kN/m (2,000 lb/ft). One roll was archived; the other roll is the same as in Figure 12. Results of thermal analysis of geogrid components are summarized in Table 3. Melt transition and crystallinity sample sizes ranged from 9.4 to 10.2 mg. Only one thermogram was run per component because specimens were taken at random and results were typical of HMW HDPE.

**FIGURE 11 Unconfined tension creep evaluation of exhumed SR2 geogrid (center).**

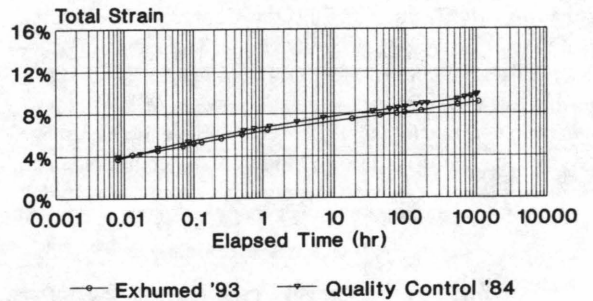
**FIGURE 12 Creep response of quality control and exhumed SR2 geogrids at 31.7 kN/m.**

Figure 12 shows the creep response of two SR2 geogrid specimens manufactured in the 1984–1985 era; one taken from a roll selected for QC assessment and the other exhumed from the

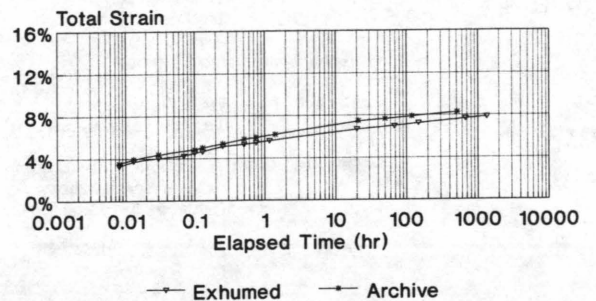
**FIGURE 13 Creep response of archived and exhumed SR2 geogrids at 29 kN/m.**

The Tanque Verde and archived geogrid samples were produced about 1984 but were from different production lots. The HMW HDPE geogrid experienced no significant installation or exhumation damage and exhibited no evidence of biological attack or surface oxidation. No significant change in physical, mechanical, thermal, or resin properties occurred throughout 8 or more years in service. The creep behavior of the archived and exhumed Tanque Verde geogrids is essentially identical and indicates that

the mechanism by which creep occurs has not changed throughout the years in service. Thus assessment has shown that the first project using a geogrid of HMW HDPE as reinforcement in a concrete-faced, MSE retaining wall in a major transportation-related application in North America has not experienced any significant change in the performance and physical properties of the geogrid or in the morphological properties of its resin in more than 8 years of exposure to an elevated temperature environment.
