TRANSPORTATION RESEARCH  
**RECORD**

No. 1439

**Durability of  
Geosynthetics**

# Transportation Research Record 1439

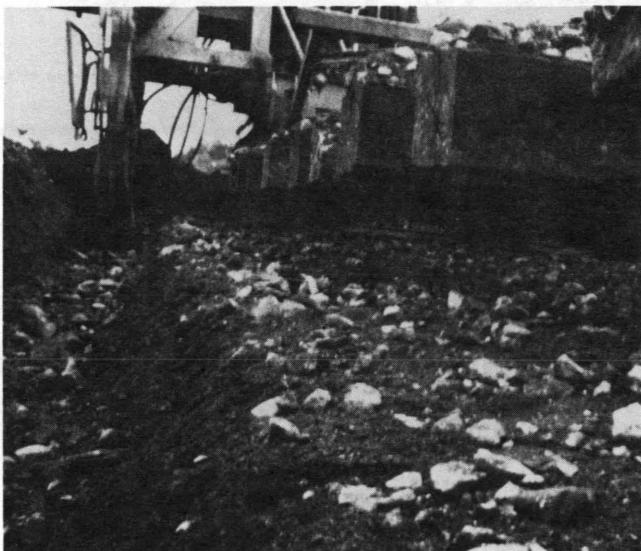
FIGURE 3 Condition of undercut ballast surface showing protruding particles.

the sharpness of the crushed particles, geotextiles that span and cannot elongate are cut from the impact of repetitive axle loading. Thus only geotextiles that can elongate around the particles were found to be satisfactory.

Undercut ballast has protruding aggregate particles, as illustrated in Figure 3. Track geotextiles must be able to elongate around

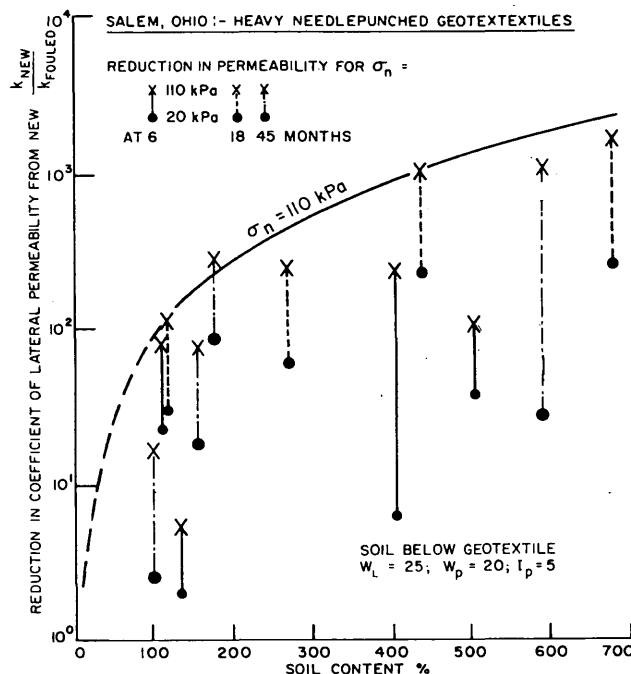
FIGURE 4 Permeability change ratio of exhumed geotextiles heavier than 500 g/m<sup>2</sup> when new.

It is concluded that a new geotextile's in-plane permeability was reduced less by products with low FOS. In general these products were constructed of fibers whose linear density was 0.7 tex or less, whose fibers had been tightly mechanically bonded by needle-punching, and were often resin bonded. Note that tex is the mass in milligram/meter length.

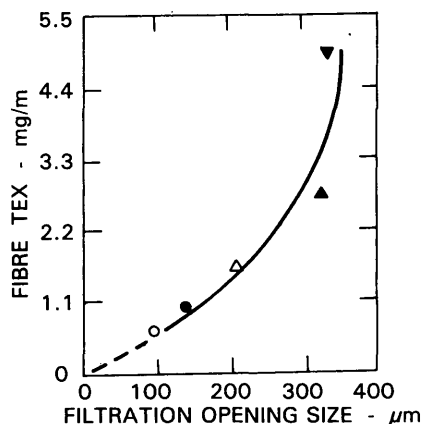
FIGURE 6 Effect of polyester fiber tex on measured filtration opening size of similarly manufactured 600 g/m<sup>2</sup> mass/unit area nonwoven needle-punched (80 p/cm<sup>2</sup>) geotextiles.

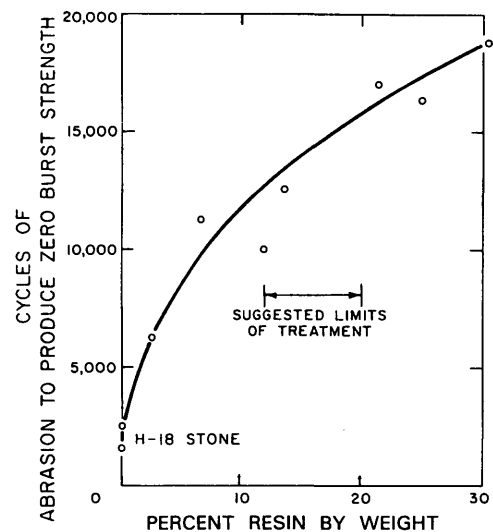
FIGURE 7 Cycles of abrasion required to cause zero burst strength for a 1000 g/m<sup>2</sup> polyester geotextile treated with different percentages by weight of resin.

A geotextile placed in a track environment must resist abrasion from large stone particle movement on its surfaces and from small particles that penetrate its fiber matrix. If the geotextile is installed at too shallow a depth the tamper tines will cut and tear the geotextile, as seen in Figure 2. At depths just below the penetration of the tamper tines the ballast is agitated during tamping. At even greater depths particle movement, although less abrasive, still occurs. Geotextiles in a track environment must clearly be abrasive resistant. An assessment of a geotextile's ability to resist abrasion was initially reported by Van Dine et al. (8) and extended by Costa and Raymond (9). Costa and Raymond recommended testing in the laboratory using the Taber Abrasor (ASTM D-3884, Rotary Platform Double Head Method) fitted with two H-18 Calibrade stones, each carrying a 1000-g mass. Figure 7 shows the results

of abrasion testing on a 1000-g/m<sup>2</sup> needle-punched polyester fiber geotextile using different percentages of resin treatment. Clearly even a little resin caused a major increase in abrasion resistance. The porosity of the untreated geotextile is about 85 percent. Because the resin has a specific gravity similar to polyester the resin treatment has little effect on the geotextile's porosity and in-plane permeability. Excess resin makes the geotextile too stiff to handle and install in the field, limiting the amount to 20 percent by weight.

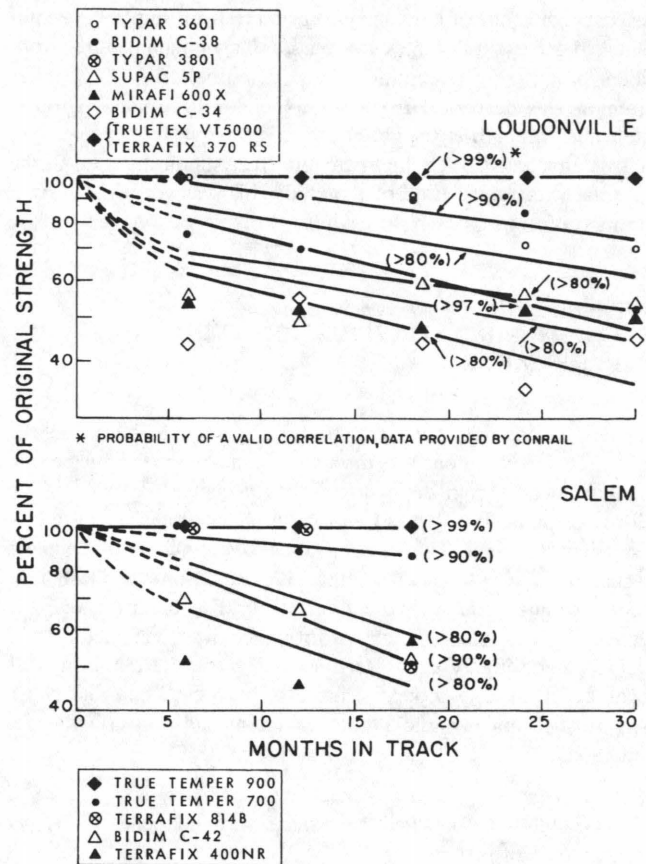
FIGURE 9 Relationship of time variation on Mullen burst strength of exhumed geotextiles from Conrail's two sites.

len burst test (ASTM D751) results from samples extracted at 6-month intervals after installation are shown in Figure 9. Figure 9 shows the burst strength ratios (exhumed burst strength-initial burst strength) against time. The data were subject to regression analysis (including the initial 100 percent value), and the regression fits are shown along with their statistical significance in the figure. Examination of plotted data shows that only well-needled polyester fiber materials showed little to no loss of burst strength and were statistically significant. These were Truetex VT5000 and Terrafix 370 (RS at  $r^2 = 99$  percent significance) from Loudonville, and True Temper 900 (at  $r^2 = 99$  percent significance) and True Temper 700 (at  $r^2 = 90$  percent significance) from Salem. The other polyester fiber materials were the three Bidim products that were manufactured as spun-bonded geotextiles with only a small amount of needle-punching. All the other geotextiles, made partly or wholly from other than polyester fiber, recorded between 25 and 70 percent loss in burst strength. The test data for these other geotextiles showed considerable scatter, having a statistical significance between 80 and 90 percent.

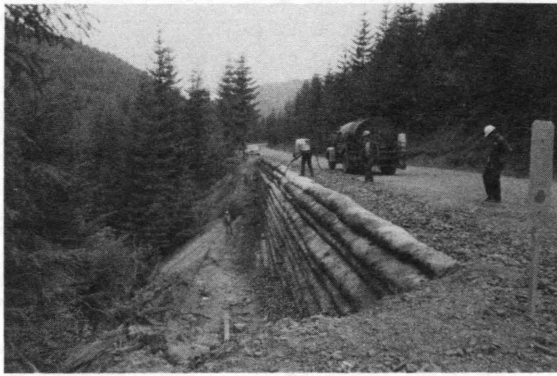
**FIGURE 1** Geotextile wall, with exposed material being sprayed with emulsified asphalt after construction.

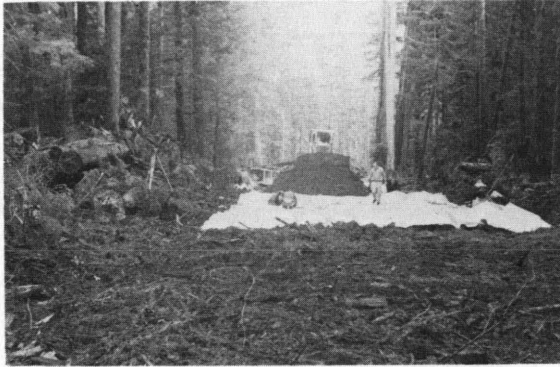
FIGURE 4 Dozer spreading rockfill on geotextile.

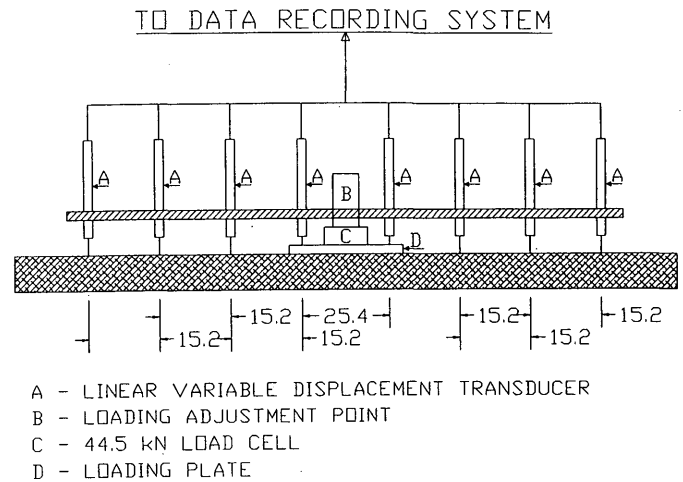
FIGURE 3 Schematic of instrumentation system.

The instrumentation system consisted of eight LVDTs and one load cell, as illustrated in Figure 3. The LVDTs were mounted at 15-cm intervals along the longitudinal axis of the test pit and were secured by a frame that was isolated from the motions of the reaction frame and loading system, except for the two LVDTs on the two loading plates, which were mounted 2.5 cm from the edge of the plate. The LVDTs were used to measure pavement surface displacement and the load cell was used to monitor the loads applied by the air piston. The data acquisition system consisted of analog-to-digital converters and multiplexing cards that mea-

sured the resulting voltages, converted them to binary format, and stored them in a data file. Measurements were collected five times per second.

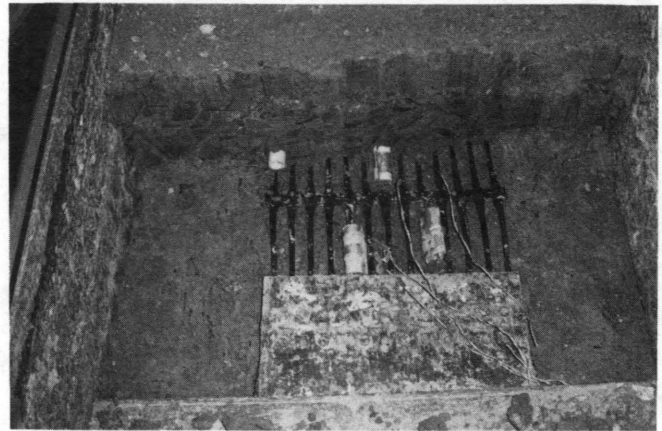
FIGURE 5 Placement of instrumented HDPE geogrid in confined extension test.

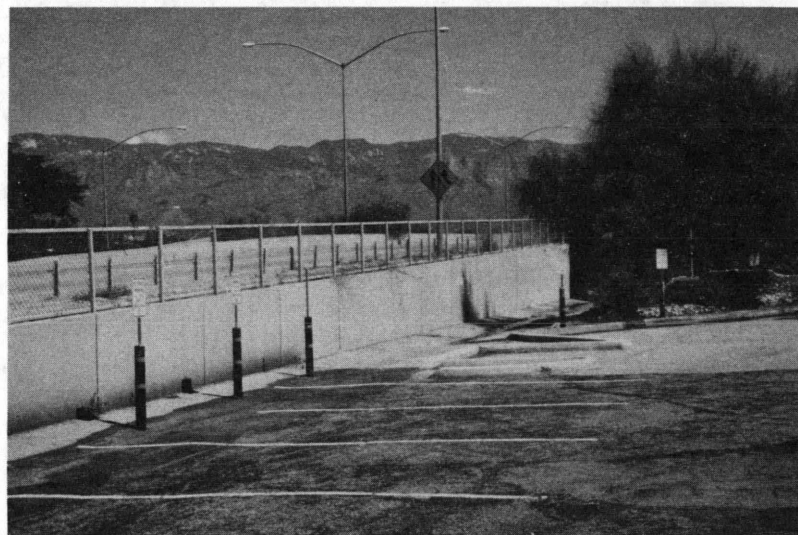
FIGURE 4 Type A wall where SR2 geogrid sample was exhumed.
