Polymer-Concrete Bridge Deck Overlays

MICHAEL E. DOODY AND RICK MORGAN

The results of a survey of polymer-concrete bridge deck installations (test patch and overlay) in New York and the results of a canvassing of the experiences of other states with these overlays are summarized. In New York two types of polymer overlay materials—thin epoxies and a thicker polyester—are used, with one thin epoxy used in New York State Department of Transportation Region 1 (Albany), two polyesters used in Region 10 (Long Island), and two thin epoxies used in Region 11 (New York City). In inspections during the summer of 1991 the conditions and performances of most of these overlays were found to be satisfactory.

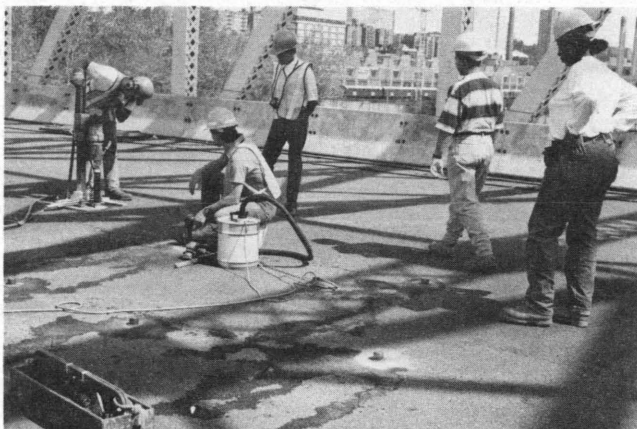
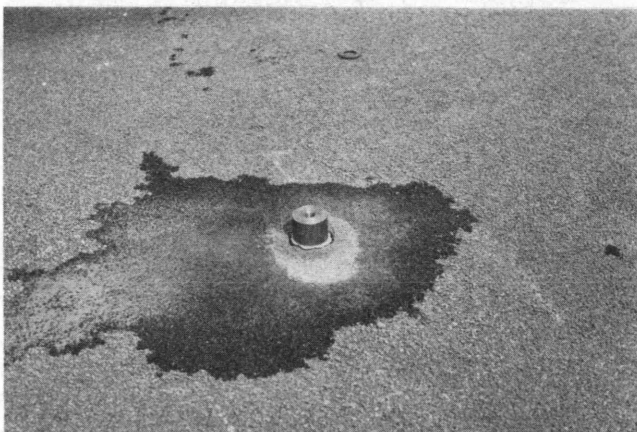
FIGURE 1 Adhesion testing included (a) partial-depth coring through overlay to underlying slab, (b) epoxying a steel plug to core, and (c) using a reaction frame and load cell.

Overlay bonding to an existing concrete surface (substrate) is an extremely important consideration in placing any overlay, because any bond deficiencies may lead to later delamination or punchout of the overlay. To test this tensile bond of the epoxy overlays, equipment was built to specifications established by the American Concrete Institute (9). The apparatus used for this surface adhesion test is shown in Figure 1. Tests involved partial-depth coring through the overlay into the existing slab. After cleaning and drying the overlay surface, steel plugs were epoxied to the surface of the partial-depth core. A reaction frame and calibrated load cell measured the direct force to pull the overlay from the existing substrate.

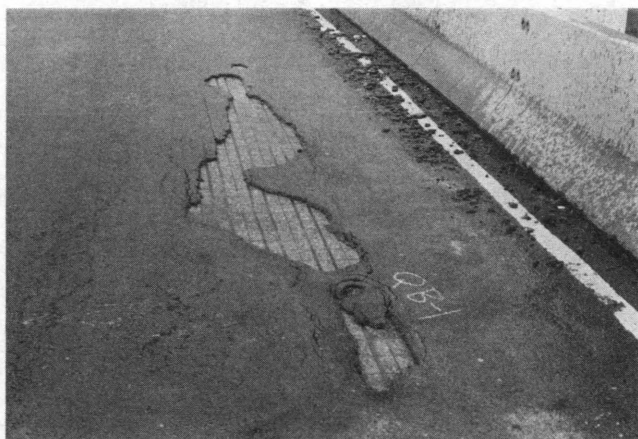
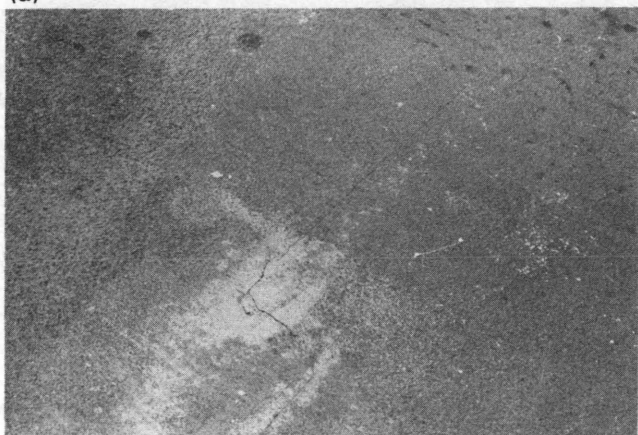
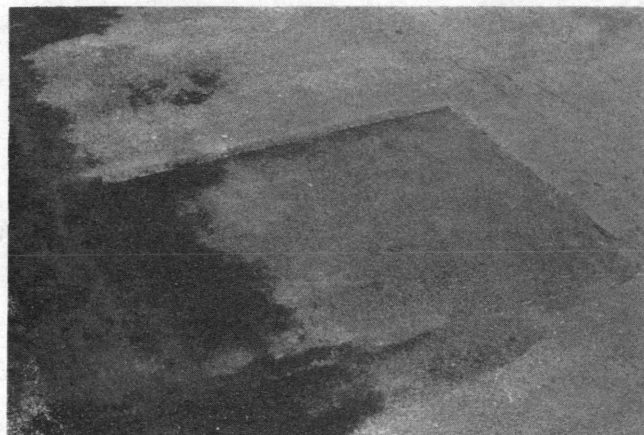
FIGURE 2 Surveys recorded peeling of overlay, exposing (a) underlying steel, (b) cracking, and (c) patching.

The PC overlays in place in New York were visually inspected by two project engineers in August and September 1991. Overlay condition was classified as (a) good, (b) peeled because of a poor bond, (c) cracked or worn, or (d) patched. Estimates of the surface area of each type of distress were mutually agreed upon by the two engineers. No chain drag or other means were used to determine delaminated areas. Each type of overlay distress is shown in Figure 2.

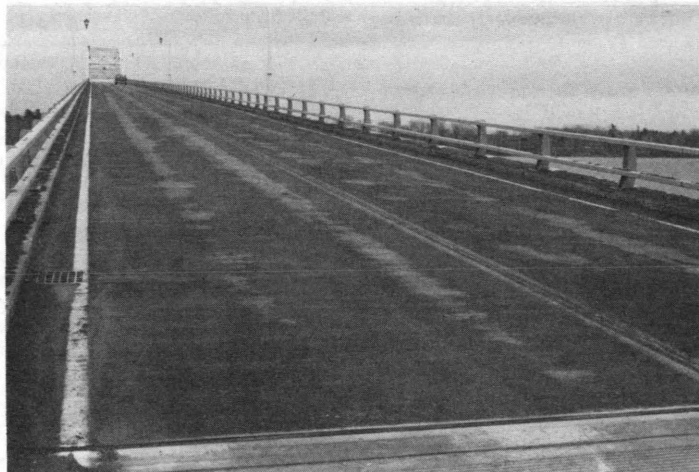
The PC wearing course was not well suited to this bridge. The product on the Approved List was obsolete, and the manufacturer had to prepare a special batch for this job. Because of the bridge's steep grade and the PC's flow characteristics it tended to run, and it proved difficult to achieve a smooth riding surface. Part of the first application of the wearing course was leveled off or removed and replaced because of an unacceptable riding surface caused by the product's tendency to run. The manufacturer modified the product a number of times to try to minimize this problem.

To characterize the resulting "washboard" effect (Figure 4), roughness was measured with a Soiltest road roughness indicator (roughometer). Measurement of pavement roughness is a primary indicator of riding quality, a general reading that translates the effect of all distress into the road user's frame of reference. Roughness caused by any factor can lead to additional deterioration by inducing more vertical movement of vehicles, producing more frequent and increasingly severe impact loads.

FIGURE 4 "Washboard" deterioration on Crown Point Bridge.

The roughometer ran twice on the approach section, midspan, and leave sections in both eastbound and westbound directions, and the readings were averaged to determine average roughness in millimeters per meter (inches per mile). Reading less than 3 mm/m (190 in./mi) are considered "good." For comparison readings were taken on a bridge with similar geometry on Congress Street (Route 2) over the Hudson River in Troy (BIN 1004279). Average roughness on the Crown Point Bridge was 2.21 mm/m (140 in./mi) eastbound and 2.12 mm/m (134 in./mi) westbound. Average roughness on the Route 2 bridge was 1.72 mm/m (109 in./mi) eastbound and 1.88 mm/m (119 in./mi) westbound. Both surfaces are performing adequately. In the most recent inspections of these overlays the wearing course low value was 6 on the Route 2 bridge (September 21, 1990) and 6 at Crown Point (January 21, 1992). The wearing course median value was 6 (all spans) on Route 2 and 6 (all spans) at Crown Point. On the basis of these measurements the performance at Crown Point is comparable after only 1 year of service to that at Route 2 after 7 years of service.
