Destructive Testing of Deteriorated Prestressed Box Bridge Beam

RICHARD MILLER AND KETAN PAREKH

A deteriorated prestressed box bridge beam was tested to destruction to determine the effects of deterioration on prestressed beam performance. Three prestressing tendons in one corner of the beam had corroded causing spalling of that corner. One of the tendons had broken and the other two were badly corroded, so only 15 tendons were effective. The resulting tendon pattern was asymmetric. A destructive test was conducted by loading the beam with two point loads. For comparison purposes, an undamaged beam with all 18 tendons intact was cast and tested. The undamaged beam held an applied moment of 2720 kN-m (2005 kip-ft) and did not fail. The deteriorated beam failed suddenly at a total applied moment of 1805 kN-m (1310 kip-ft). This reduction in moment capacity is not totally attributable to loss of tendons or cross section. The deteriorated beam also showed less deflection capacity at the midspan [270 mm (10.7 in.) versus 432 mm (17 in.)], more lateral deflection [28 mm (1.1 in.) versus 0 mm] and more web cracking than the undamaged beam. The final failure of the deteriorated beam appe

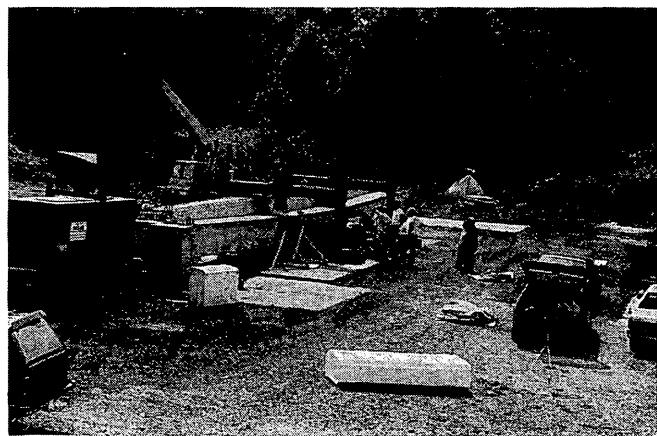
FIGURE 3 Testing frame.

of an existing foundation that could be used for securing two testing frames and because equipment for casting the undamaged beam and moving both the deteriorated and undamaged beams was readily available. The beams were loaded with two point loads placed 6.4 m (21 ft) apart, 8.5 m (28.8 ft) from either end. This load position was dictated by the position of existing tie-down plates for the testing frames. Two steel testing frames were fabricated to apply the loads (Figure 3).

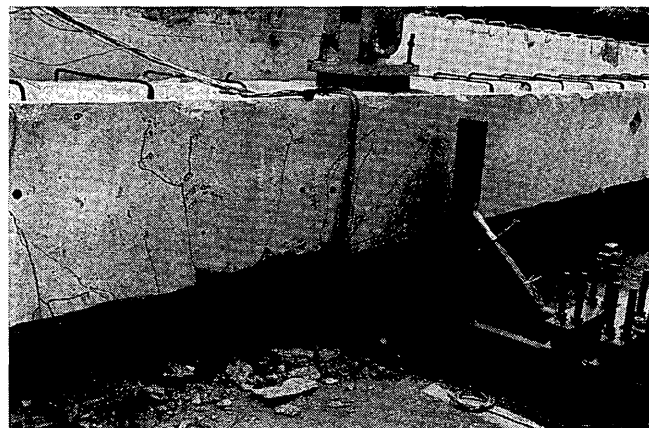
FIGURE 10 Crack pattern for deteriorated beam just before failure.

midspan deflection curve became flatter than that of the undamaged beam (Figure 7). The lateral deflection also increased significantly after cracking (Figure 9). It was noted that the initial flexural cracks propagated much higher into the web of the deteriorated beam than into the web of the undamaged beam (Figure 10).

As the load increased, the flexural cracks propagated high into the web and began to propagate into the top flange (Figure 10). The cracks in the deteriorated beam also are much farther apart than

those in the undamaged beam, probably because most of the prestressing steel under this web is missing and the remaining steel is not sufficient to properly distribute the cracks.
