TRANSPORTATION RESEARCH
RECORD

No. 1460

*Bridges, Other Structures, and
Hydraulics and Hydrology*

Semi-Integral Bridges: Movements and Forces

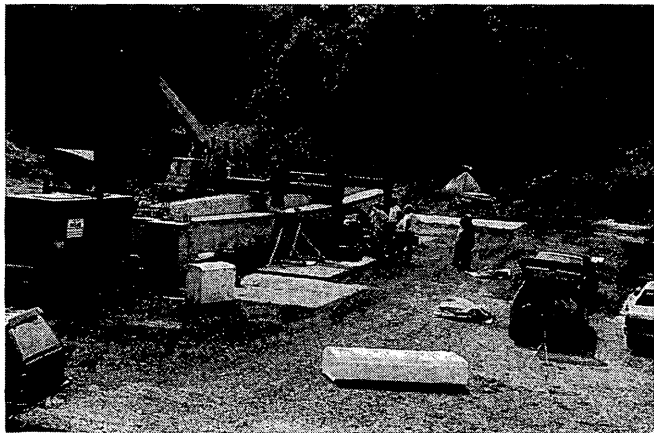
FIGURE 3 Testing frame.

The Ohio Department of Transportation (ODOT) engineers desired to match field conditions as closely as possible during the test. Because the test beam was an edge beam, the lateral deflection in one direction would be constrained by the presence of other

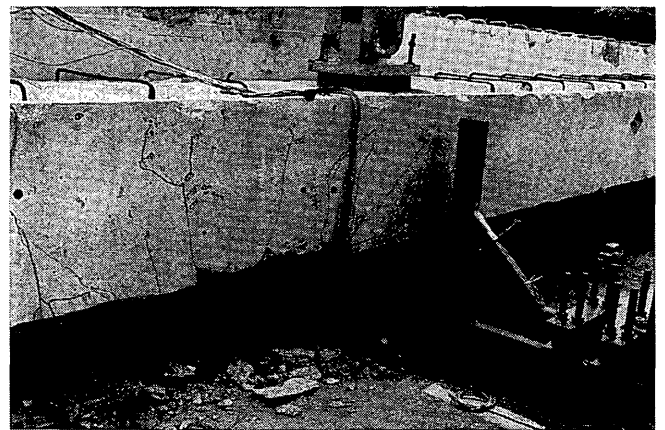
FIGURE 10 Crack pattern for deteriorated beam just before failure.

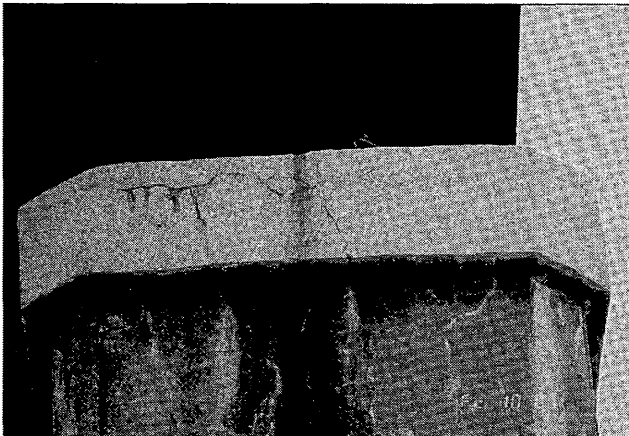
FIGURE 3 Observed deterioration of pier at Site 10 (chromium site).

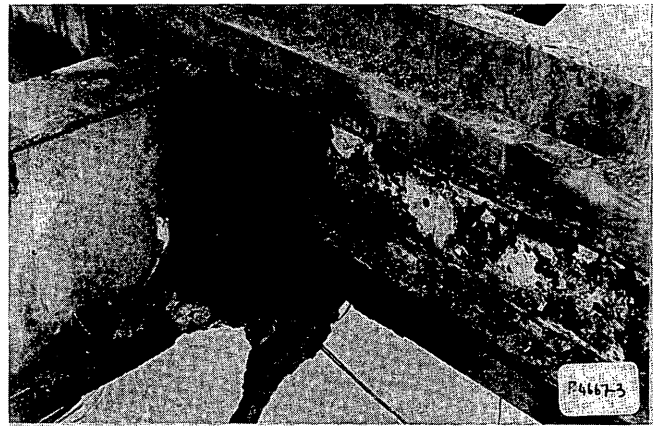
(b) Connections of Floor Beam and Exterior Stringer

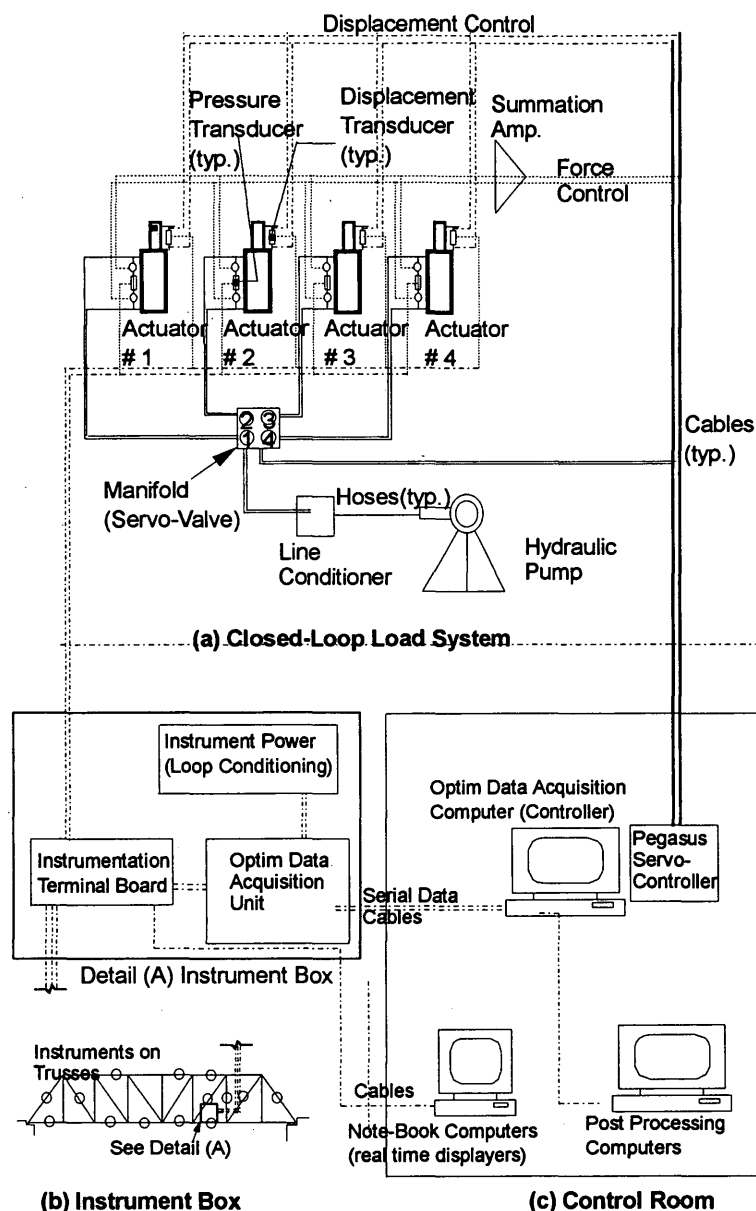
FIGURE 4 Loading and data acquisition system.

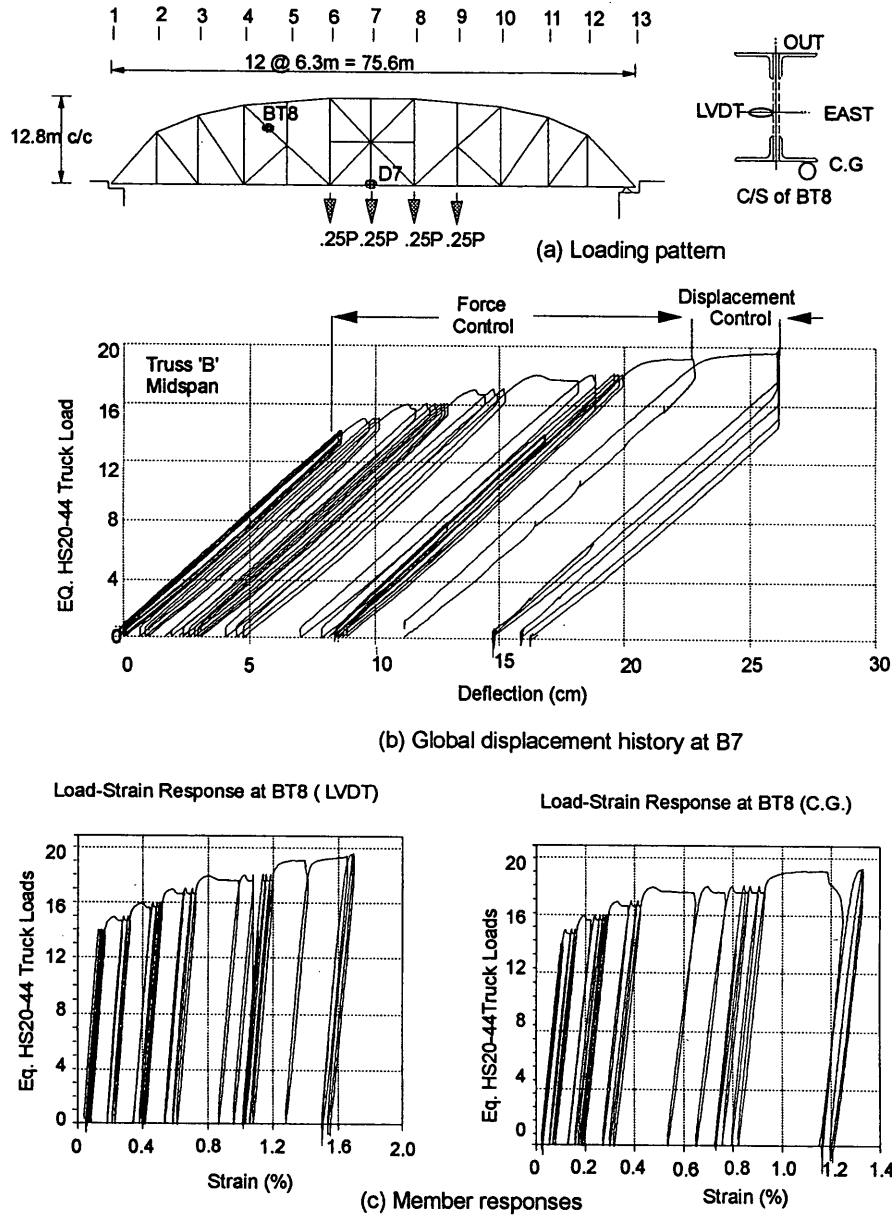
FIGURE 10 Destructive test responses of the Camelback Bridge.

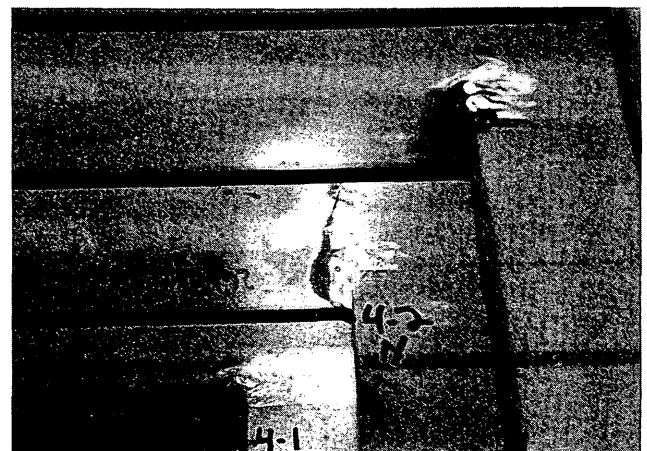
FIGURE 3 Crack in centerbeam at toe of stirrup weld.
