Tennessee Bridge Rail to Guardrail Transition Designs

KING K. MAK, ROGER P. BLYGH, AND PETE FALKENBERG

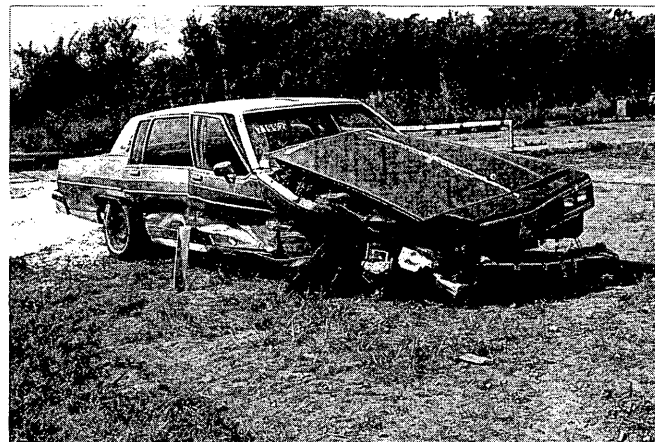
The damage to both the test installation and the vehicle is shown in Figure 6. The transition and concrete parapet sustained only minor damage. There was residual deformation to the rail in the area of the first three posts, with the maximum permanent rail deformation being 5.0 in. (12.7 cm). The spacer pipe positioned between the W-beam rail and the flared portion of the parapet collapsed approximately 1 in. (2.54 cm).

The damage sustained by the test vehicle was substantial. The maximum crush was 16.0 in. (40.6 cm) at the right front corner of the vehicle. The right front wheel and control arm were bent and pushed rearward 15.3 in. (38.7 cm) because of contact with the end and sloped face of the concrete parapet. The front end of the vehicle was shifted to the left 3.0 in. (7.6 cm). In addition, the subframe was bent, the floor pan was buckled, and the windshield was broken.

FIGURE 6 Barrier (*top*) and vehicle (*bottom*) damage after testing of System 1.

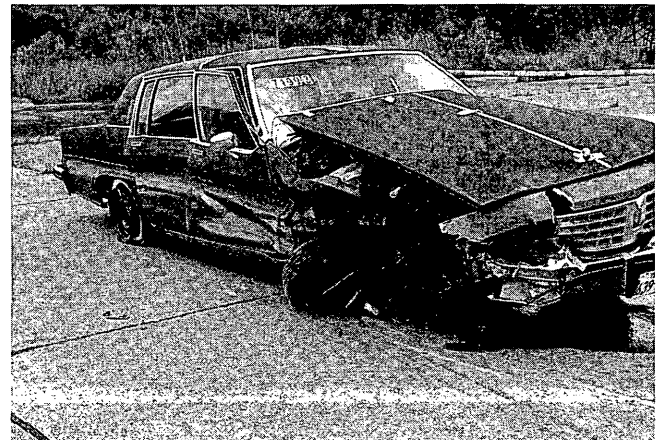
Figure 8 shows the damage to the barrier and vehicle after the test. Residual deformation of the guardrail occurred in the vicinity of the first six posts. The maximum permanent rail deformation was measured to be 4.0 in. (10.2 cm). Vehicle tire marks were noted on the outside flanges of Posts 1 and 2 and on the end of the concrete bridge parapet. The introduction of additional posts in the wheel-path of the vehicle permitted more wheel snagging to occur, which in turn damaged the wheel and resulted in contact with the end of the parapet. The spacer pipe experienced 2.5 in. (6.53 cm) of permanent deformation and performed as intended.

The test vehicle sustained extensive damage. The maximum recorded crush was 20.0 in. (50.8 cm) at the right front corner of the

FIGURE 8 Barrier (*top*) and vehicle (*bottom*) damage after testing of System 2.

vehicle. The right front wheel and control arm were bent and pushed rearward a distance of 11.0 in. (27.9 cm). The entire front end of the vehicle was shifted to the left 2.5 in. (6.4 cm). In addition, the right front brake disc was pulled off the spindle, the subframe was bent, and the windshield was broken. Contact of the subframe with the face of the concrete parapet resulted in some minor buckling or wrinkling of the floor pan. The entire right side of the vehicle was dented and scraped by contact with the nested W-beam rail.

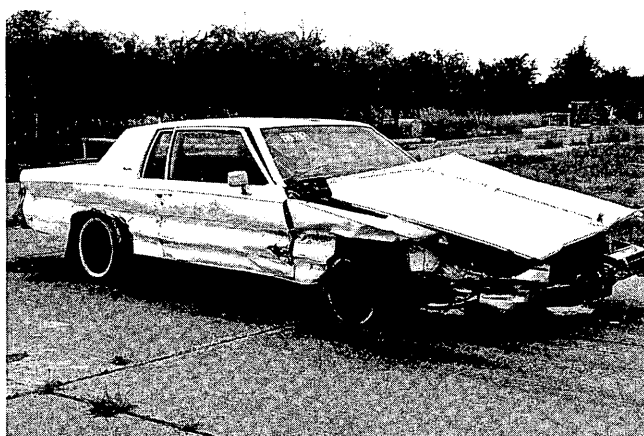
Damage to the transition and vehicle after testing of System 3 is shown in Figure 10. The installation sustained relatively minor damage for an impact of this severity. There was residual deformation to the guardrail in the vicinity of the first three posts. The maximum permanent deformation along the W-beam rail was 4.5 in. (11.4 cm). Maximum permanent deformation to the rub rail was 2.0 in. (5.1 cm). The steel spacer pipe collapsed 1.5 in. (3.81 cm).

Damage to the test vehicle was considerable. The maximum crush was 19.0 in. (48.3 cm) at the right front corner of the vehicle. The right front wheel and control arm were severely bent and pushed rearward 11.0 in. (27.9 cm). The entire front end of the vehicle was shifted to the left 4.5 in. (11.4 cm). In addition, the subframe was bent, the floor pan was buckled, and the windshield was broken.

FIGURE 10 Barrier (top) and vehicle (bottom) damage after testing of System 3.
