# Improved Breakaway Utility Pole, AD-IV

DEAN C. ALBERSON AND DON L. IVEY

Performance-tested breakaway utility poles have been available for almost a decade. The Texas Transportation Institute developed the Hawkins Breakaway System for FHWA under a contract completed in 1985. Design modifications to decrease the tolerance requirements of the upper hinge connection and the base connection have been completed by the Texas Transportation Institute. These modifications have reduced the amount of material used in the base connection, reduced the machining cost for the upper hinge straps, and significantly reduced the maintenance procedures for the upper connection. In turn initial costs and maintenance costs have been reduced. The new design, AD-IV, was subjected to three pendulum tests and was crash tested with a 1,800-lb automobile at 60 mph. AD-IV meets the test evaluation criteria of *NCHRP Report 230*. FHWA granted approval of the system on June 17, 1993.

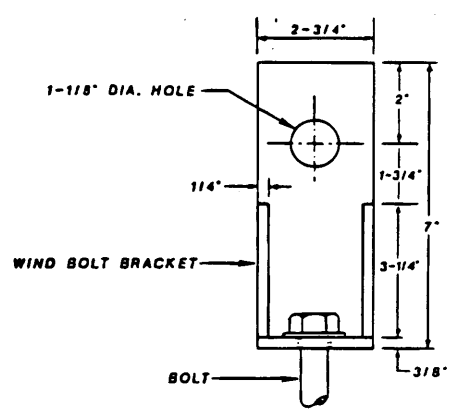
**ROTATION STRAP DETAIL**  
SCALE: 1/2"-1"

**WIND BOLT & BRACKET DETAIL**  
SIDE VIEW  
SCALE: 1/2"-1"

**WIND BOLT & BRACKET DETAIL**  
FRONT VIEW  
SCALE: 1/2"-1"

**FIGURE 5** Detail of rotation strap, wind bolt, and bracket.

Similar in basic structure, this connection consists of a pair of pole bands installed above and below a saw cut through the pole. The straps connecting the pole bands are detailed in Figure 5. The pole bands (and straps) are further secured to the pole by means of 1-in.-diameter through bolts as shown in Figure 6. At the bottom pole band, the bolt pass through the upper-end of a 5¾-in. slot. Initial bending resistance is provided by the strength of four ½-in. gal-

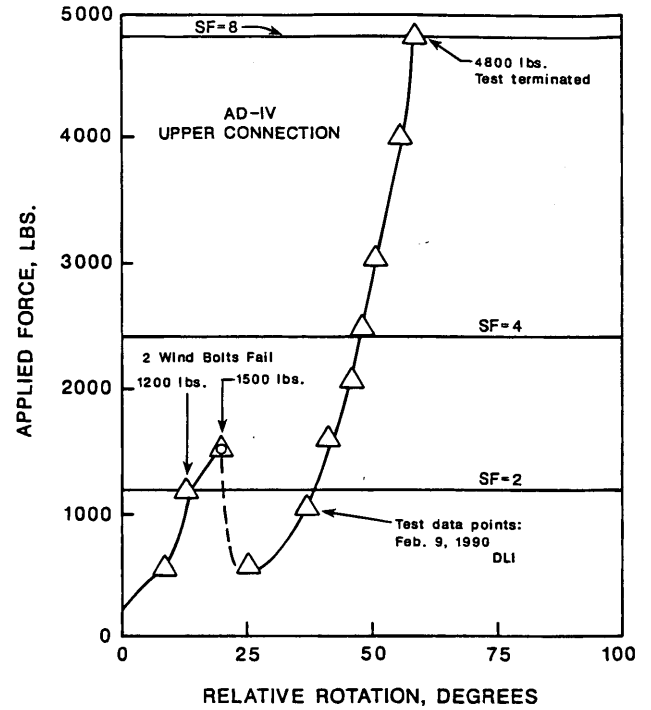
FIGURE 8 Load-rotation characteristic of AD-IV upper connection (ultimate load safety factor is greater than eight).

The load versus rotation curve is presented in Figure 8. This curve is similar to that of the HBS upper connection (shown in Figure 2) and achieves the same safety factors at the appropriate angular rotation levels.

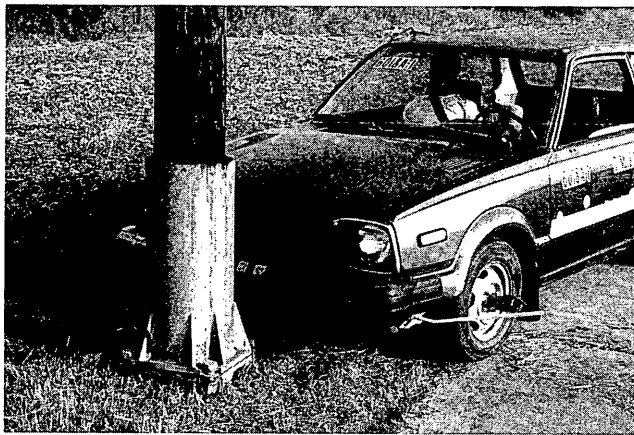
FIGURE 9 Vehicle and utility pole geometrics for Test 6018A-1.

A 1980 Honda Civic (Figure 9) was used for the full scale crash test. The inertial mass of the test vehicle was 1,800 lb (816 kg), and its gross static mass was 2,130 lb (966 kg). The vehicle was directed into the utility pole by the cable reverse tow and guidance system and was released to be freewheeling and unrestrained just before impact. The vehicle impacted the pole at a speed of 59.6 mph (95.9 km/hr), and the angle of impact was 15.0 degrees relative to the strung wires.

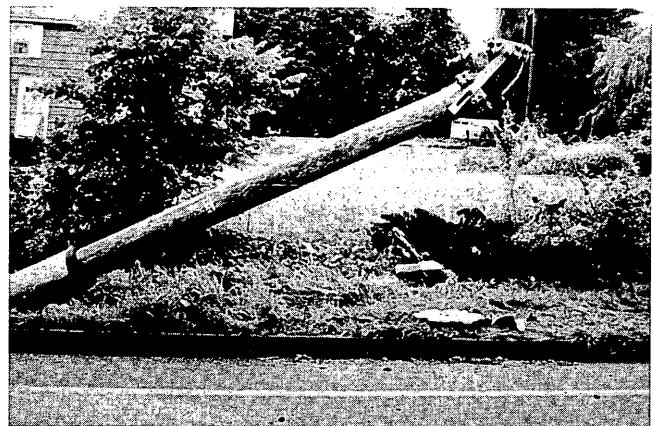
FIGURE 10 Field installation after collision.

As can be seen in Figure 10, the pole received minor damage at the top cross members, the hinge deflected, and the upper guy wire broke at its connection at 0.377 sec after impact. This guy wire break would not be the normal case in a field installation because it was found that a 3/8-in. wire rope was used; it should have been 1/2 in. The normal field installation after being impacted in the August 24, 1990, hit in Grafton, Massachusetts, is shown in Figure 11. The lower section of the pole and the slip base were undamaged. Brakes were applied at 1.13 sec, and the vehicle came to rest 165.0 ft (50.3 m) from the point of first contact.

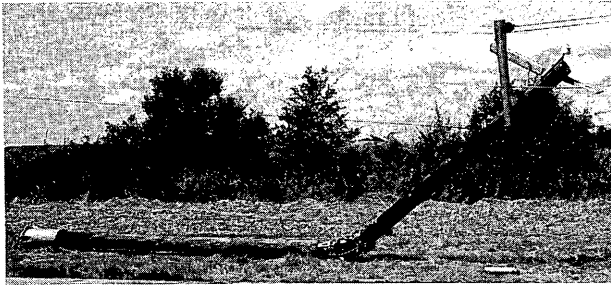
FIGURE 11 Utility pole after Test 6018A-1.

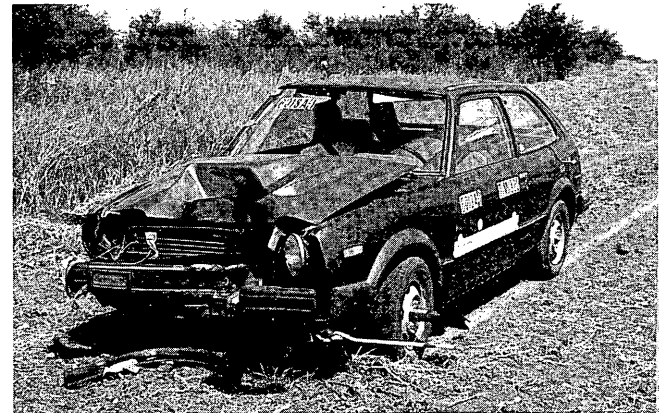
FIGURE 12 Vehicle after Test 6018A-1.

The vehicle sustained damage as shown in Figure 12. Maximum crush at the center front bumper height was 17.0 in. (43.2 cm), and

both the left and right front corners were pulled inward approximately 2.0 in. (5.1 cm).
